Annual Inspection

Mid Suffolk District Council

Drinkstone

Annual Inspection - 11 September 2015 at 08:06 Inspector: Matt Clay (RPII Annual Inspector)

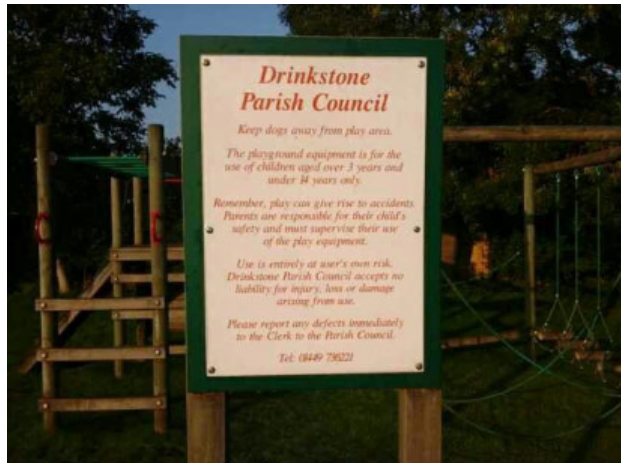
Item: Ancillary Items - Sign
Manufacturer: Owner/Operator
Surface Type: N/A
Equipment Compliance: N/A
Surface Area Compliance: N/A
Ref/Part Number:
Total Findings: 3

It is recommended that information signs with emergency contact details are installed at each entrance/exit point to the playground - Provide in accordance with the recommendations set out in BS EN 1176

There is some strimmer damage apparent on the posts, this can penetrate the preservative applied to the timber and accelerate the rotting process - Monitor for any deterioration (rot) and replace as required

There is some evidence of rot in the timber - Monitor for any further deterioration and replace as required

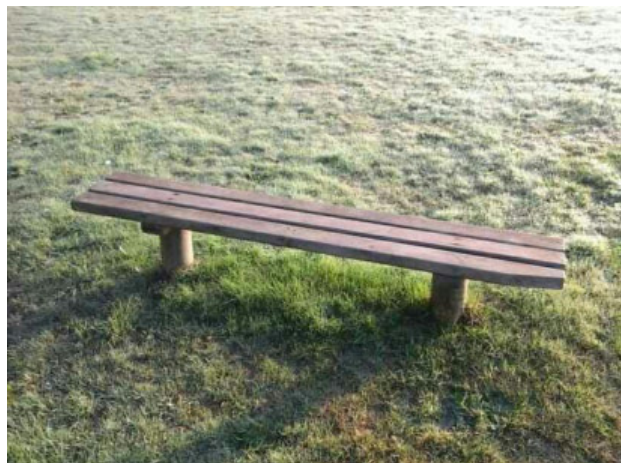
Item: Ancillary Items - Bench
Manufacturer: Owner/Operator
Surface Type: N/A
Equipment Compliance: N/A
Surface Area Compliance: N/A
Ref/Part Number:
Total Findings: 1

There is some strimmer damage apparent on the posts, this can penetrate the preservative applied to the timber and accelerate the rotting process - Monitor for any deterioration (rot) and replace as required

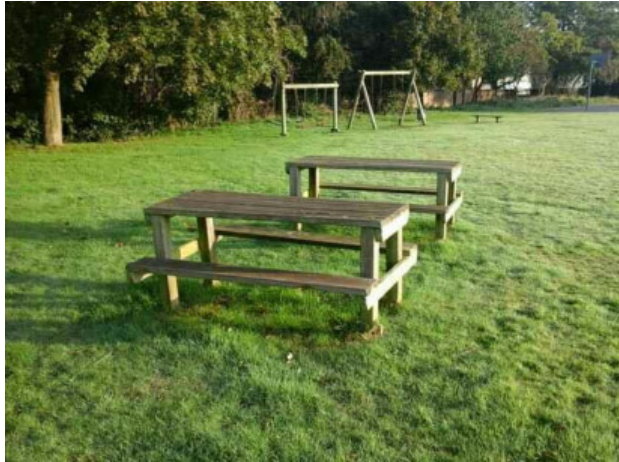
Item: Ancillary Items - Picnic Table
Manufacturer: Owner/Operator
Surface Type: N/A
Equipment Compliance: N/A
Surface Area Compliance: N/A
Ref/Part Number:
Total Findings: 2

There is some strimmer damage apparent on the posts, this can penetrate the preservative applied to the timber and accelerate the rotting process - Monitor for any deterioration (rot) and replace as required

There is some evidence of rot in the timber - Monitor for any further deterioration and replace as required

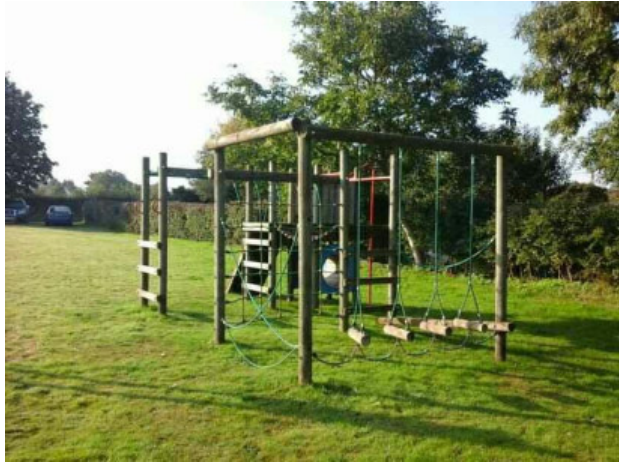
Item: Activity Equipment - Log Climber
Manufacturer: Adventure Playgrounds
Surface Type: Grass Matrix Tiles
Equipment Compliance: No
Surface Area Compliance: Yes
Ref/Part Number:
Total Findings: 9

There is some evidence of rot in the timber - Monitor for any further deterioration and replace as required

There is some strimmer damage apparent on the posts, this can penetrate the preservative applied to the timber and accelerate the rotting process - Monitor for any deterioration (rot) and replace as required

The balance beam forms a hard object within the falling space of the equipment in contravention of the requirements of BS EN 1176 Part 1 - Monitor use

The item fails to meet the requirements of BS EN 1176:2008 Part 1 4.2.7.2 for head and neck entrapment between the timbers - Monitor use

A number of fixing(s) have worked loose - Secure all loose fixings

There is some evidence of rot in the timber crossbar - Monitor for any further deterioration and replace as required

The connecting links are in excess of 8.6mm and less than 12mm and fail the requirements of BS EN 1176:2008 Part 1; clause 4.2.13, Chains - Monitor use and replace with compliant links at the next maintenance cycle

The timber has a number of air cracks apparent, the splits will have penetrated the preservative applied to the timber and allow water ingress to the unprotected areas - Monitor for any deterioration (rot) and replace as required

There is/are bolt cap covers missing or damaged on the item - Replace missing or damaged bolt cap covers

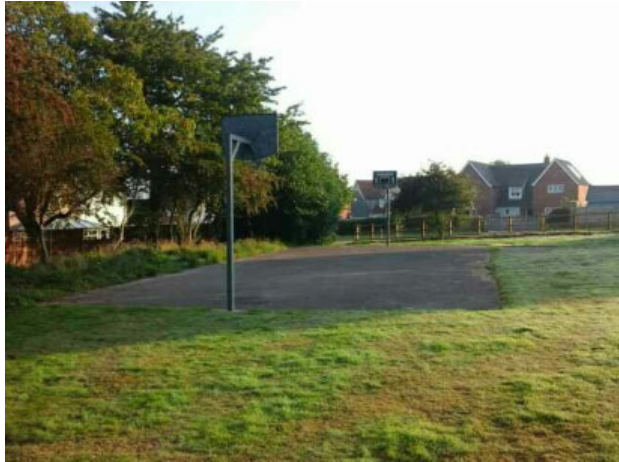
Item: Multi Use Games Area - Multi Use Games Area (MUGA)
Manufacturer: Sport England
Surface Type: Tarmac
Equipment Compliance: Yes
Surface Area Compliance: N/A
Ref/Part Number:
Total Findings: 2

A clearly visible sign should be provided in a prominent position with the wording as detailed BS EN 15312 - the equipment is not intended for children less than 3 years old - the warning Do not climb on the framework or nets - the warning Do not hang on the ring (if provided) - the warning Do not wear rings or other jewellery - name and telephone number of the administrator - number to call in case of accident - Provide signage to BS EN 15312

There is some graffiti present - Remove the graffiti

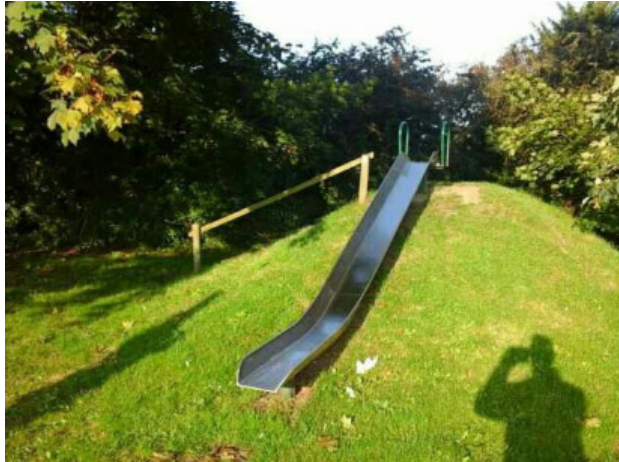
Item: Activity Equipment - Multi Play (Junior)
Manufacturer: Owner/Operator
Surface Type: Grass
Equipment Compliance: No
Surface Area Compliance: Yes
Ref/Part Number:
Total Findings: 5

There is some evidence of rot in the timber - Monitor for any further deterioration and replace as required

The foundations are exposed - Reinstate surface levels as required

The slide start section incline is not in the direction of travel; it should slope towards the direction of the sliding surface - Monitor use

There is a toggle entrapment at the top of the slide - Monitor Use

The surface around the item is worn - Reinstate surface levels as required

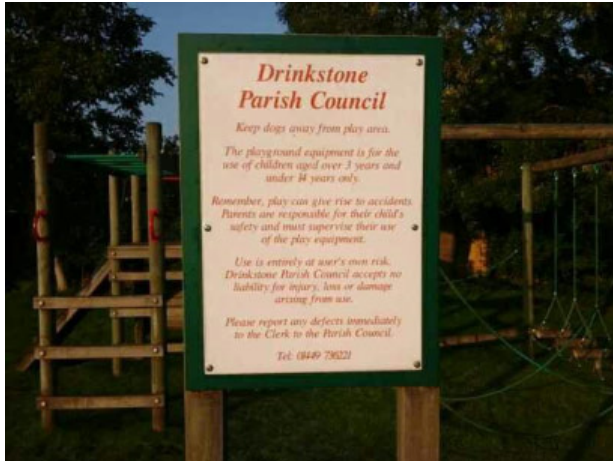
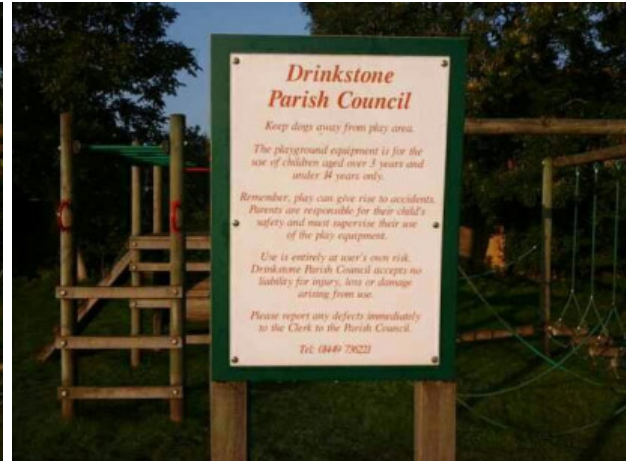
Item: Ancillary Items - Sign
Manufacturer: Owner/Operator

Finding: It is recommended that information signs with emergency contact details are installed at each entrance/exit point to the playground

Action: Provide in accordance with the recommendations set out in BS EN 1176

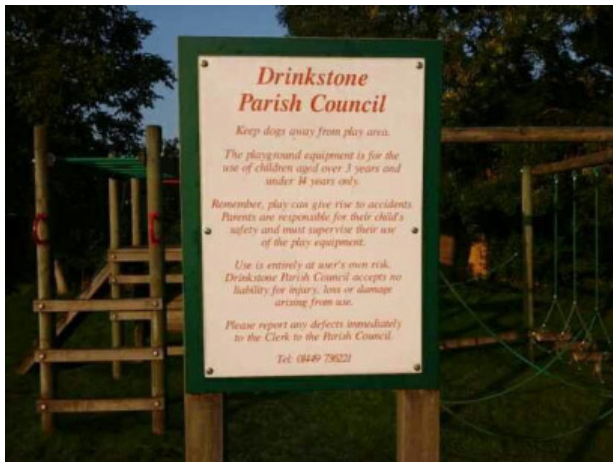
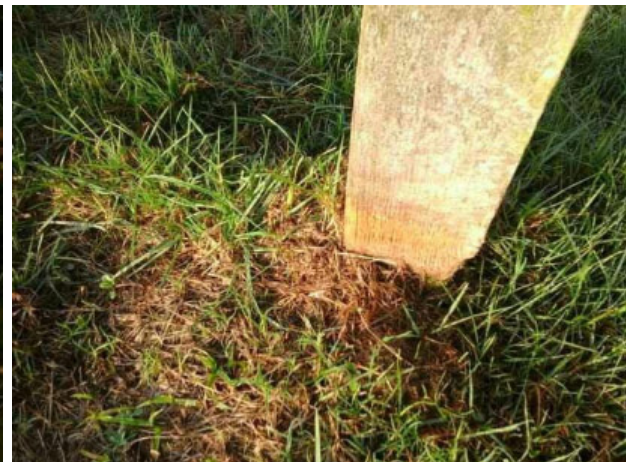
Item: Ancillary Items - Sign
Manufacturer: Owner/Operator

Finding: There is some strimmer damage apparent on the posts, this can penetrate the preservative applied to the timber and accelerate the rotting process

Action: Monitor for any deterioration (rot) and replace as required

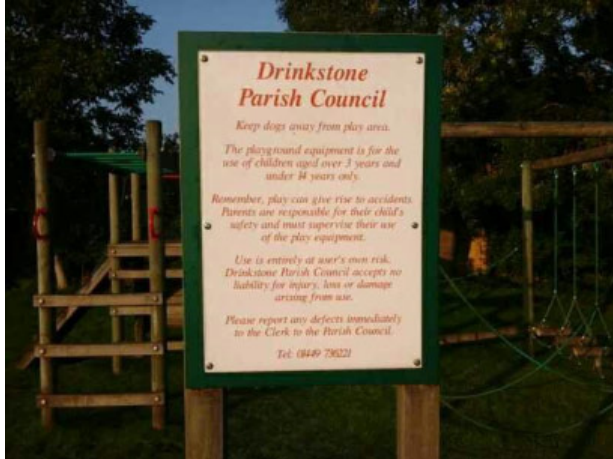
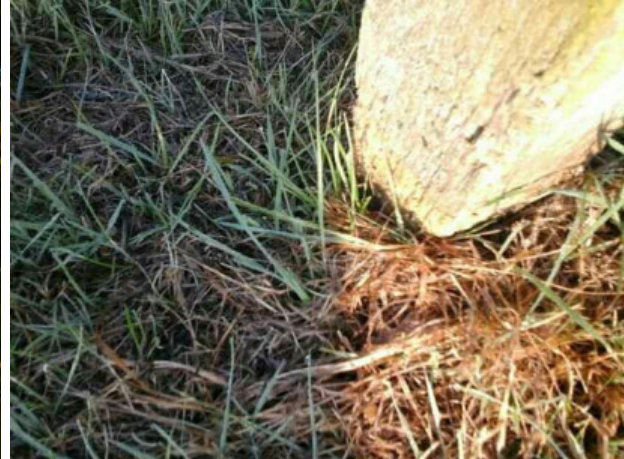
Item: Ancillary Items - Sign
Manufacturer: Owner/Operator

Finding: There is some evidence of rot in the timber

Action: Monitor for any further deterioration and replace as required

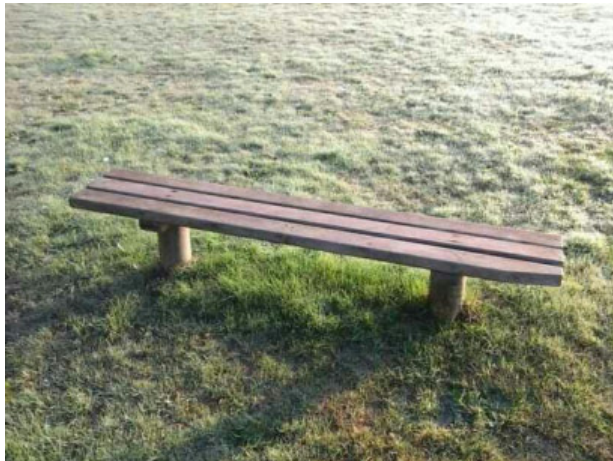
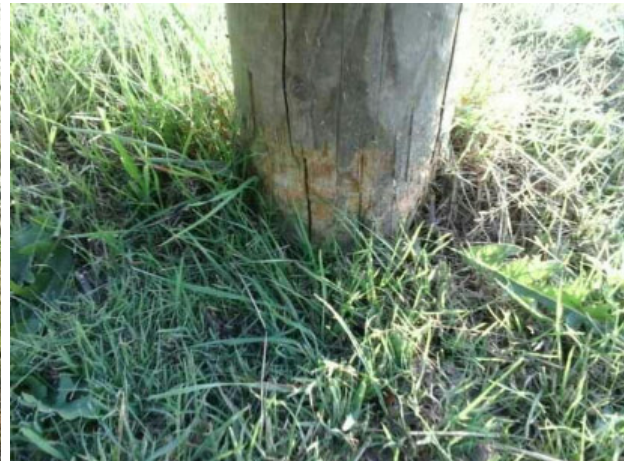
Item: Ancillary Items - Bench
Manufacturer: Owner/Operator

Finding: There is some strimmer damage apparent on the posts, this can penetrate the preservative applied to the timber and accelerate the rotting process

Action: Monitor for any deterioration (rot) and replace as required

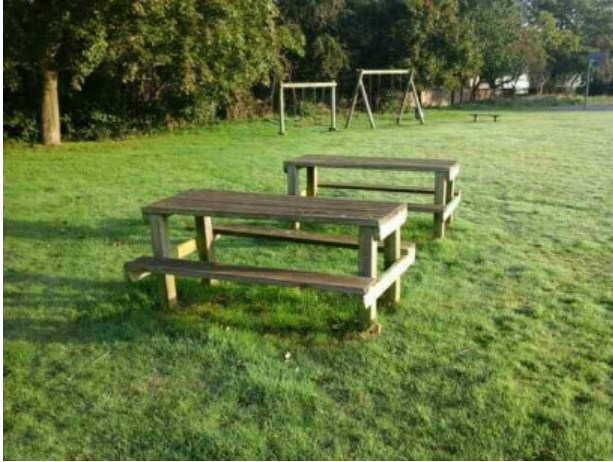
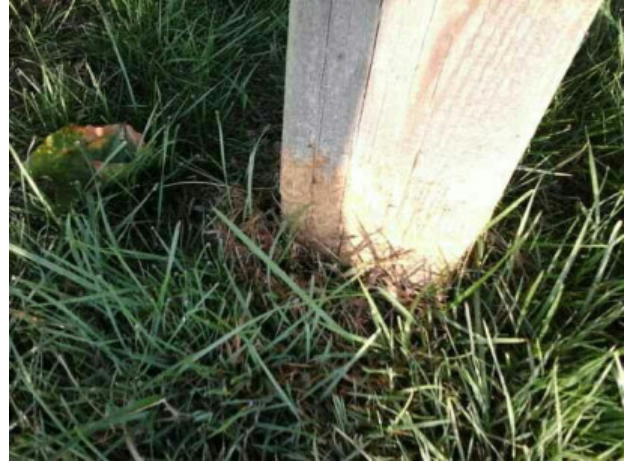
Item: Ancillary Items - Picnic Table
Manufacturer: Owner/Operator

Finding: There is some strimmer damage apparent on the posts, this can penetrate the preservative applied to the timber and accelerate the rotting process

Action: Monitor for any deterioration (rot) and replace as required

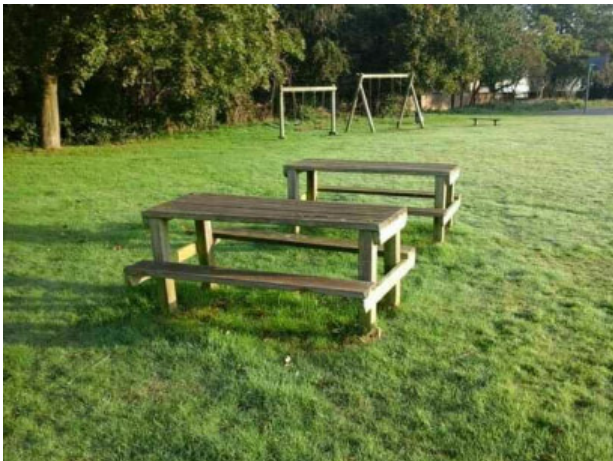
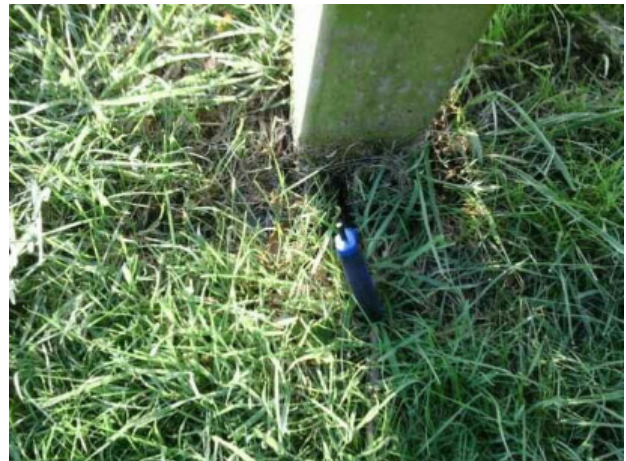
Item: Ancillary Items - Picnic Table
Manufacturer: Owner/Operator

Finding: There is some evidence of rot in the timber

Action: Monitor for any further deterioration and replace as required

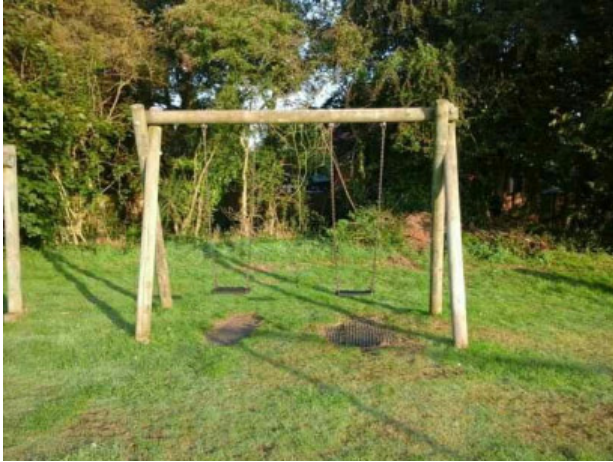
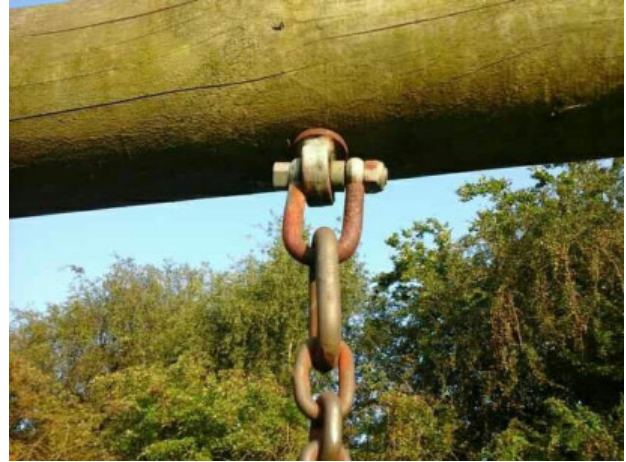
Item: Swings - 1 Bay 2 Seat (Flat)
Manufacturer: Adventure Playgrounds

Finding: The bushes are showing signs of wear

Action: Monitor for any further deterioration and replace as required

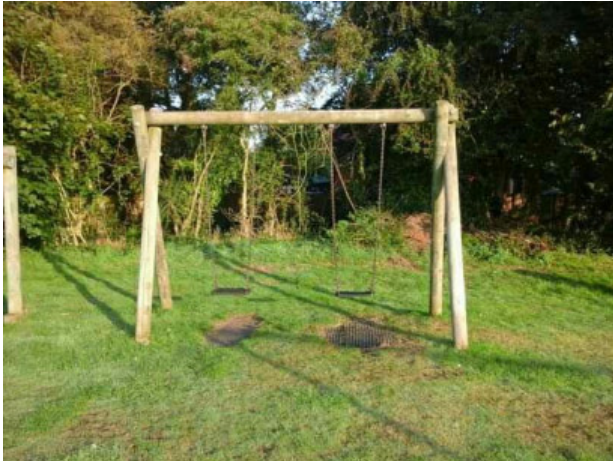
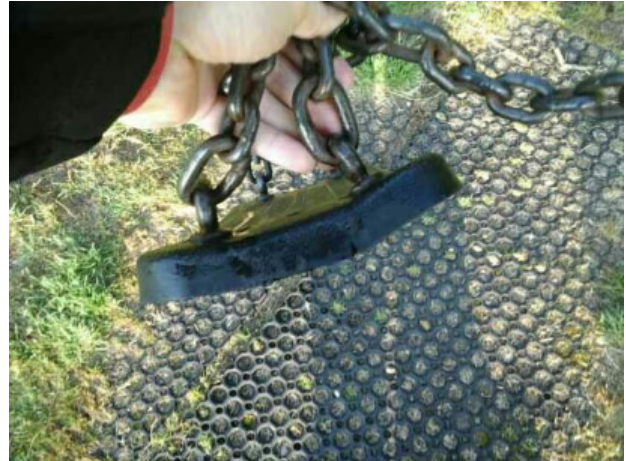
Item: Swings - 1 Bay 2 Seat (Flat)
Manufacturer: Adventure Playgrounds

Finding: The seat has minor damage or wear

Action: Monitor for any further deterioration and replace as required

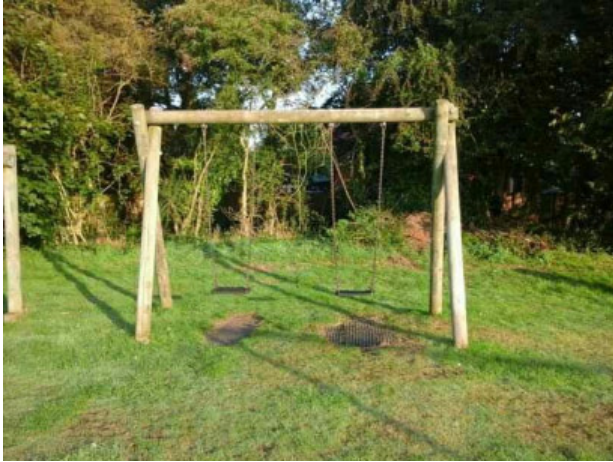
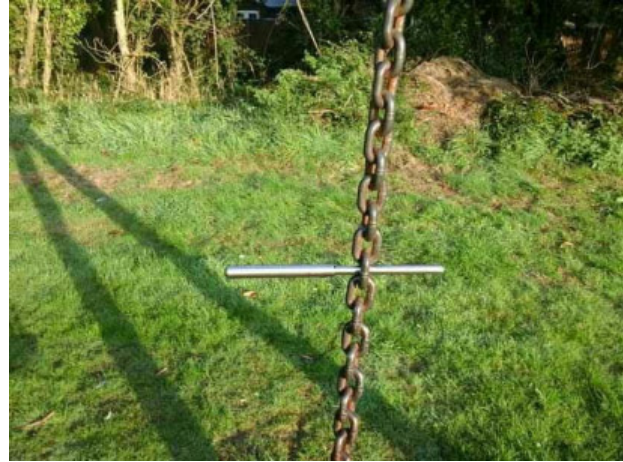
Item: Swings - 1 Bay 2 Seat (Flat)
Manufacturer: Adventure Playgrounds

Finding: The chain openings are in excess of the 8.6mm as recommended by BS EN 1176

Action: Monitor use and replace with compliant chains during next maintenance cycle.

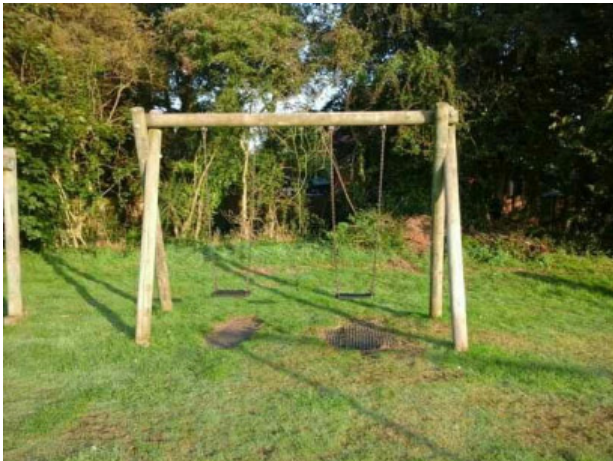
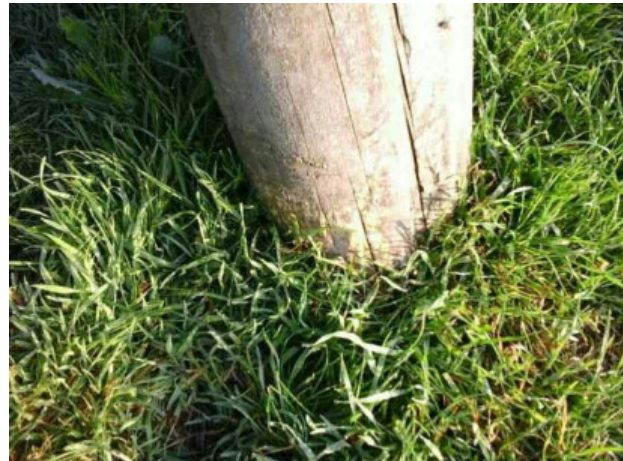
Item: Swings - 1 Bay 2 Seat (Flat)
Manufacturer: Adventure Playgrounds

Finding: There is some strimmer damage apparent on the posts, this can penetrate the preservative applied to the timber and accelerate the rotting process

Action: Monitor for any deterioration (rot) and replace as required

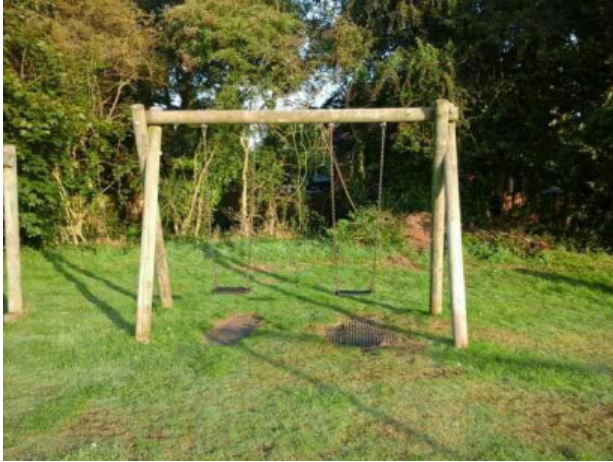
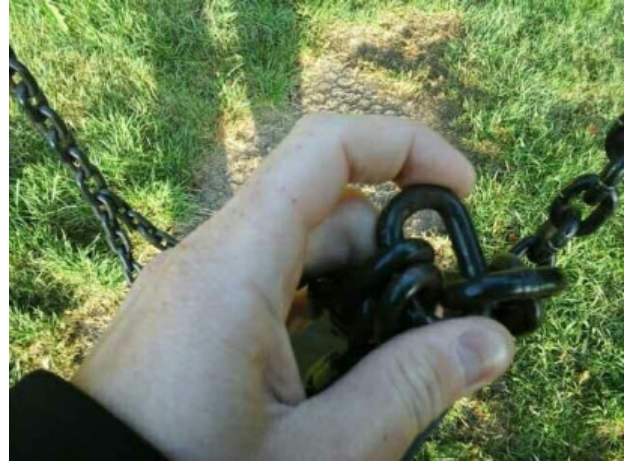
Item: Swings - 1 Bay 2 Seat (Flat)
Manufacturer: Adventure Playgrounds

Finding: There is some chain wear

Action: Monitor for any further deterioration and replace when 40% worn

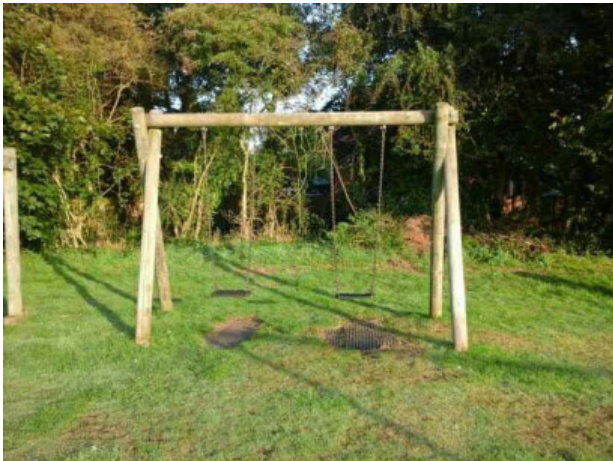
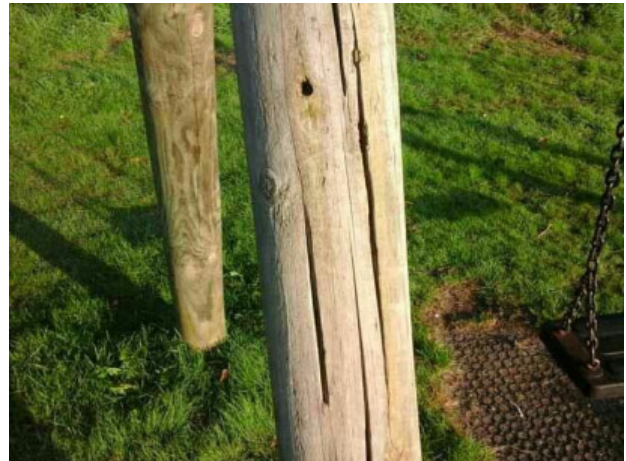
Item: Swings - 1 Bay 2 Seat (Flat)
Manufacturer: Adventure Playgrounds

Finding: The timber has a number of air cracks apparent, the splits will have penetrated the preservative applied to the timber and allow water ingress to the unprotected areas

Action: Monitor for any deterioration (rot) and replace as required

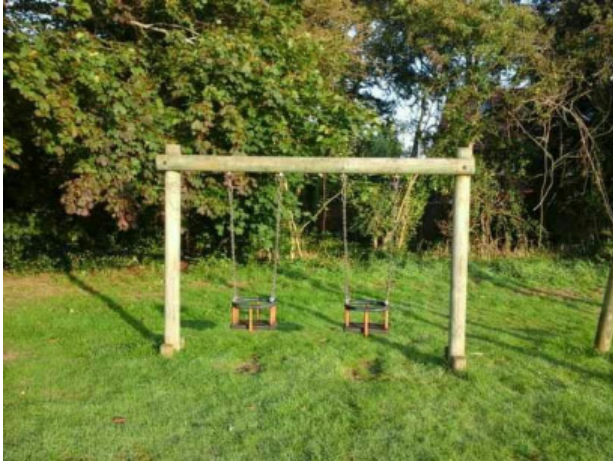
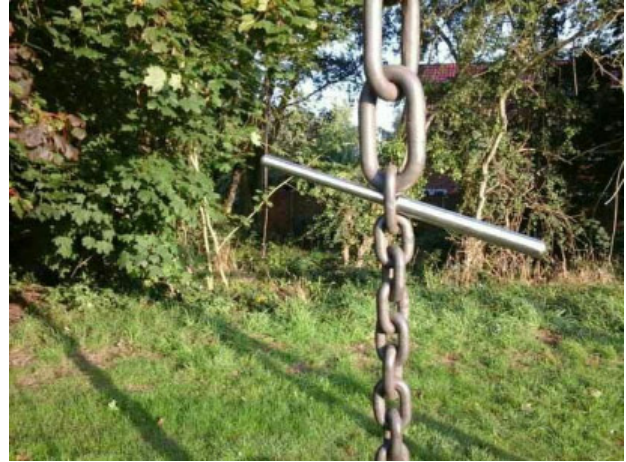
Item: Swings - 1 Bay 2 Seat (Cradle)
Manufacturer: Adventure Playgrounds

Finding: The connecting links are in excess of 8.6mm and less than 12mm and fail the requirements of BS EN 1176: 2008 Part 1; clause 4.2.13, Chains

Action: Monitor use and replace with compliant connectors at the next maintenance cycle

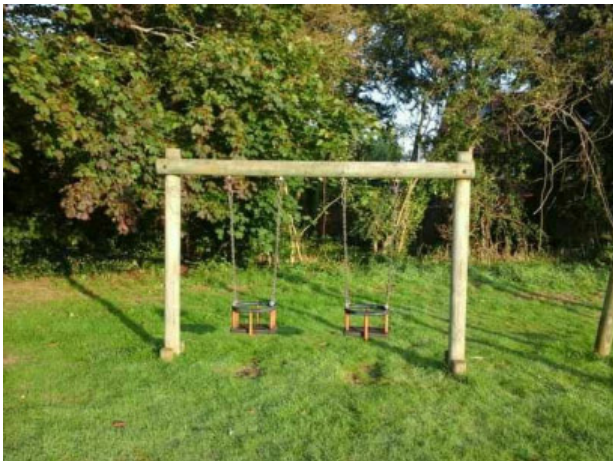
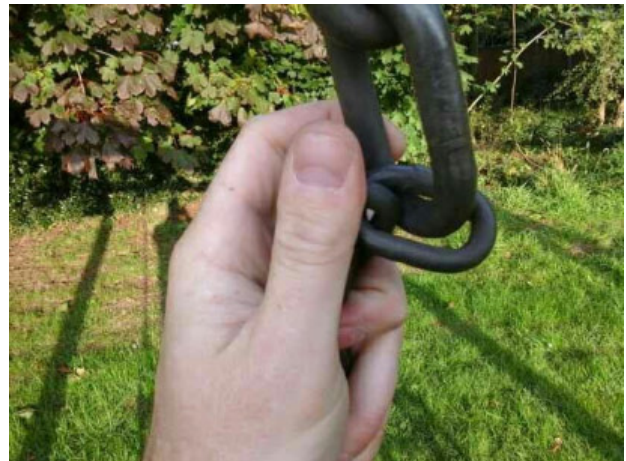
Item: Swings - 1 Bay 2 Seat (Cradle)
Manufacturer: Adventure Playgrounds

Finding: There is some chain wear

Action: Monitor for any further deterioration and replace when 40% worn

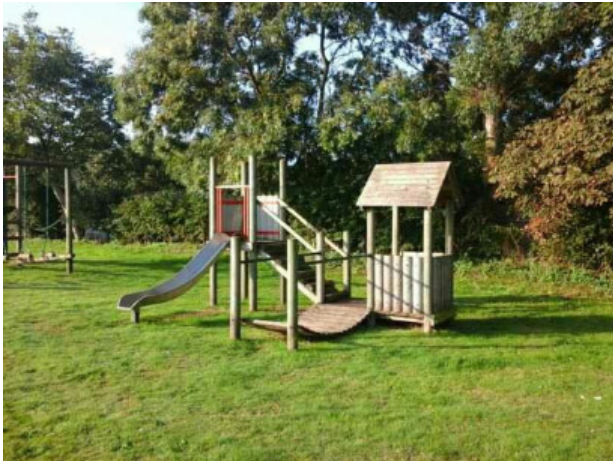
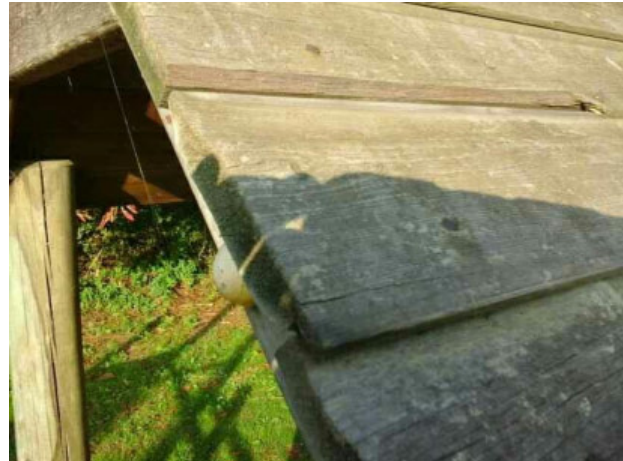
Item: Activity Equipment - Multi Play (Junior)
Manufacturer: Adventure Playgrounds

Finding: A number of fixing(s) have worked loose

Action: Secure all loose fixings

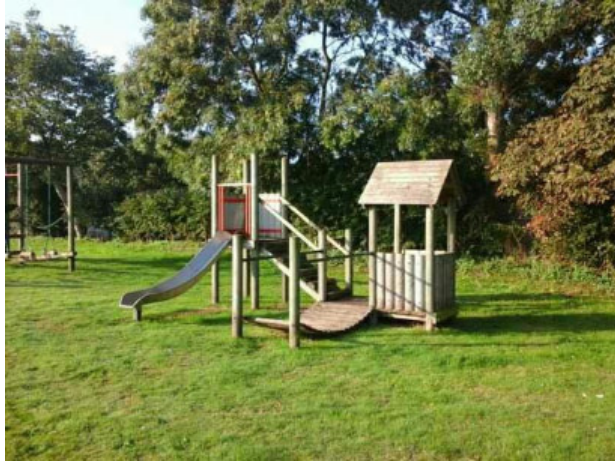
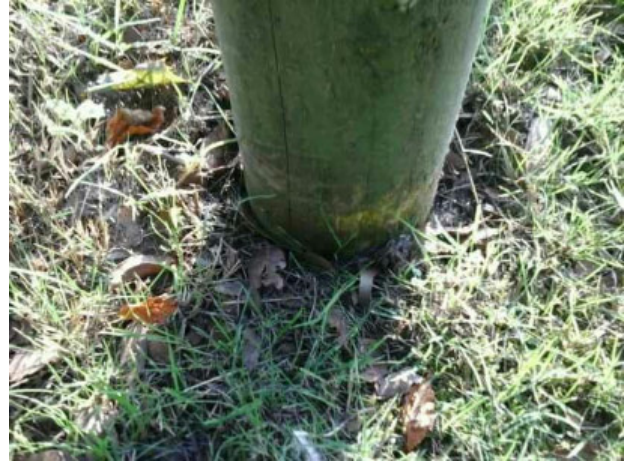
Item: Activity Equipment - Multi Play (Junior)
Manufacturer: Adventure Playgrounds

Finding: There is some strimmer damage apparent on the posts, this can penetrate the preservative applied to the timber and accelerate the rotting process

Action: Monitor for any deterioration (rot) and replace as required

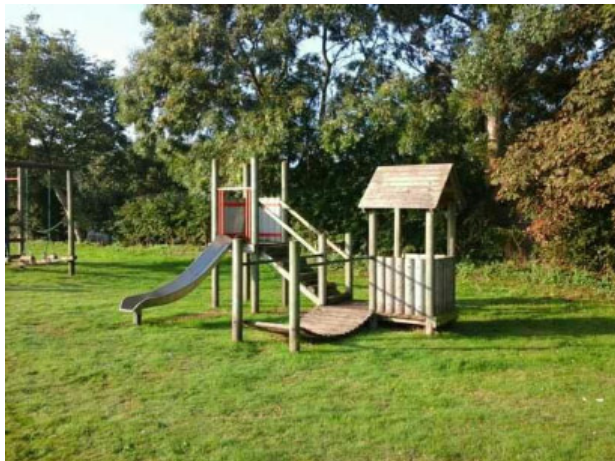
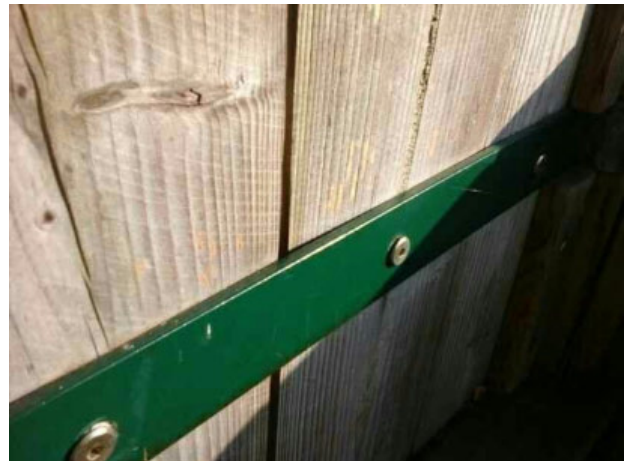
Item: Activity Equipment - Multi Play (Junior)
Manufacturer: Adventure Playgrounds

Finding: A number of fixing(s) have worked loose

Action: Secure all loose fixings

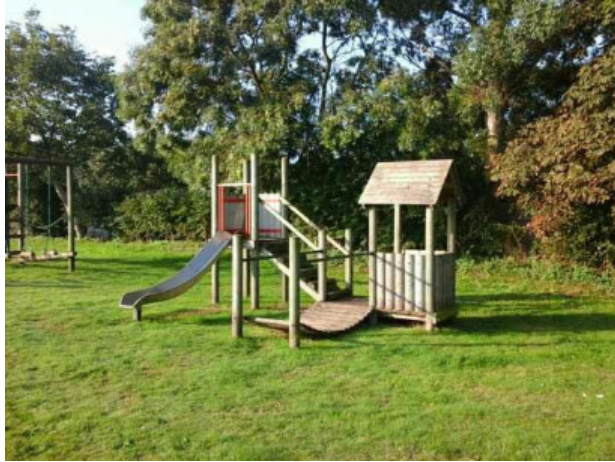
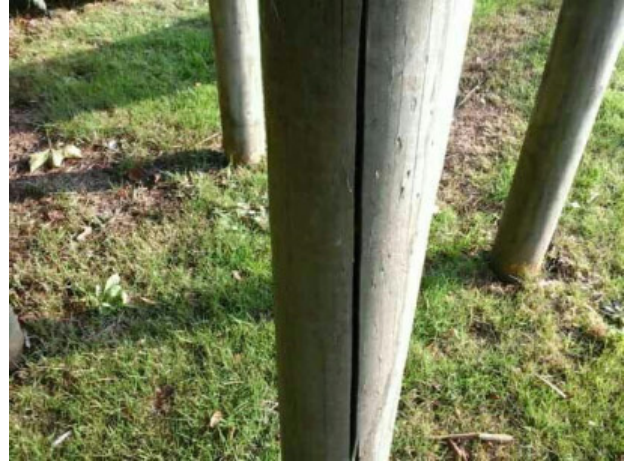
Item: Activity Equipment - Multi Play (Junior)
Manufacturer: Adventure Playgrounds

Finding: The timber has a number of air cracks apparent, the splits will have penetrated the preservative applied to the timber and allow water ingress to the unprotected areas

Action: Monitor for any deterioration (rot) and replace as required

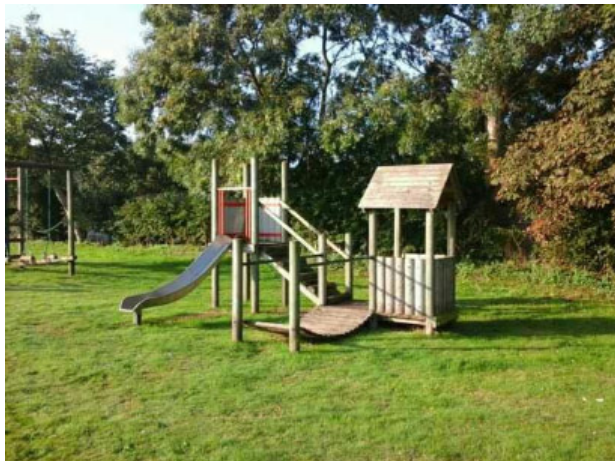
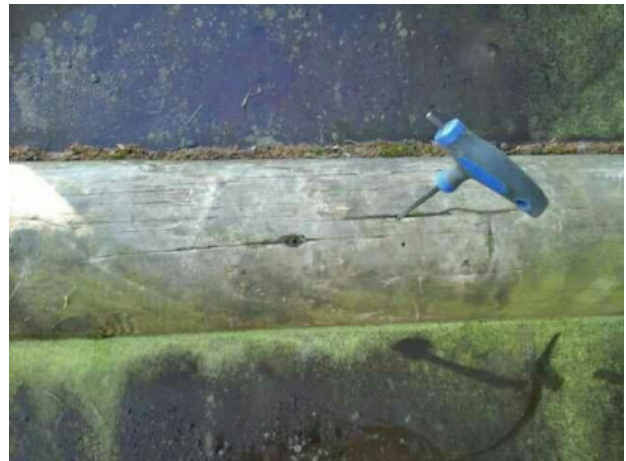
Item: Activity Equipment - Multi Play (Junior)
Manufacturer: Adventure Playgrounds

Finding: There is some evidence of rot in the timber

Action: Monitor for any further deterioration and replace as required

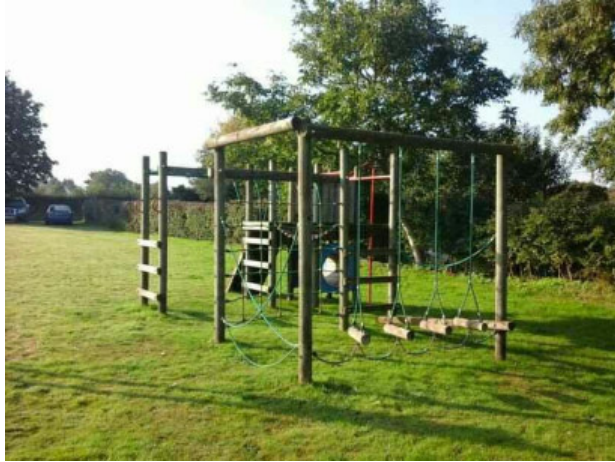
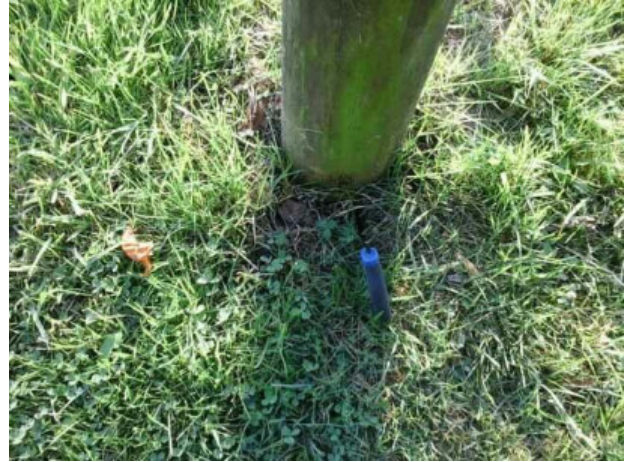
Item: Activity Equipment - Log Climber
Manufacturer: Adventure Playgrounds

Finding: There is some evidence of rot in the timber

Action: Monitor for any further deterioration and replace as required

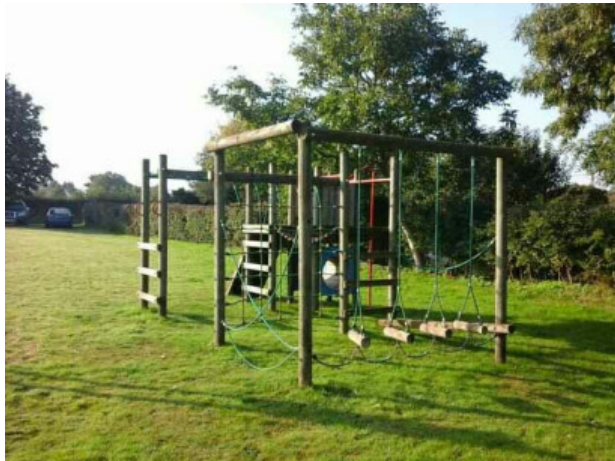
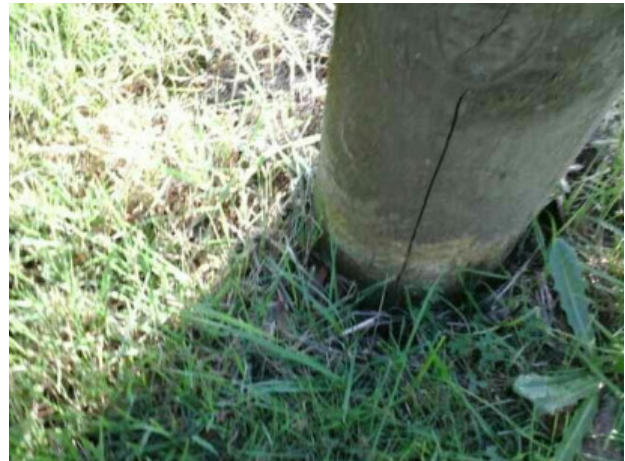
Item: Activity Equipment - Log Climber
Manufacturer: Adventure Playgrounds

Finding: There is some strimmer damage apparent on the posts, this can penetrate the preservative applied to the timber and accelerate the rotting process

Action: Monitor for any deterioration (rot) and replace as required

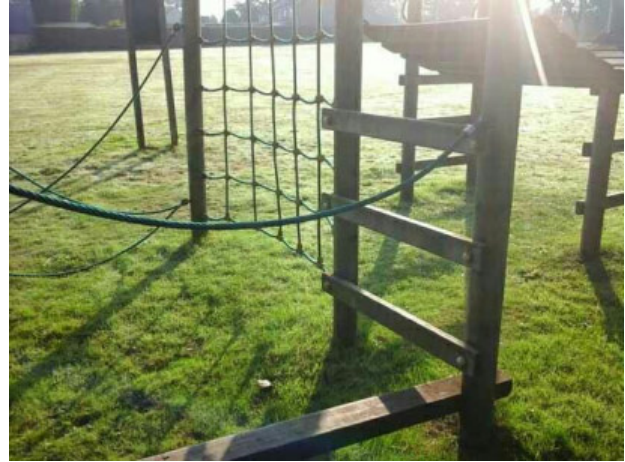
Finding: The balance beam forms a hard object within the falling space of the equipment in contravention of the requirements of BS EN 1176 Part 1

Action: Monitor use

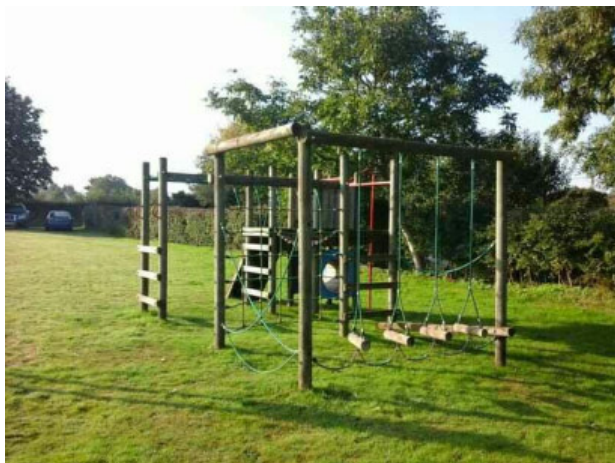
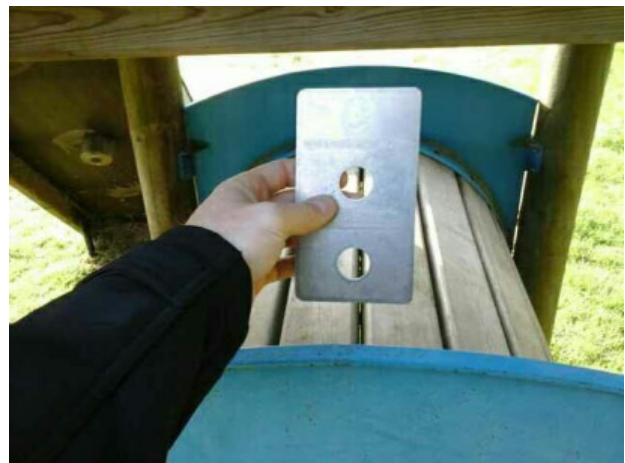
Finding: The item fails to meet the requirements of BS EN 1176:2008 Part 1 4.2.7.2 for head and neck entrapment between the timbers

Action: Monitor use

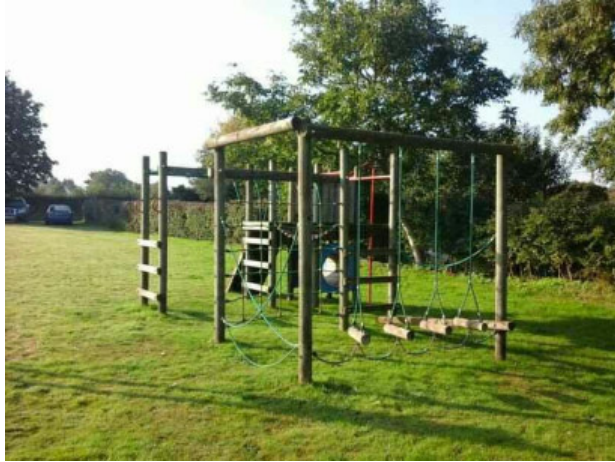
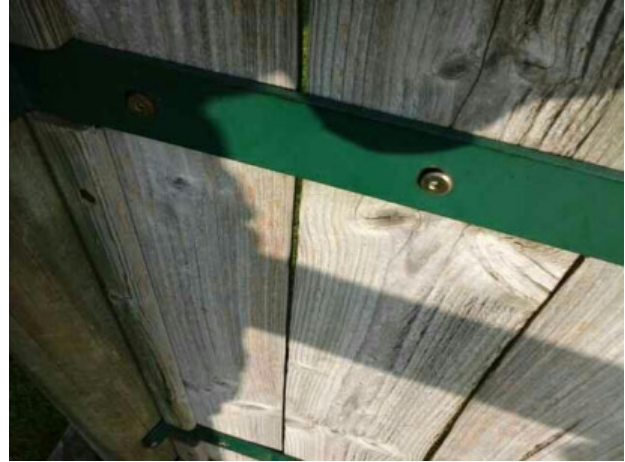
Finding: A number of fixing(s) have worked loose

Action: Secure all loose fixings

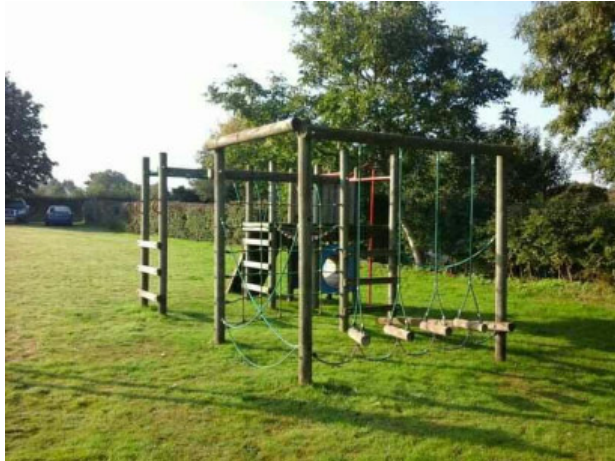
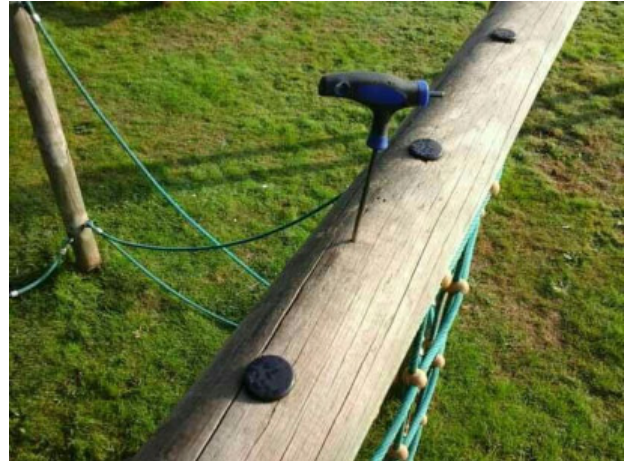
Finding: There is some evidence of rot in the timber crossbar

Action: Monitor for any further deterioration and replace as required

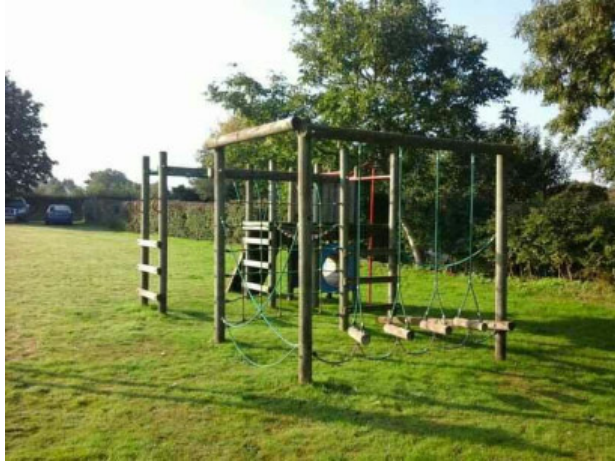
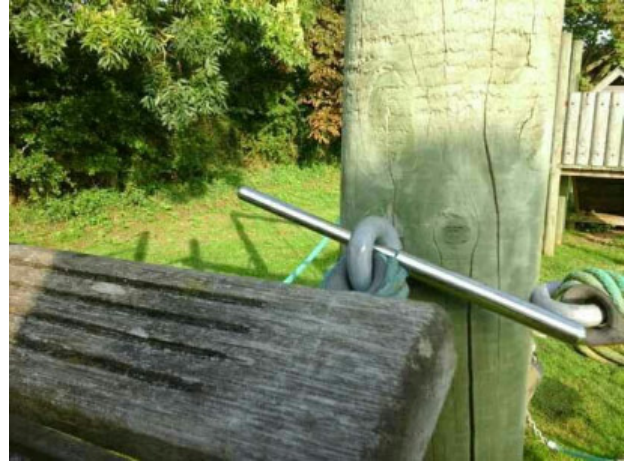
Finding: The connecting links are in excess of 8.6mm and less than 12mm and fail the requirements of BS EN 1176:2008 Part 1; clause 4.2.13, Chains

Action: Monitor use and replace with compliant links at the next maintenance cycle

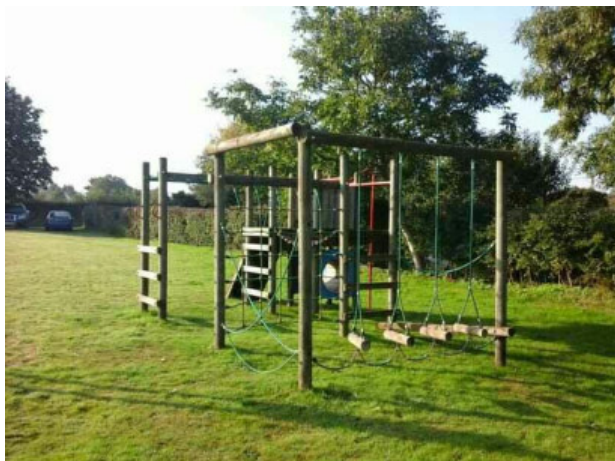
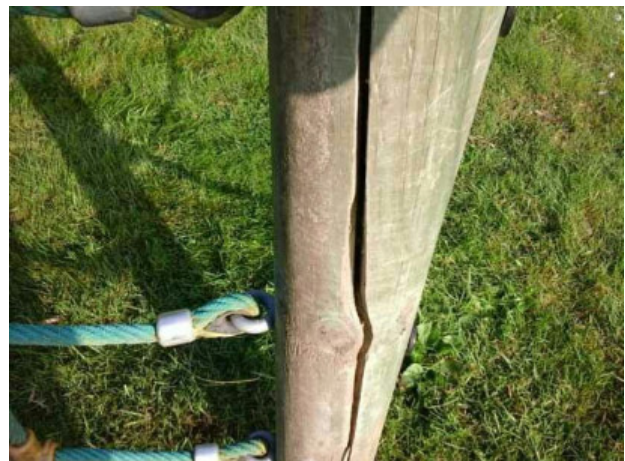
Finding: The timber has a number of air cracks apparent, the splits will have penetrated the preservative applied to the timber and allow water ingress to the unprotected areas

Action: Monitor for any deterioration (rot) and replace as required

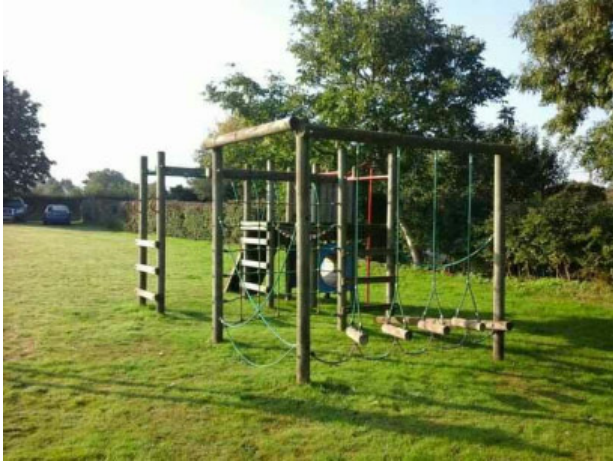
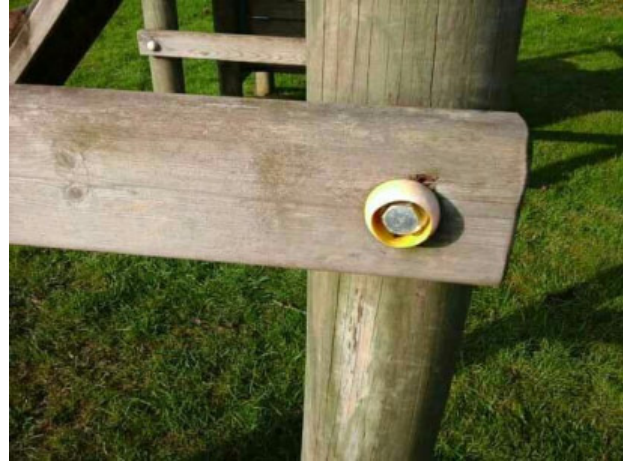
Finding: There is/are bolt cap covers missing or damaged on the item

Action: Replace missing or damaged bolt cap covers

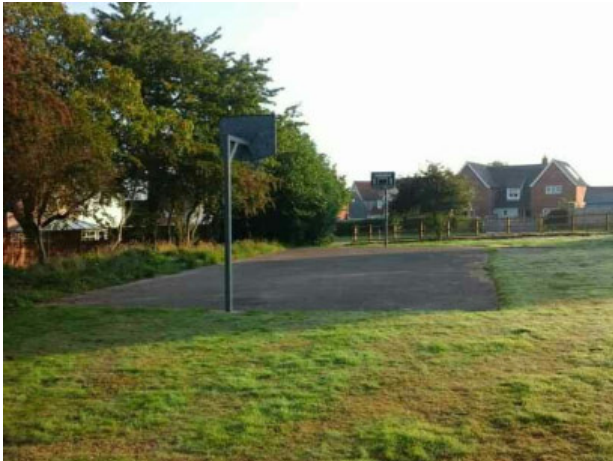
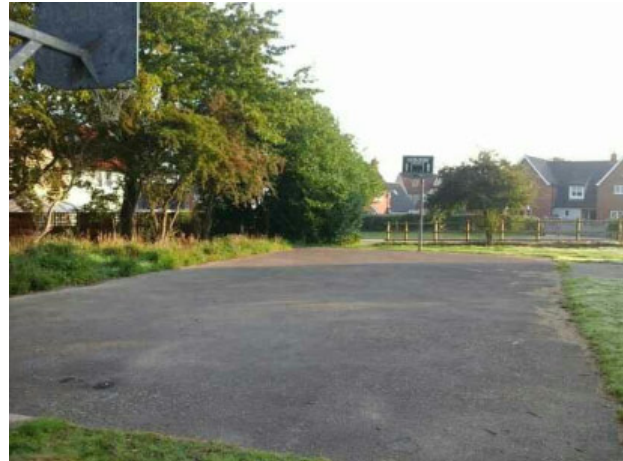
Finding: A clearly visible sign should be provided in a prominent position with the wording as detailed BS EN 15312 - the equipment is not intended for children less than 3 years old - the warning Do not climb on the framework or nets - the warning Do not hang on the ring (if provided) - the warning Do not wear rings or other jewellery - name and telephone number of the administrator - number to call in case of accident

Action: Provide signage to BS EN 15312

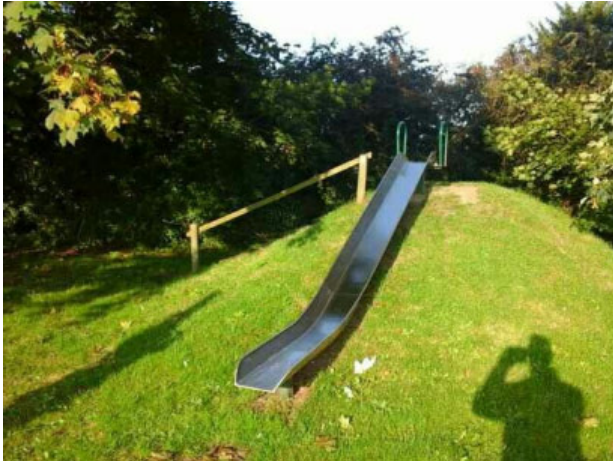
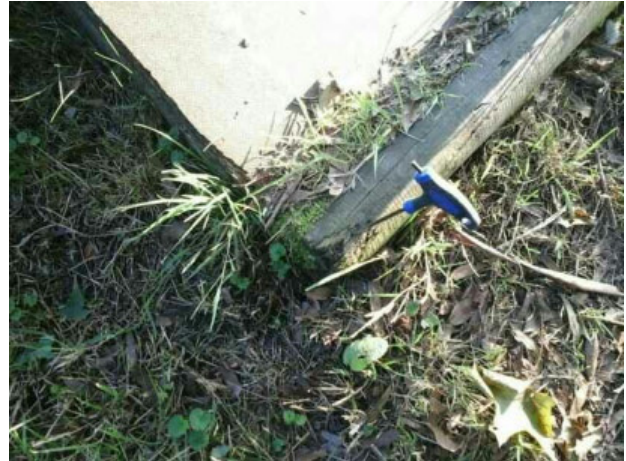
Finding: There is some evidence of rot in the timber

Action: Monitor for any further deterioration and replace as required

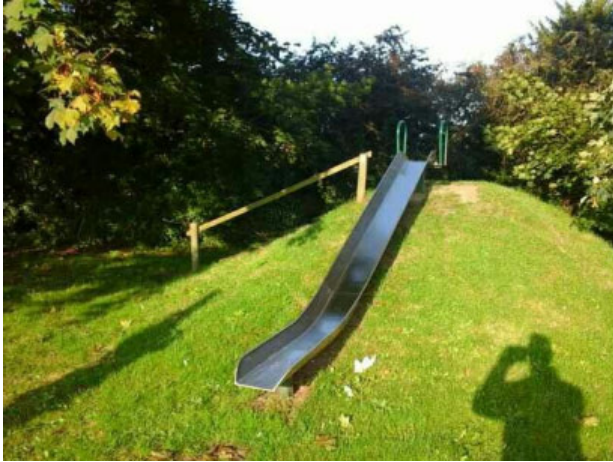
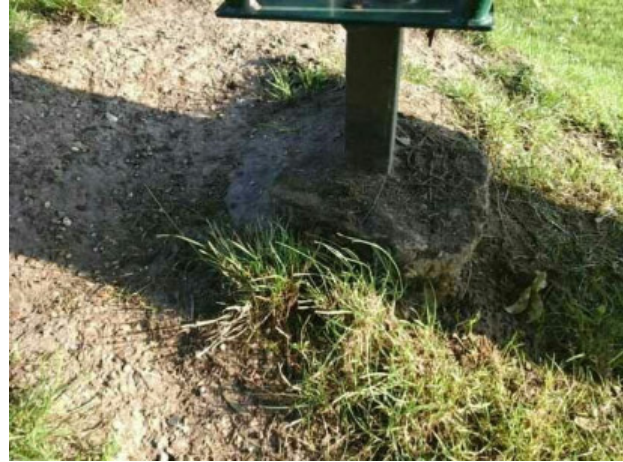
Item: Activity Equipment - Multi Play (Junior) **Risk Level:** V - Very Low Risk
Manufacturer: Owner/Operator **Surface:** Grass

Finding: The foundations are exposed

Action: Reinstatement surface levels as required

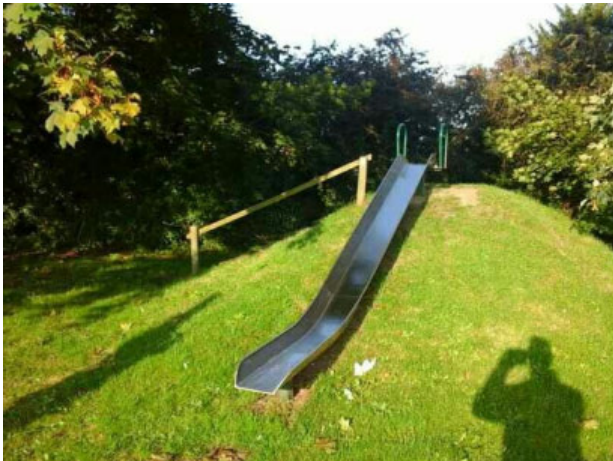
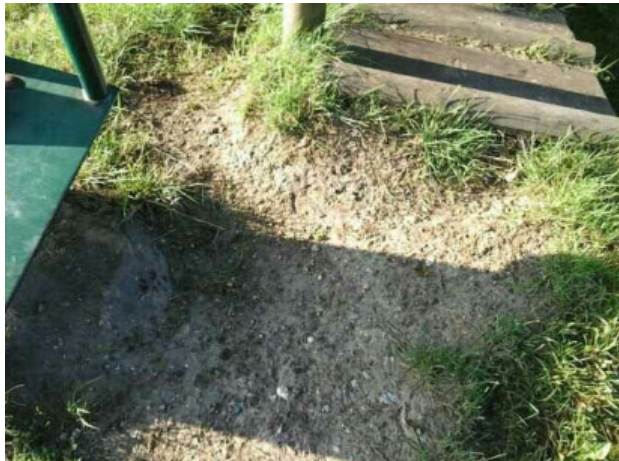
Item: Activity Equipment - Multi Play (Junior) **Risk Level:** V - Very Low Risk
Manufacturer: Owner/Operator **Surface:** Grass

Finding: The surface around the item is worn **Action:** Reinstate surface levels as required
