the **play** inspection company

Annual Inspection

Mid Suffolk District Council

Drinkstone

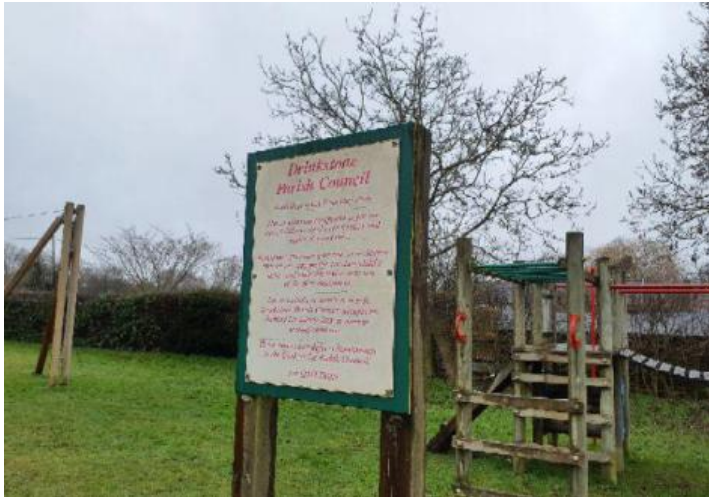
Finding: It is recommended that signage, with information including the site address, contact information for maintenance issues and emergency contact details are provided for the facility

Action: Provide in accordance with the recommendations

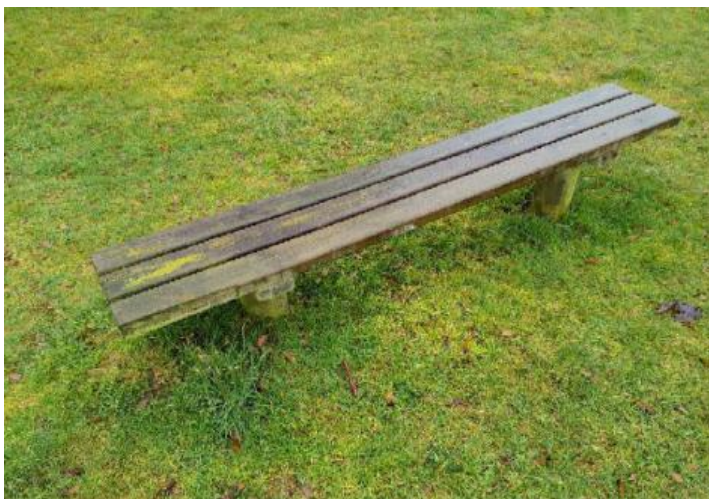
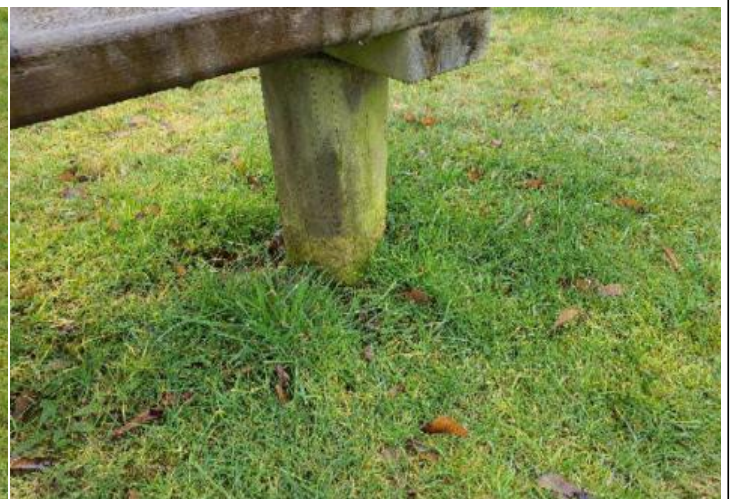
Finding: There is some strimmer / machinery damage apparent on the posts, this can penetrate the preservative applied to the timber and accelerate the rotting process

Action: Monitor for any deterioration (rot) and replace as required

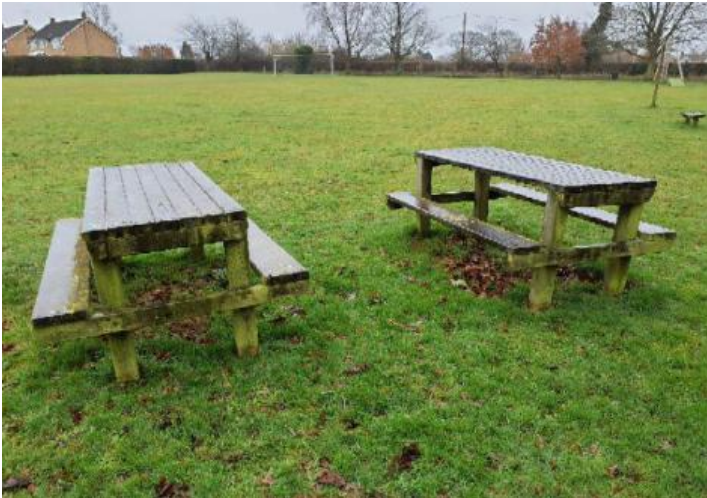
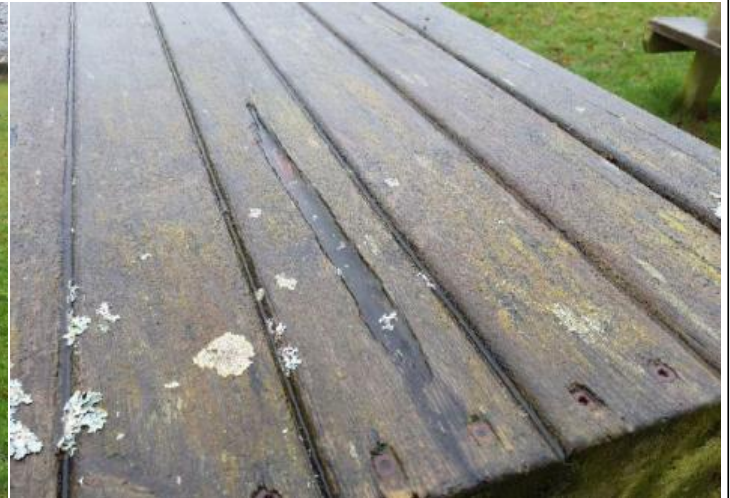
Finding: There are areas or parts of the timber on the structure that have rotted

Action: Replace all affected timbers

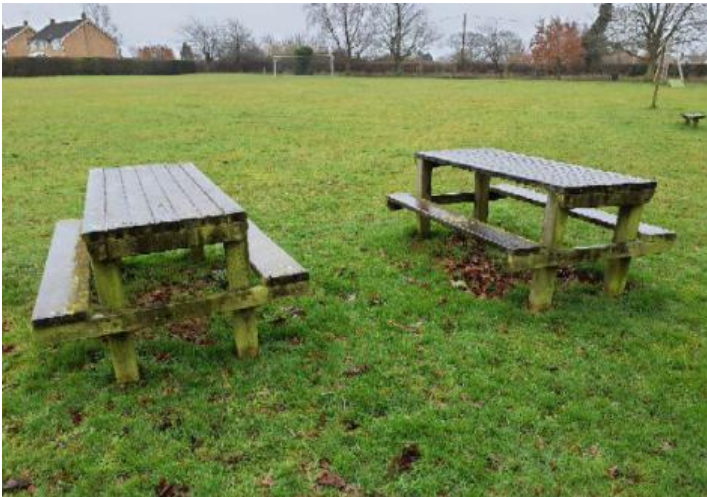
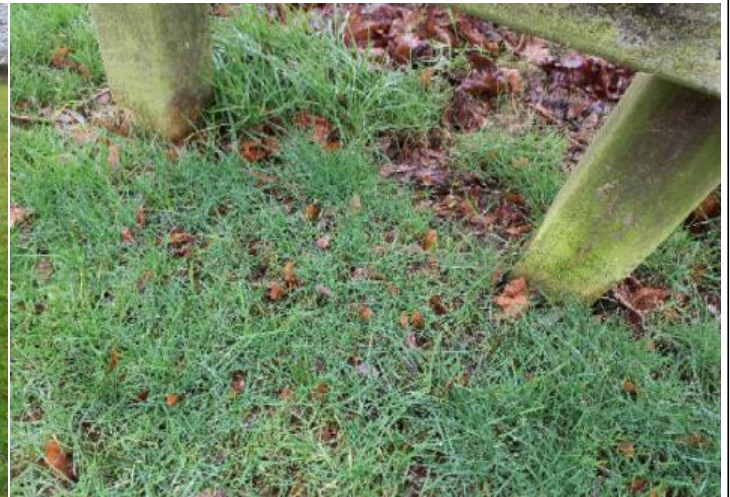
Finding: There is some strimmer / machinery damage apparent on the posts, this can penetrate the preservative applied to the timber and accelerate the rotting process

Action: Monitor for any deterioration (rot) and replace as required

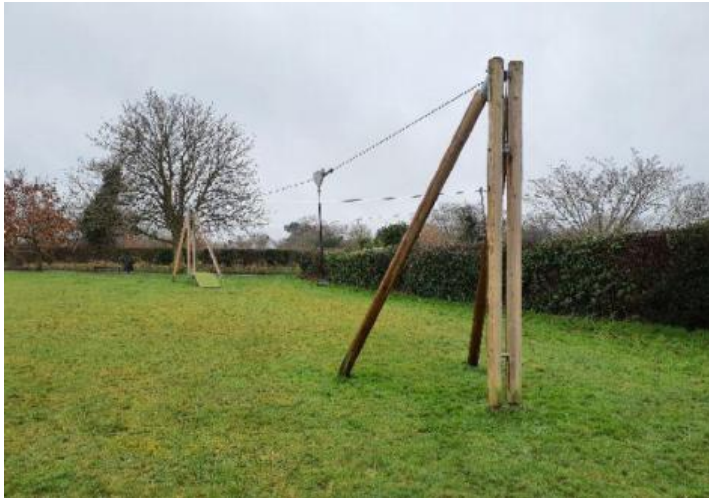
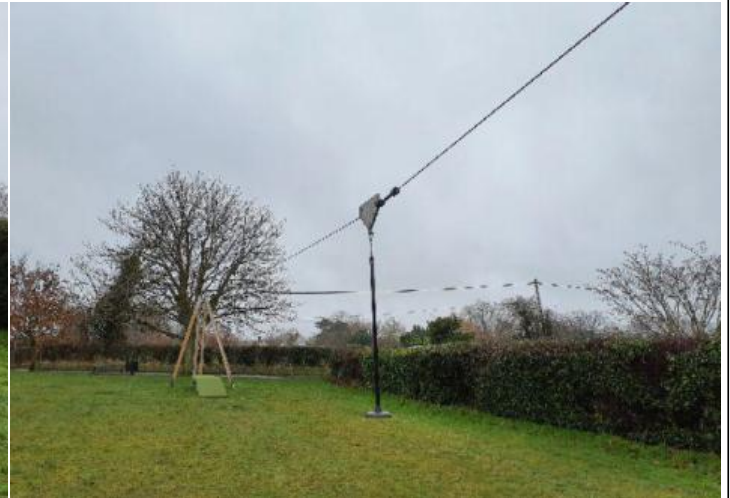
Finding: We have completed a visual inspection of the suspension links, cable and fixing points from ground level, however it is not possible to fully inspect these areas without either hiring equipment to gain access or removing the cable and suspension and inspecting at ground level. We recommend that the main cable and fixing security is thoroughly inspected at least in accordance with the manufacturers recommendations to check for wear, damage, security or internal rusting; this will help to ensure the continued safe use of the equipment

Action: Inspect in accordance with the manufacturers recommendations

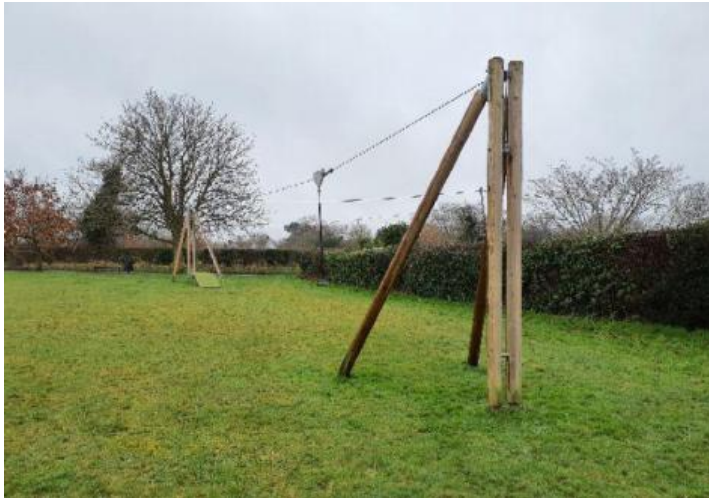
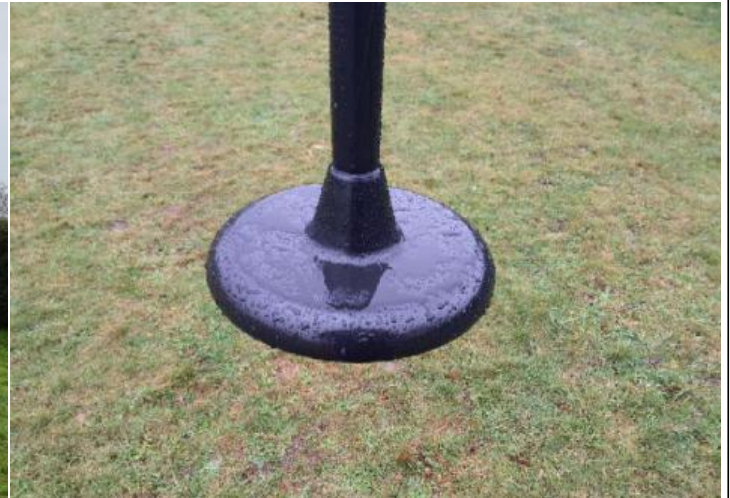
Finding: The seat connection cannot be inspected without dismantling the seat

Action: Dismantle the seat to inspect the seat connection for wear

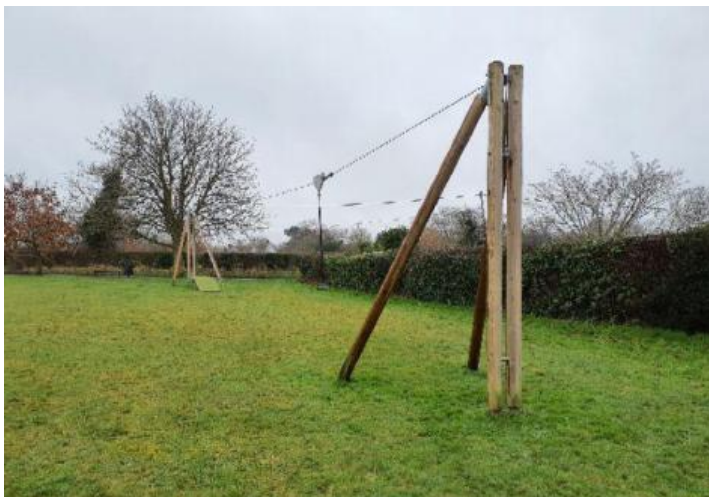
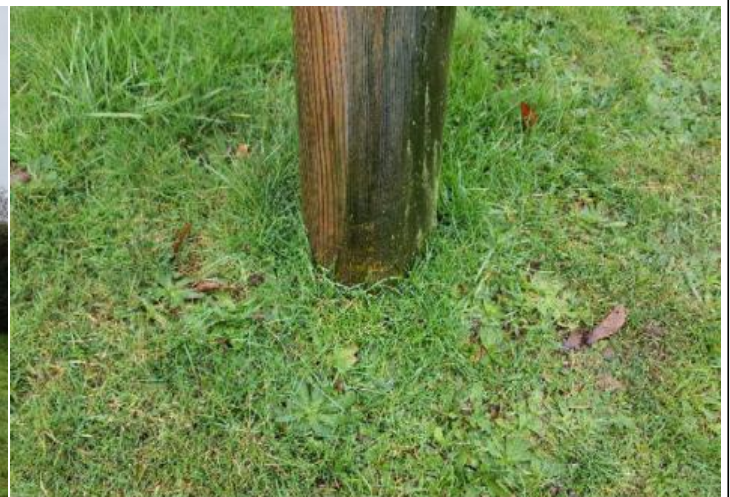
Finding: There is some strimmer / machinery damage apparent on the posts, this can penetrate the preservative applied to the timber and accelerate the rotting process

Action: Monitor for any deterioration (rot) and replace as required

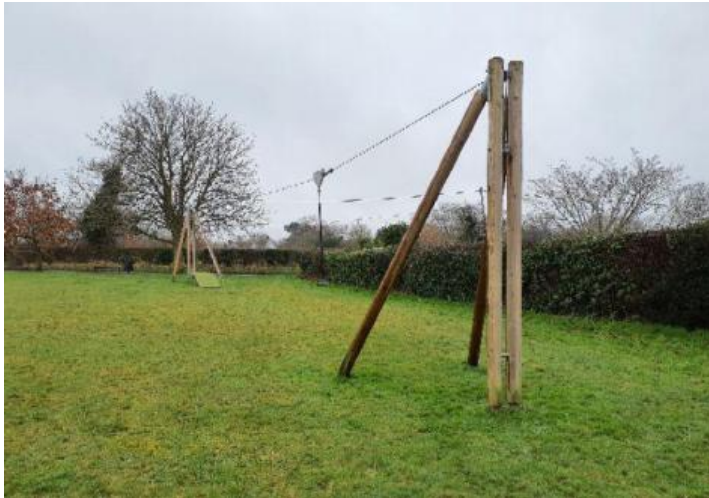
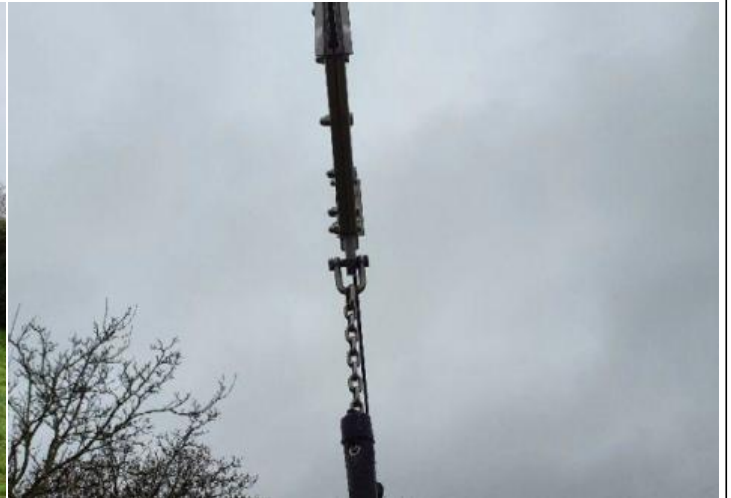
Finding: There is some notable evidence of chain and shackle wear

Action: Monitor for any further deterioration and replace when 40% worn

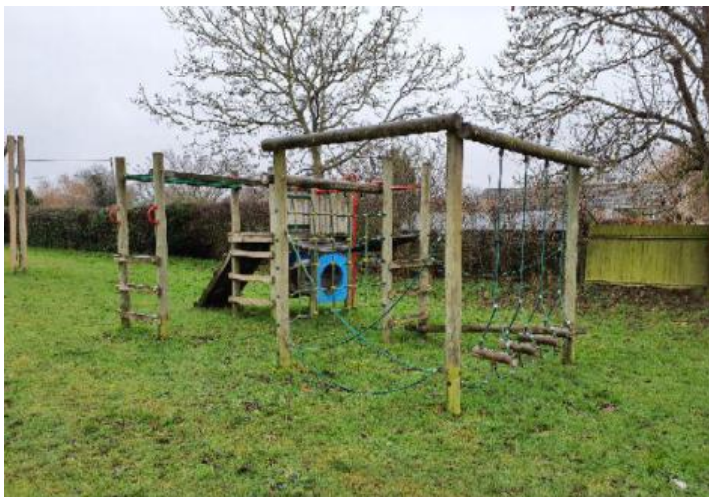
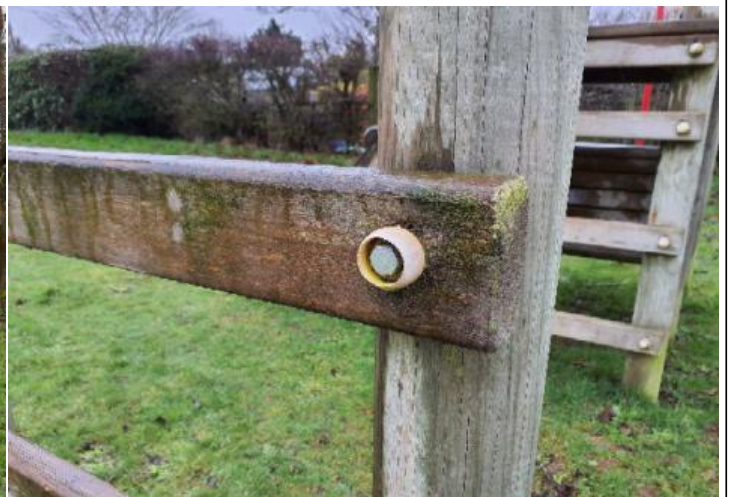
Finding: There is/are bolt cap covers missing or damaged on the item

Action: Replace missing or damaged bolt cap covers

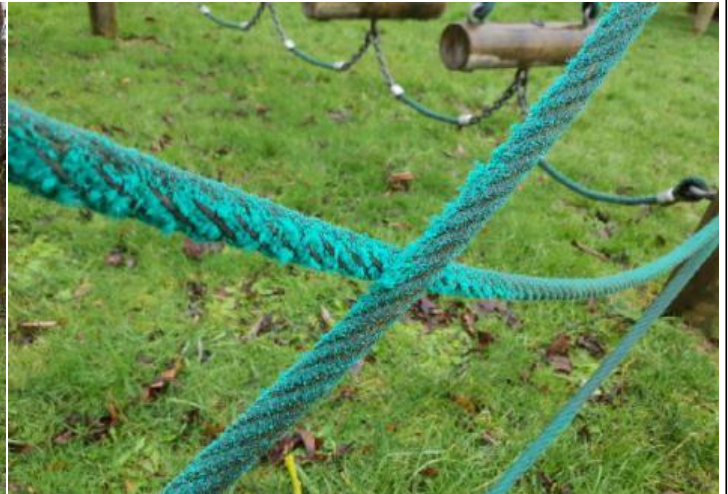
Finding: The ropes/nets are worn/damaged in places

Action: Monitor for any further deterioration and repair or replace as required

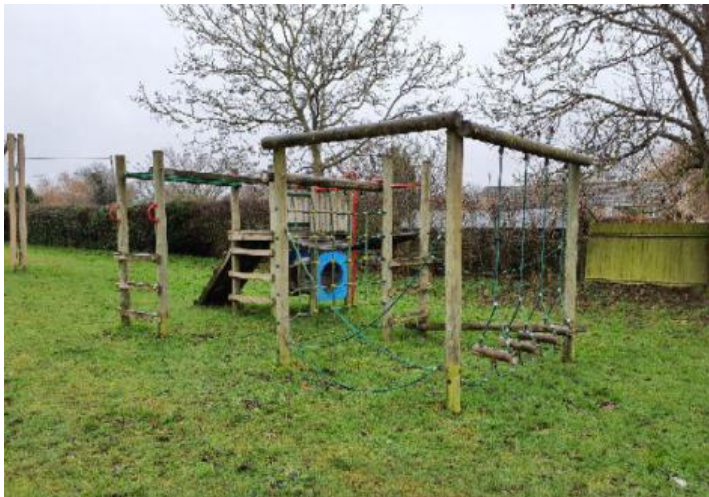
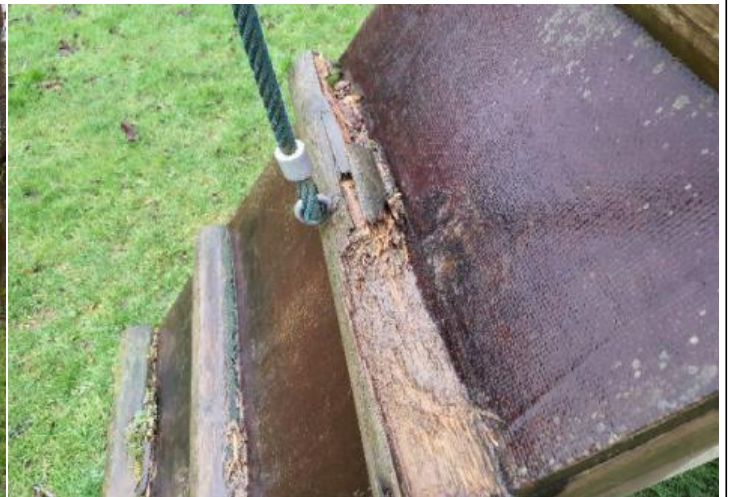
Finding: There are areas or parts of the timber on the structure that have rotted

Action: Replace all affected timbers

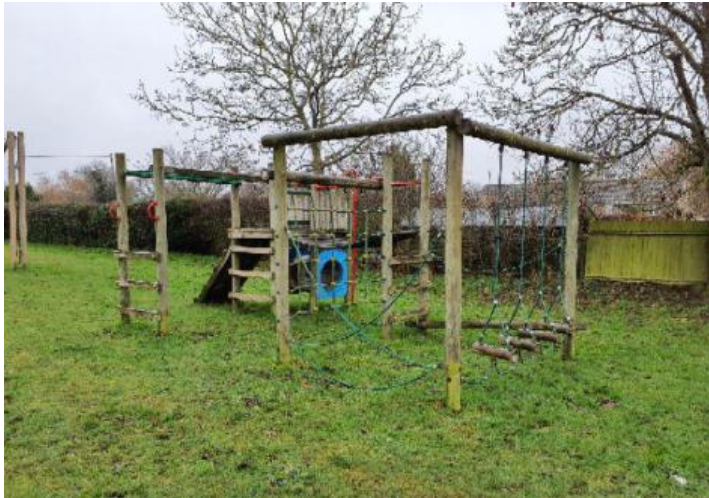
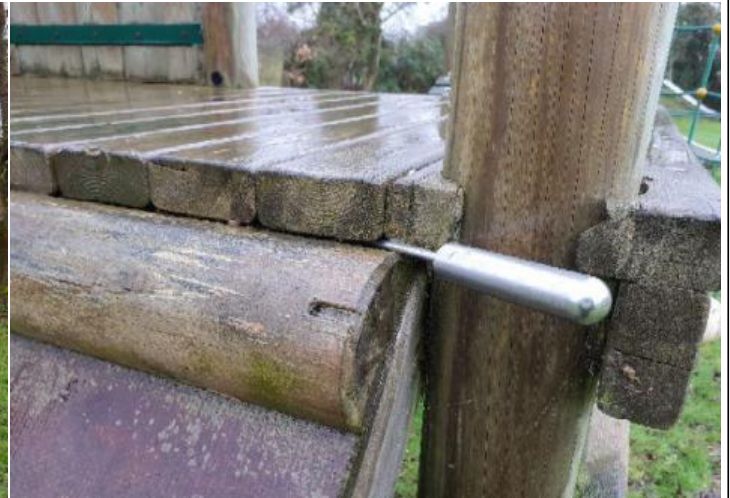
Finding: There is/are finger entrapment/s in the climbing wall and the item fails to meet the requirements of BS EN 1176 Part 1 4.2.7.6 Entrapment of fingers

Action: Monitor - No remedial work recommended

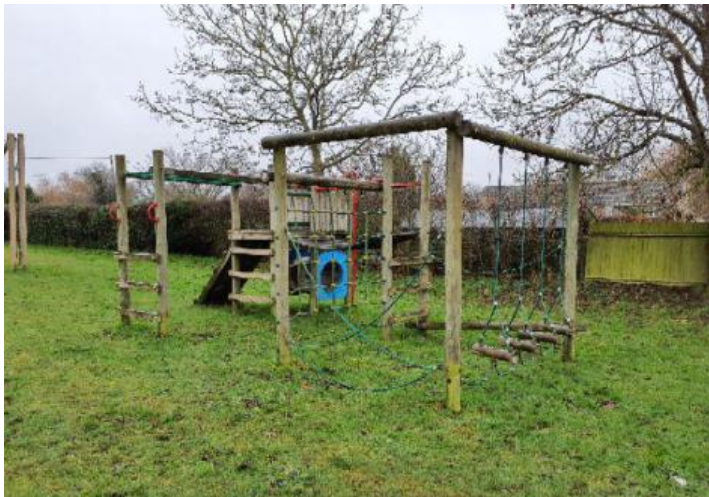
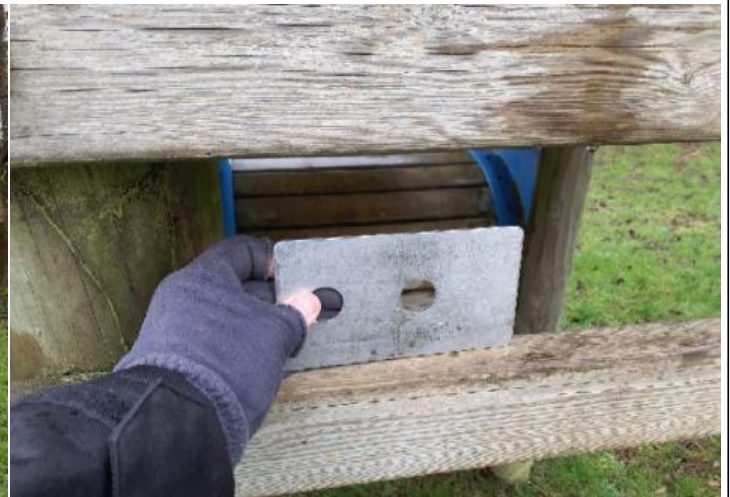
Finding: The item fails to meet the requirements of BS EN 1176 Part 1 4.2.7.2 head and neck entrapment in the barriers and/or steps

Action: Monitor - No remedial work recommended

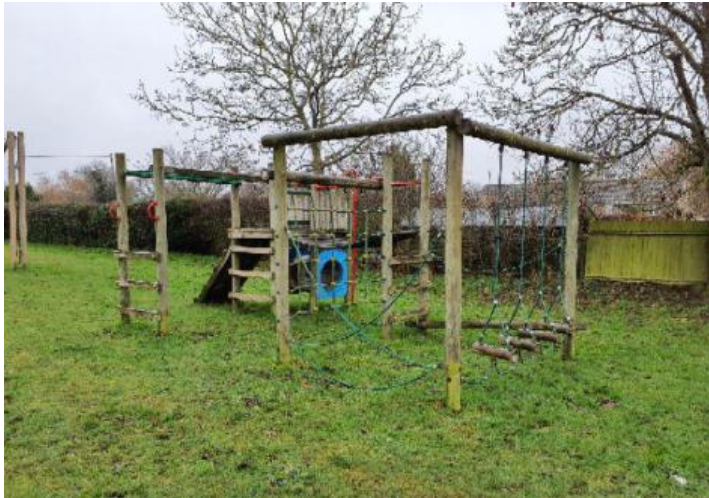
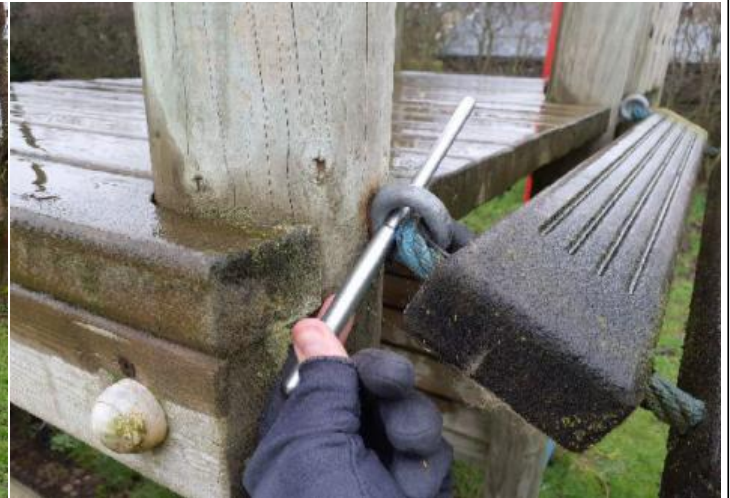
Finding: The connecting links are in excess of 8.6mm and less than 12mm and fail the requirements of BS EN 1176 Part 1; clause 4.2.13, Chains

Action: Monitor use and replace with compliant links at the next maintenance cycle

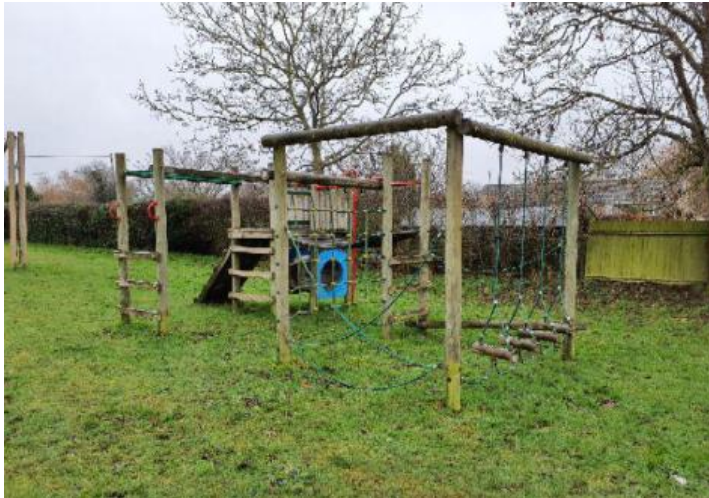
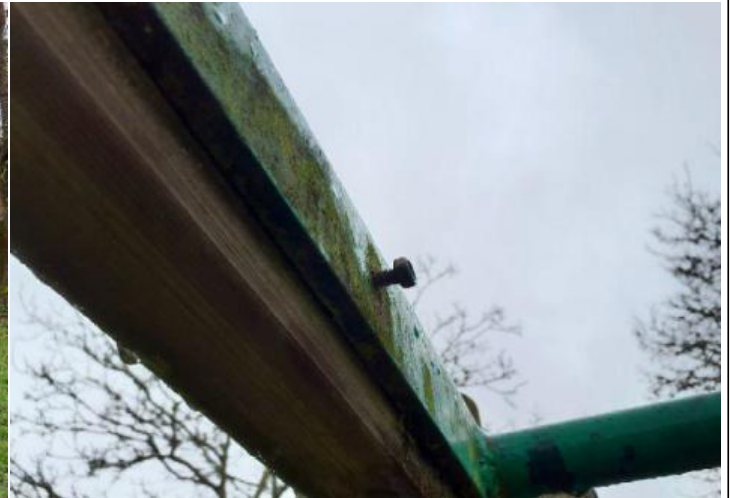
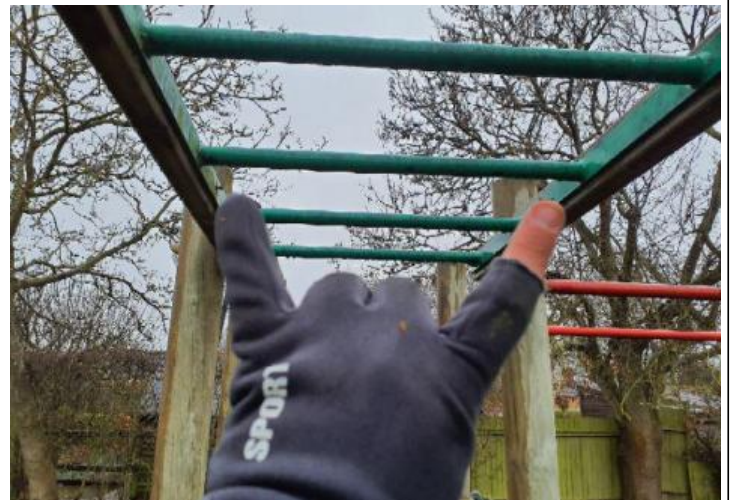
Finding: A number of fixing(s) have worked loose

Action: Secure all loose fixings

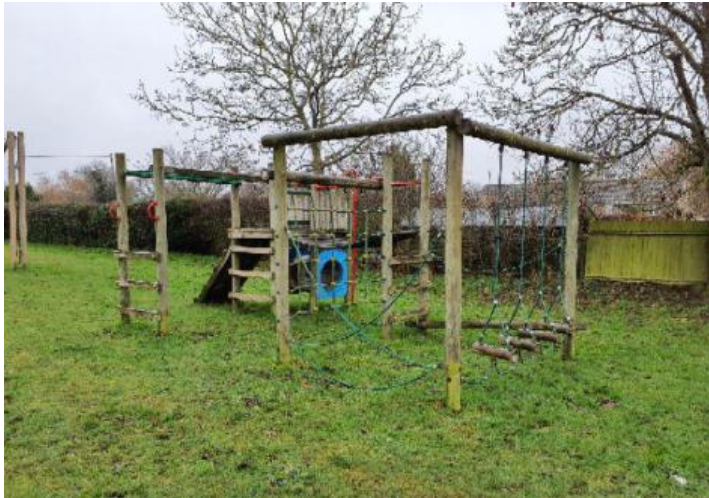
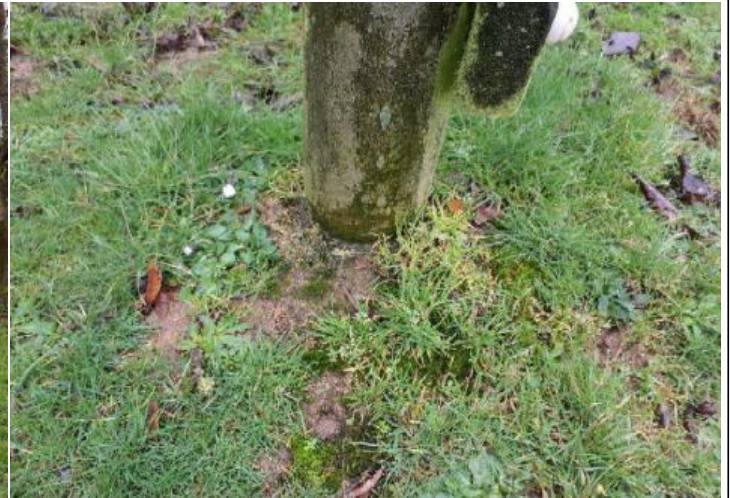
Finding: There is some strimmer / machinery damage apparent on the posts, this can penetrate the preservative applied to the timber and accelerate the rotting process

Action: Monitor for any deterioration (rot) and replace as required

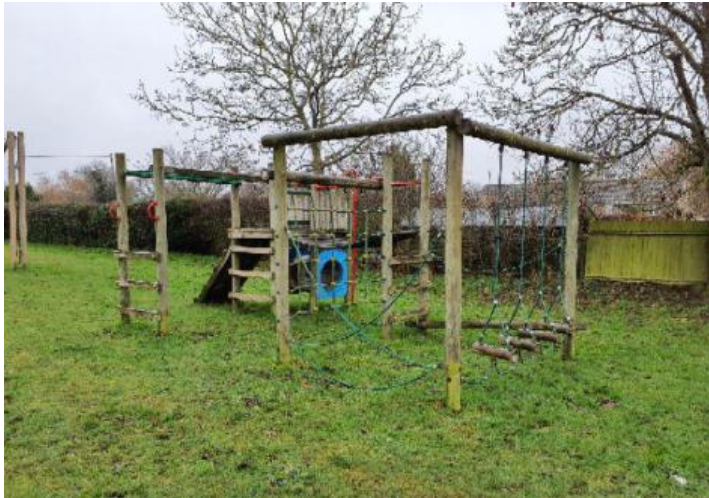
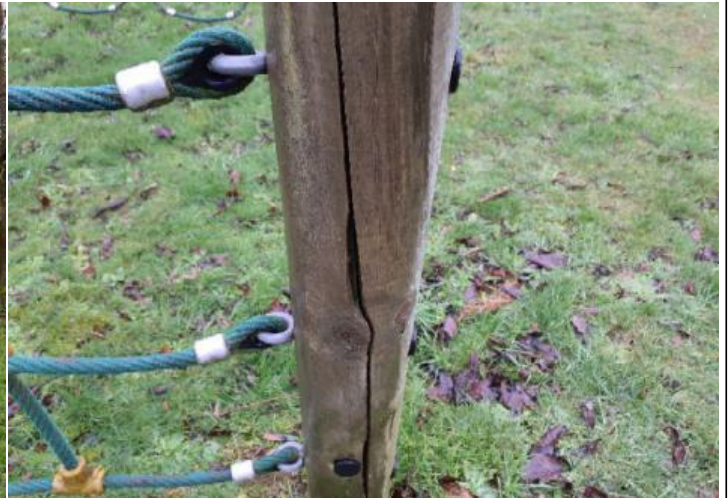
Finding: The timber has a number of splits/shakes or air cracks and this may affect the stability or allow water ingress which will accelerate the rotting process
Action: Monitor to ensure the splits do not cross through fixing points of the structure and/or cause any instability

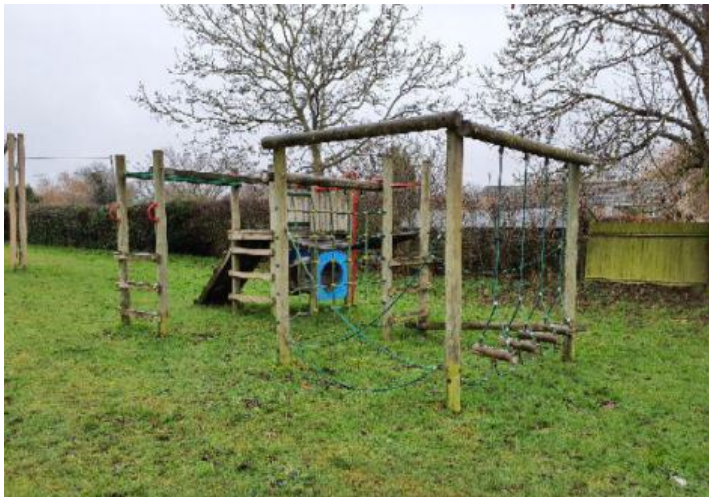
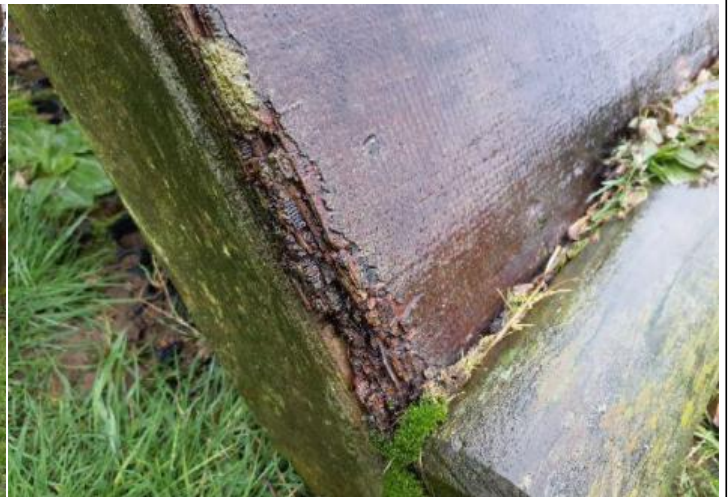
Finding: There is some evidence of rot in the timber
Action: Monitor for any further deterioration and replace as required

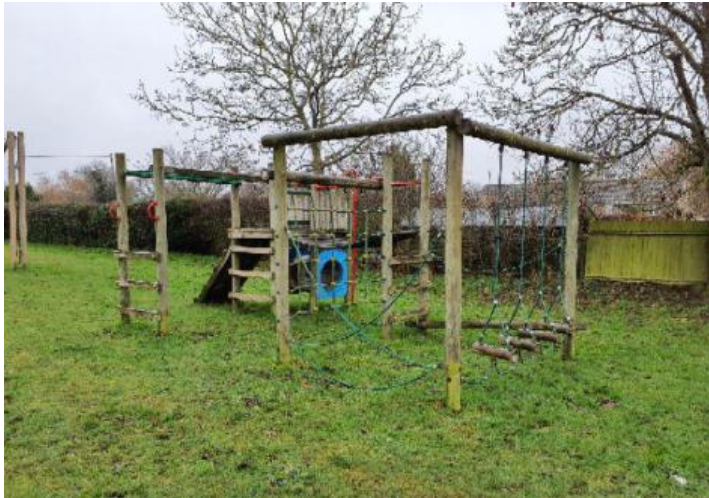
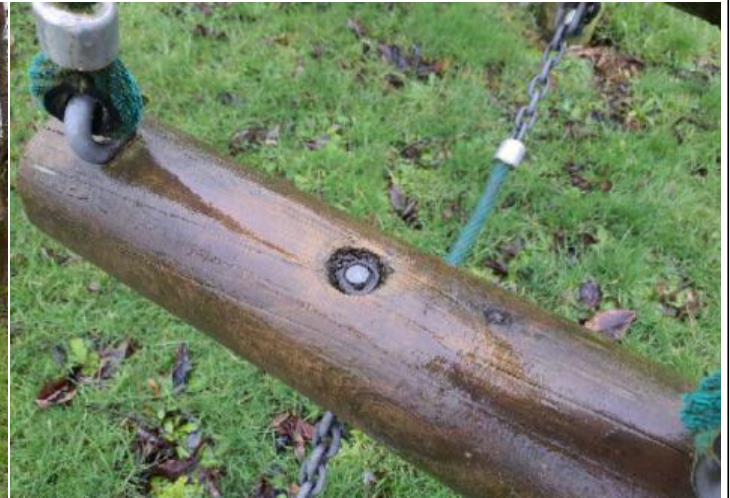
Finding: There is/are bolt cap covers missing or damaged on the item

Action: Replace missing or damaged bolt cap covers

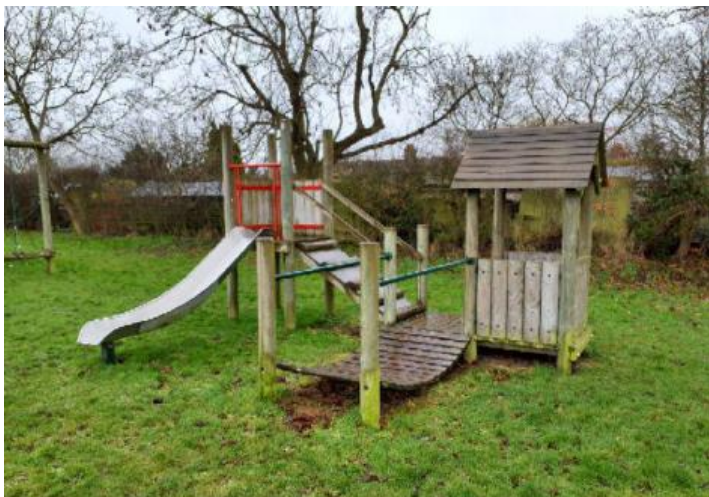
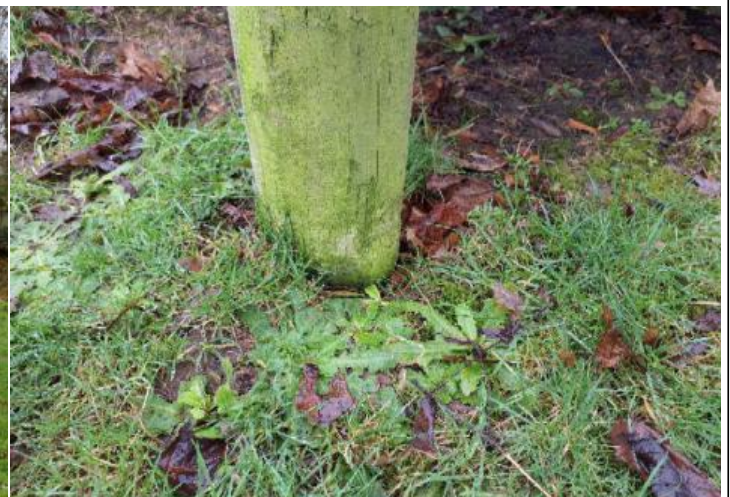
Finding: There is some strimmer / machinery damage apparent on the posts, this can penetrate the preservative applied to the timber and accelerate the rotting process

Action: Monitor for any deterioration (rot) and replace as required

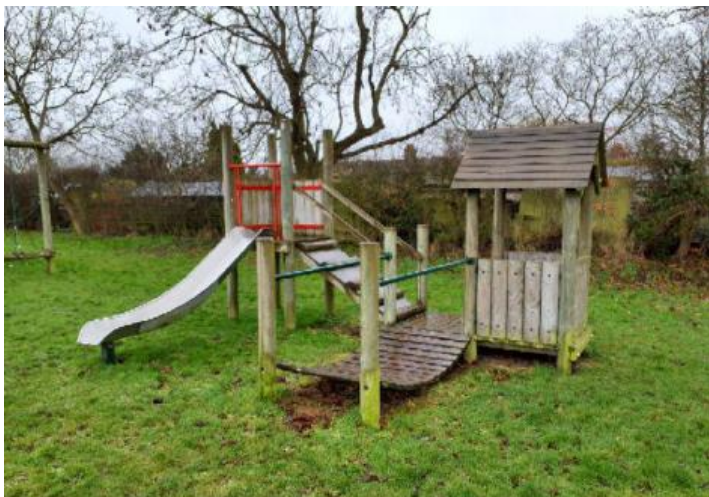
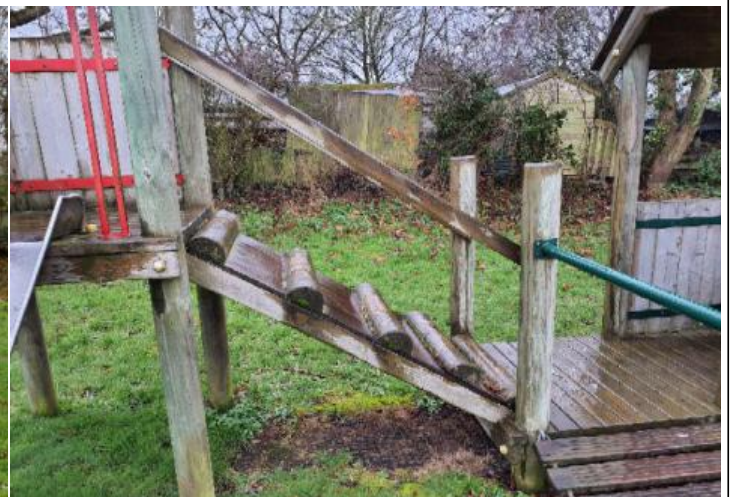
Finding: The unit is easily accessible and should have the appropriate barriers installed to meet the requirements of BS EN 1176 Part 1 as the height of the unit exceeds 600mm

Action: Monitor - No remedial work recommended

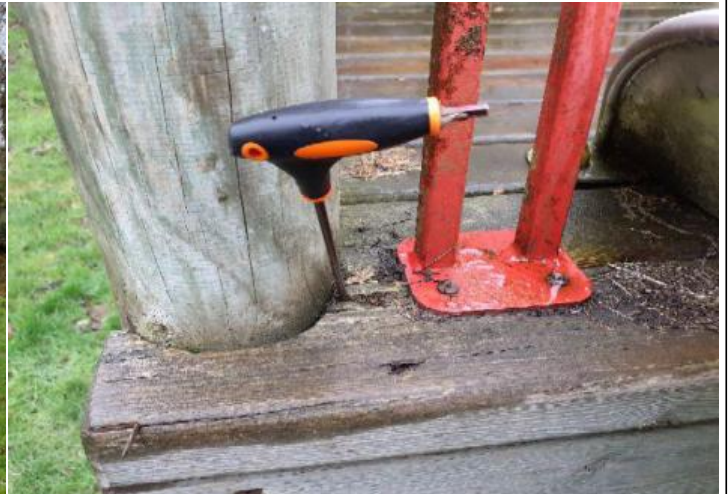
Finding: There is some evidence of rot in the timber

Action: Monitor for any further deterioration and replace as required

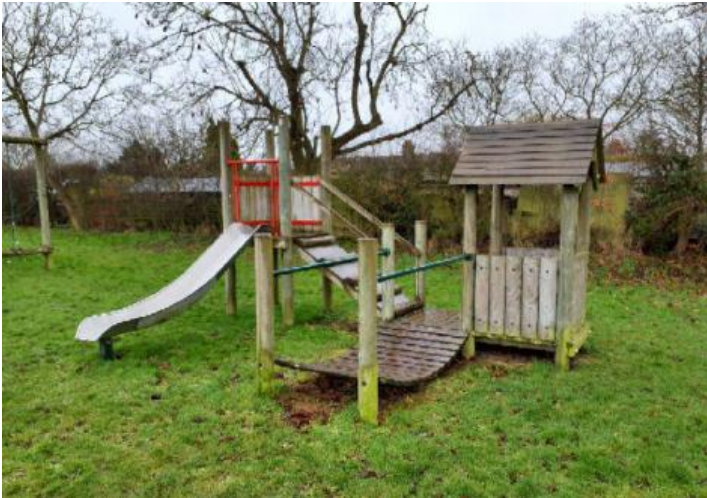
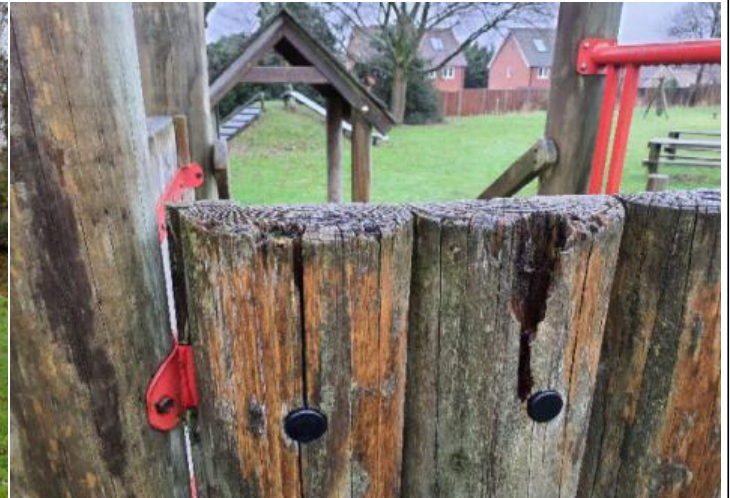
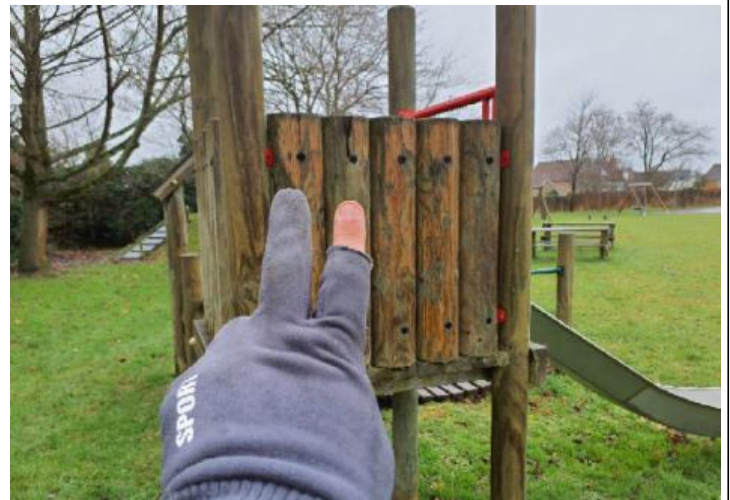
Finding: There are areas or parts of the timber on the structure that have rotted

Action: Replace all affected timbers

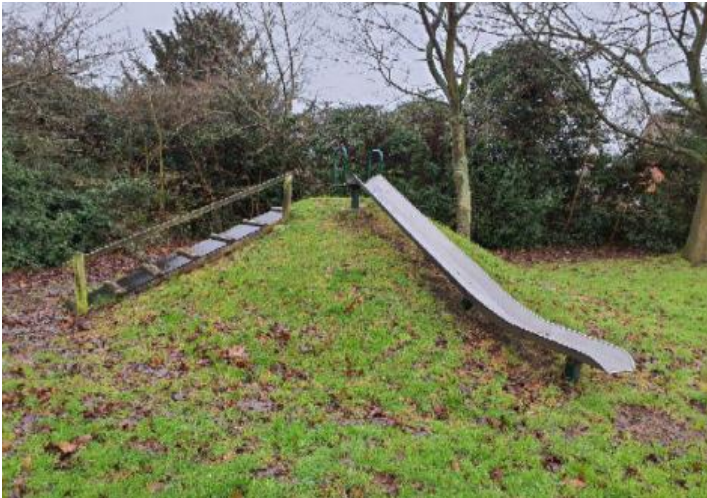
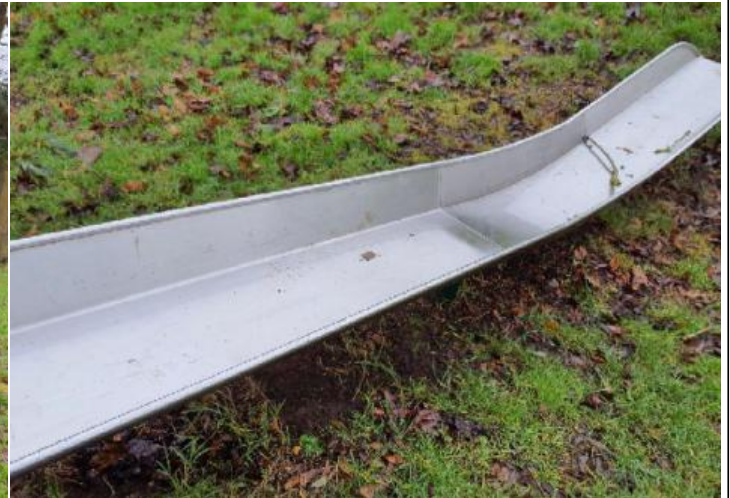
Finding: There are a number of dents in the slide surface

Action: Monitor for any further deterioration and repair as required

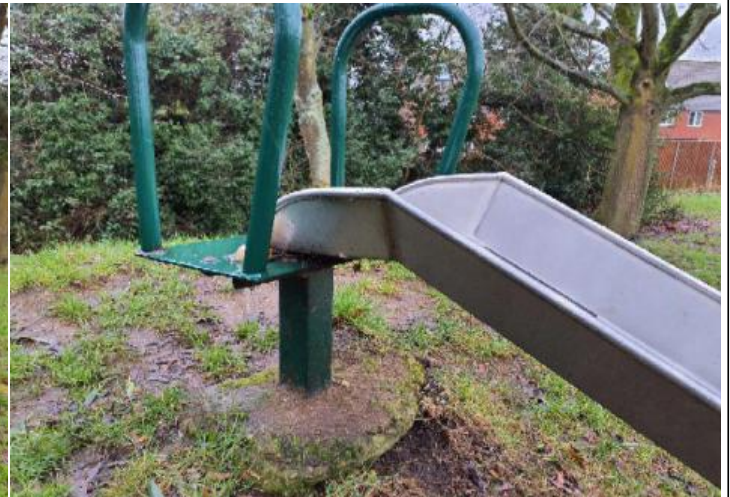
Finding: The slide start section incline is not in the direction of travel; it should slope towards the direction of the sliding surface to meet the requirements of BS EN 1176 Part 3

Action: Monitor - No remedial work recommended

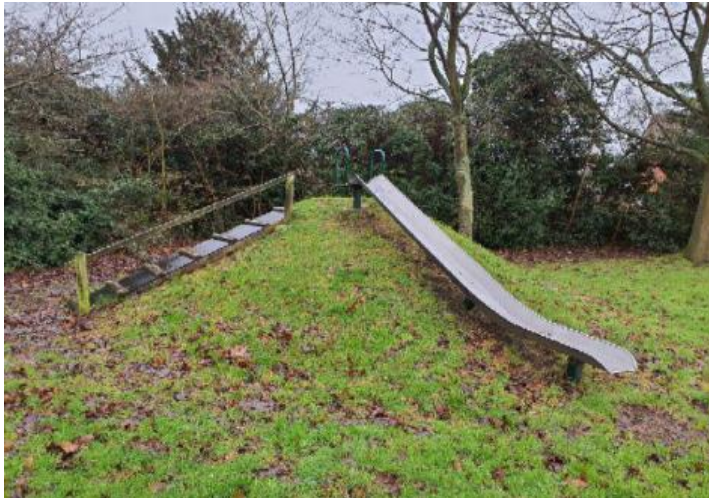
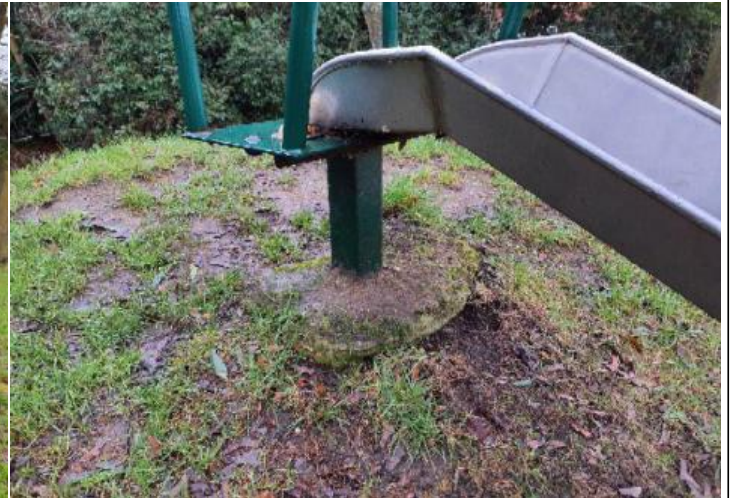
Finding: The surface has eroded and the foundations are exposed

Action: Reinstate surrounding surfaces to cover the foundations

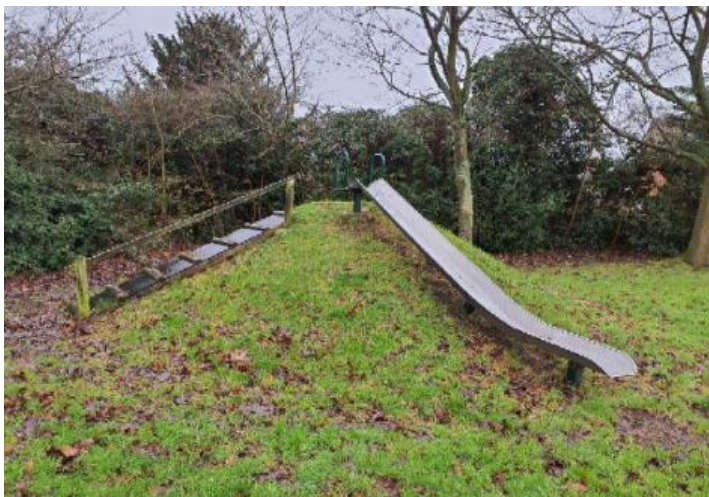
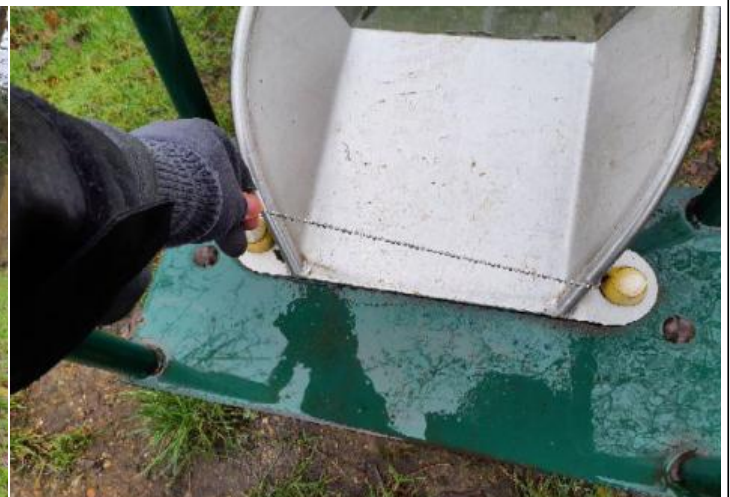
Finding: There is / are toggle entrapment/s present in contravention of the recommendations set out in BS EN 1176 Part 3

Action: Monitor - no remedial work recommended

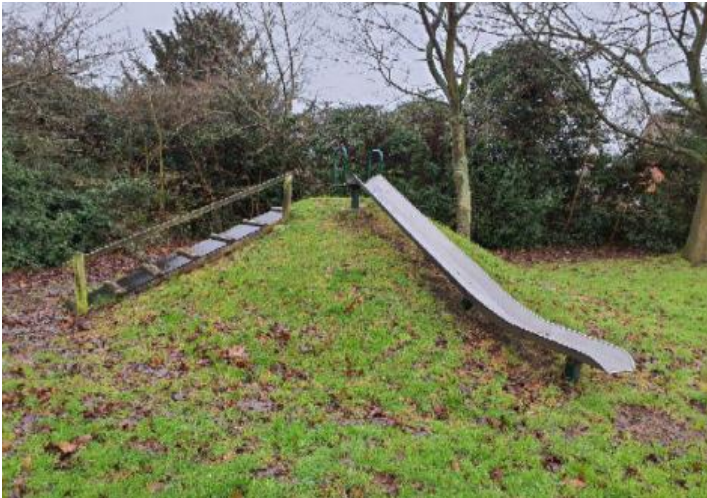
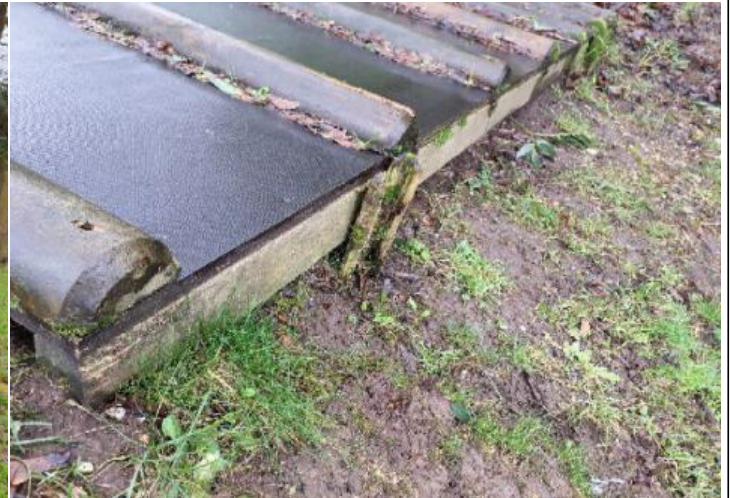
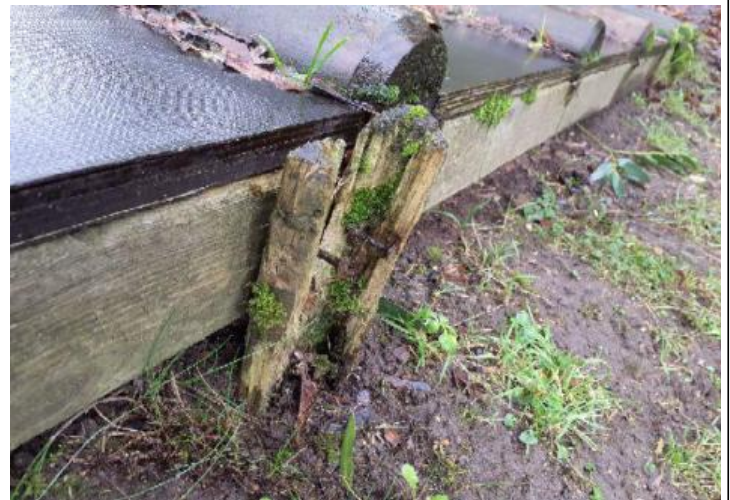
Finding: There are areas or parts of the timber access ramp that have rotted leaving projecting screws
Action: Replace all affected timbers

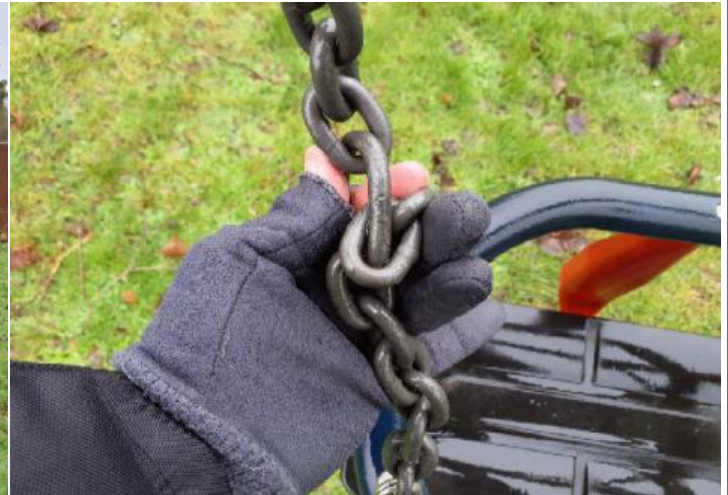
Finding: There is some notable evidence of chain wear	Action: Monitor for any further deterioration and replace when 40% worn
--	--

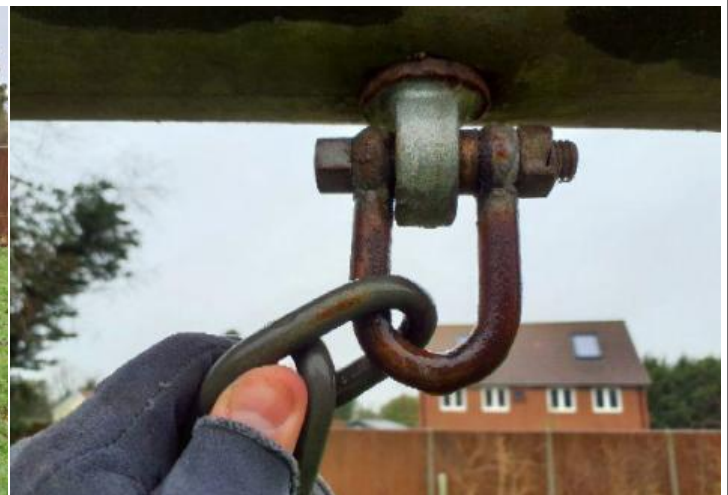
Finding: There is some wear to the shackles	Action: Monitor for any further deterioration and replace when 40% worn
--	--

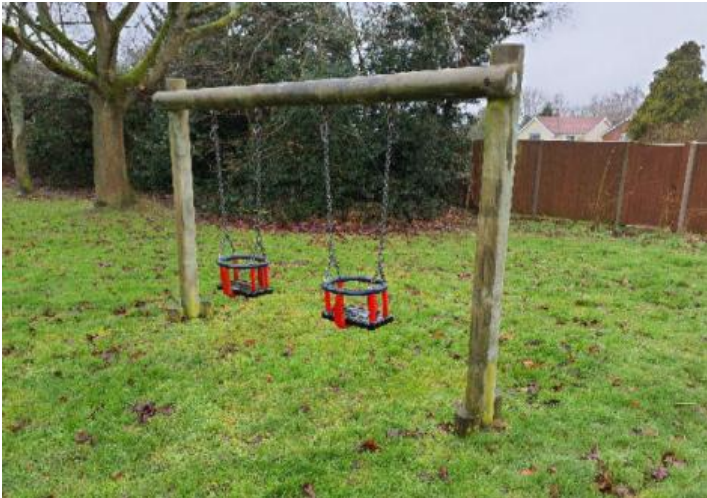
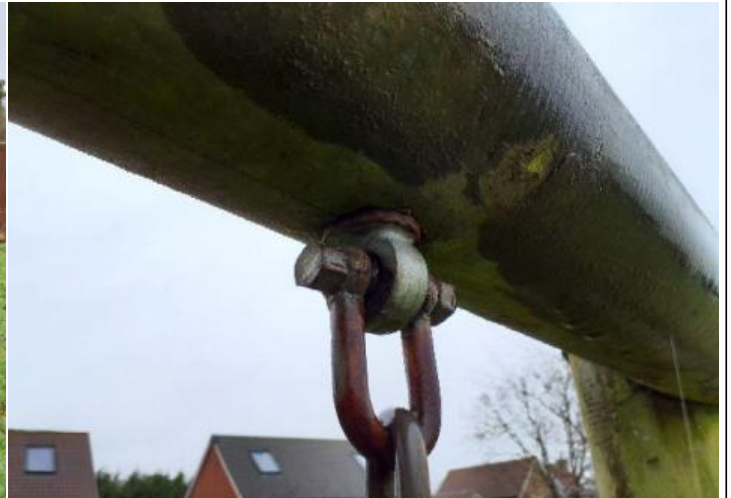
Finding: The bushes are showing signs of wear

Action: Monitor for any further deterioration and replace as required
