the **play** inspection company

Annual Inspection

Mid Suffolk District Council

Drinkstone

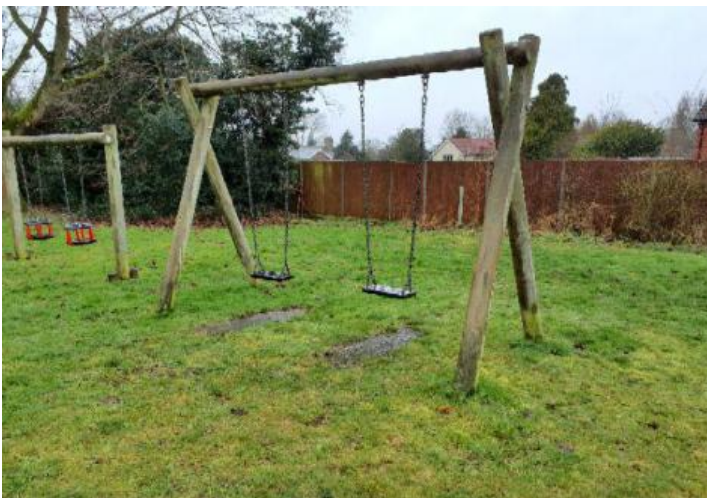
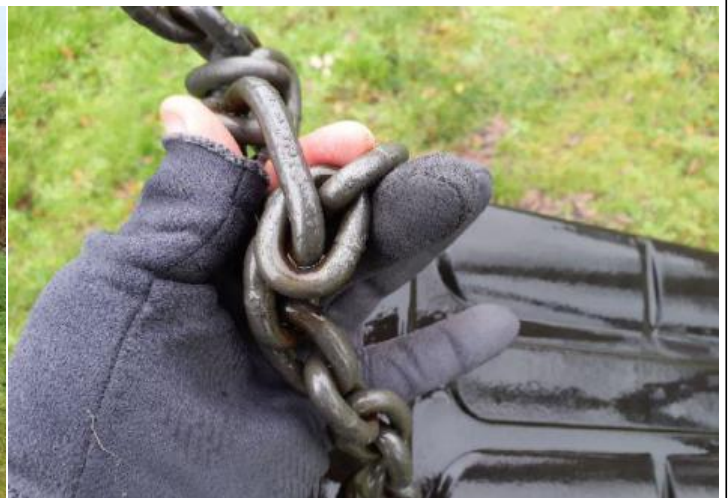
Finding: There is some notable evidence of chain wear

Action: Monitor for any further deterioration and replace when 40% worn

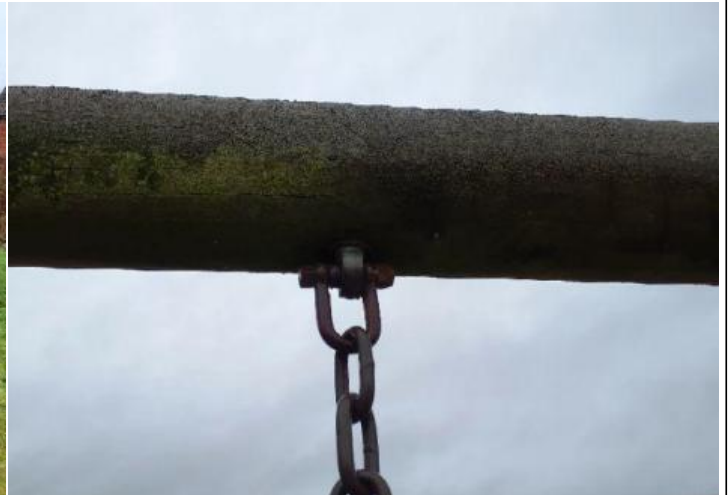
Finding: There is some wear to the shackles

Action: Monitor for any further deterioration and replace when 40% worn

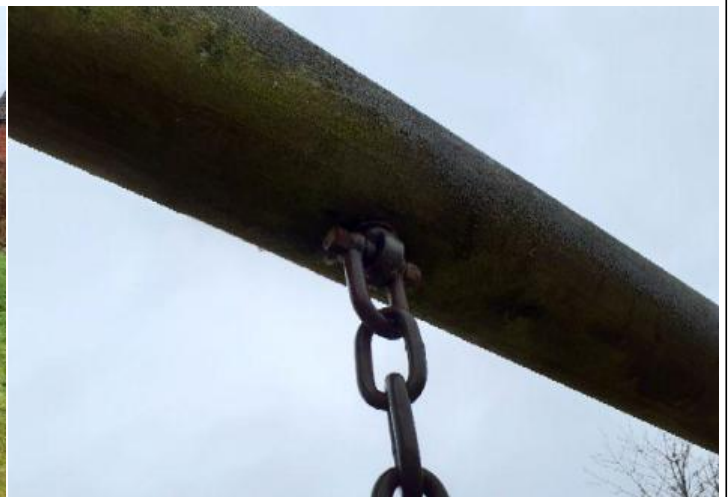
Finding: The bushes are worn or missing

Action: Replace worn or missing bushes

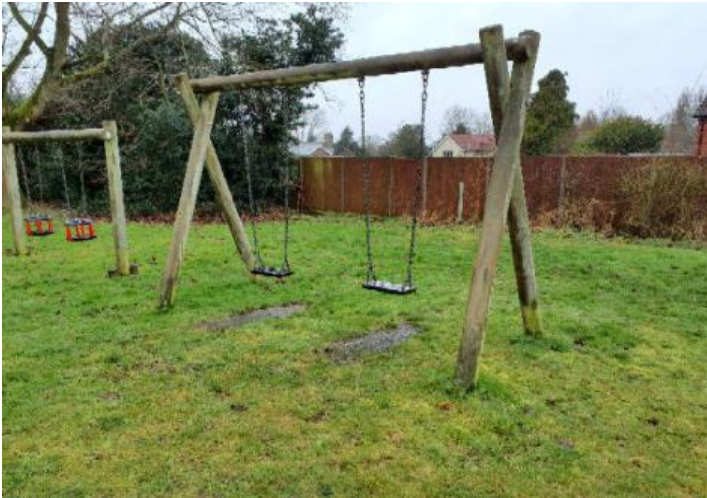
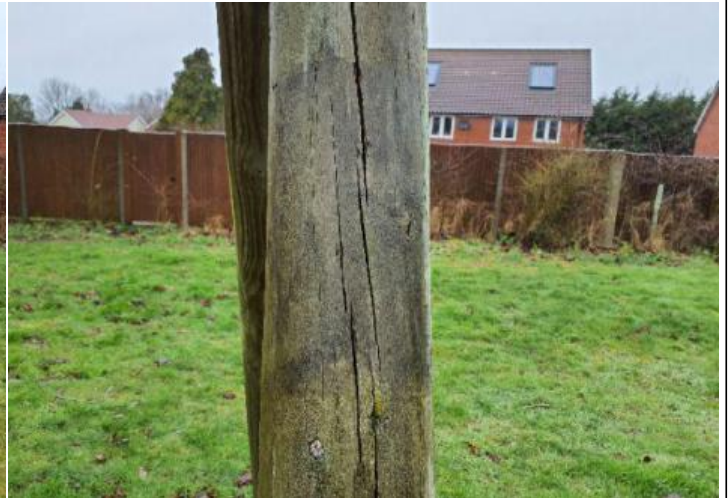
Finding: The timber has a number of splits/shakes or air cracks and this may affect the stability or allow water ingress which will accelerate the rotting process
Action: Monitor to ensure the splits do not cross through fixing points of the structure and/or cause any instability

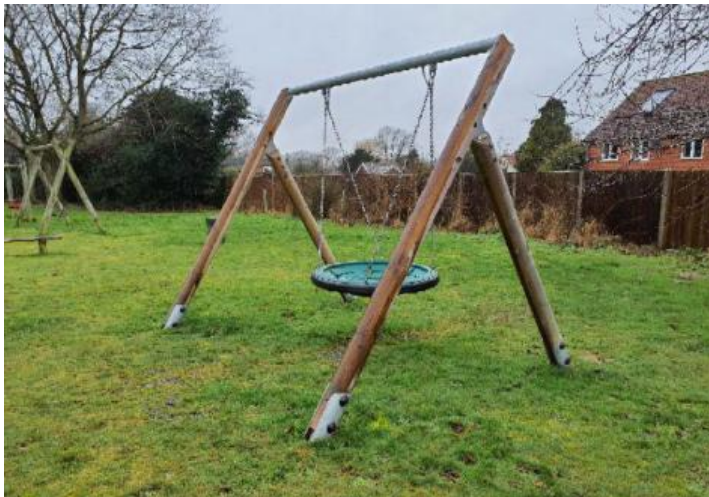
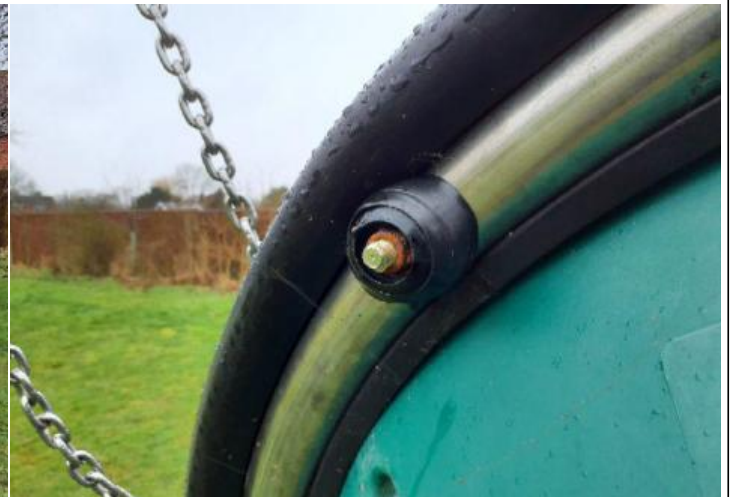
Finding: There are caps missing from the underside of the seats

Action: Replace missing caps under the seats

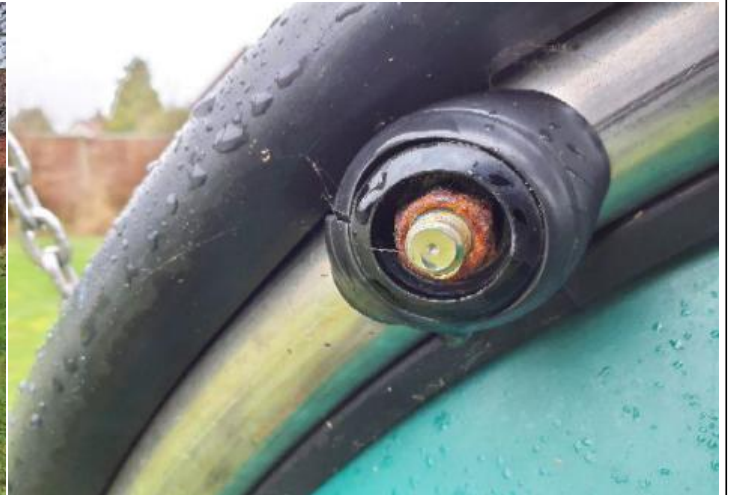
Finding: The fixings have corroded excessively

Action: Replace all corroded fixings

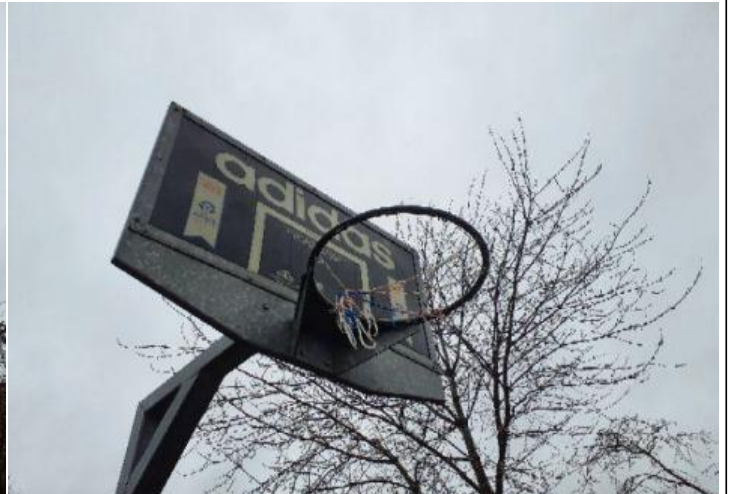
Finding: The net is damaged

Action: Replace

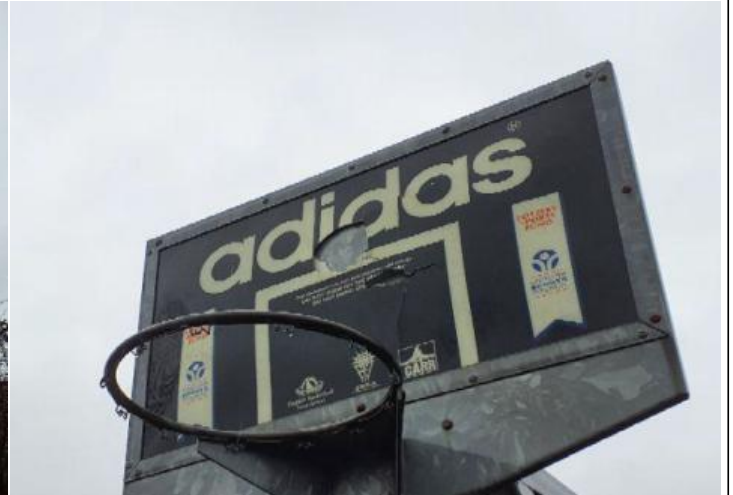
Finding: The backboard is damaged

Action: Replace backboard
