Annual Inspection

Mid Suffolk District Council

Drinkstone

Annual Inspection - 11 September 2015 at 08:06 Inspector: Matt Clay (RPII Annual Inspector)

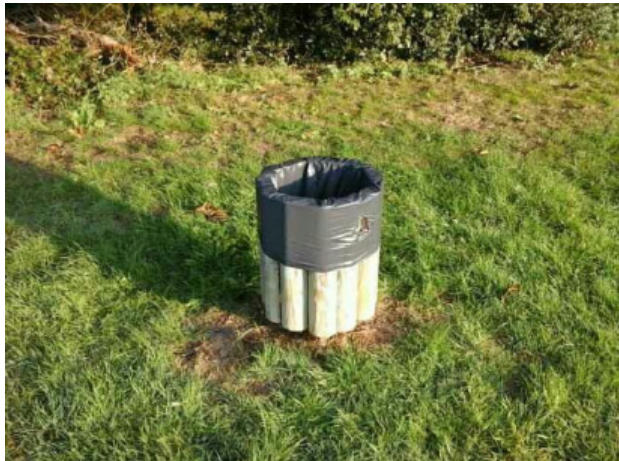
Finding 1

This item is satisfactory - no work required

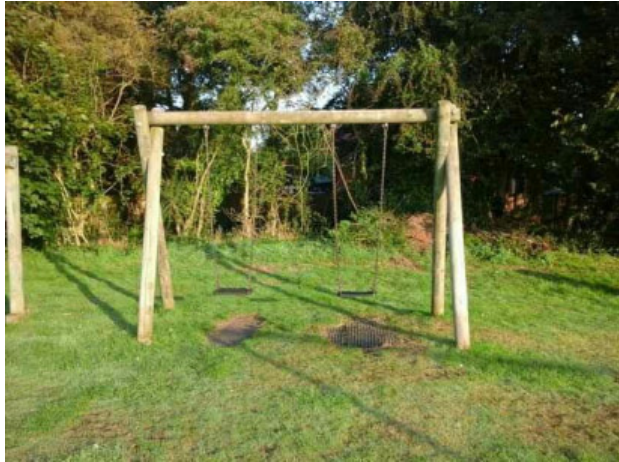
Item: Swings - 1 Bay 2 Seat (Flat)
Manufacturer: Adventure Playgrounds
Surface Type: Grass Matrix Tiles
Equipment Compliance: No
Surface Area Compliance: Yes
Ref/Part Number:
Total Findings: 8

The grass mats are silted up and the soil is compacted; this may have an effect on the impact absorbing properties of the surface - Lift and relay mats or test impact absorbing properties to ensure the correct surface qualities are maintained for the equipment

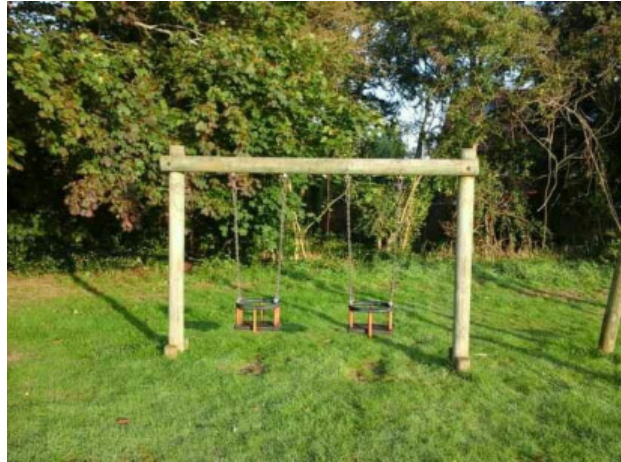
Item: Swings - 1 Bay 2 Seat (Cradle)
Manufacturer: Adventure Playgrounds
Surface Type: Grass Matrix Tiles
Equipment Compliance: No
Surface Area Compliance: Yes
Ref/Part Number:
Total Findings: 3

The grass mats are silted up and the soil is compacted; this may have an effect on the impact absorbing properties of the surface - Lift and relay mats or test impact absorbing properties to ensure the correct surface qualities are maintained for the equipment

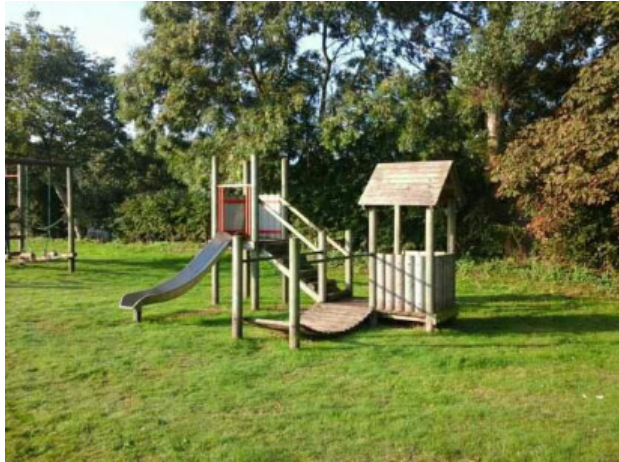
Item: Activity Equipment - Multi Play (Junior)
Manufacturer: Adventure Playgrounds
Surface Type: Grass Matrix Tiles
Equipment Compliance: No
Surface Area Compliance: Yes
Ref/Part Number:
Total Findings: 7

There is a toggle entrapment at the top of the slide - Monitor Use

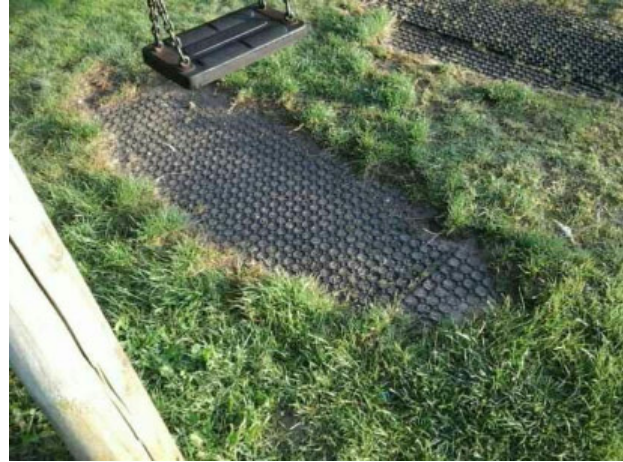
Item: Swings - 1 Bay 2 Seat (Flat)
Manufacturer: Adventure Playgrounds

Finding: The grass mats are silted up and the soil is compacted; this may have an effect on the impact absorbing properties of the surface

Action: Lift and relay mats or test impact absorbing properties to ensure the correct surface qualities are maintained for the equipment

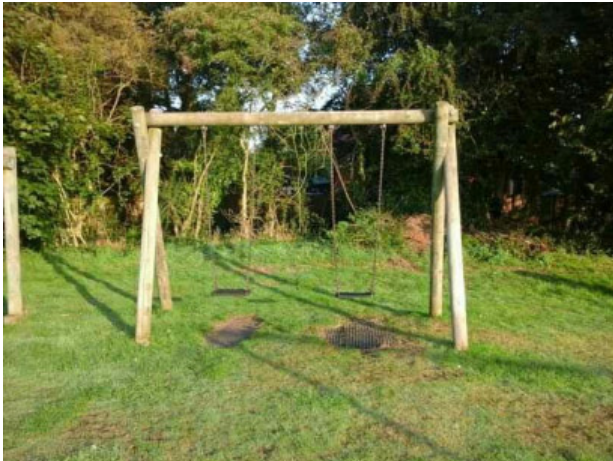
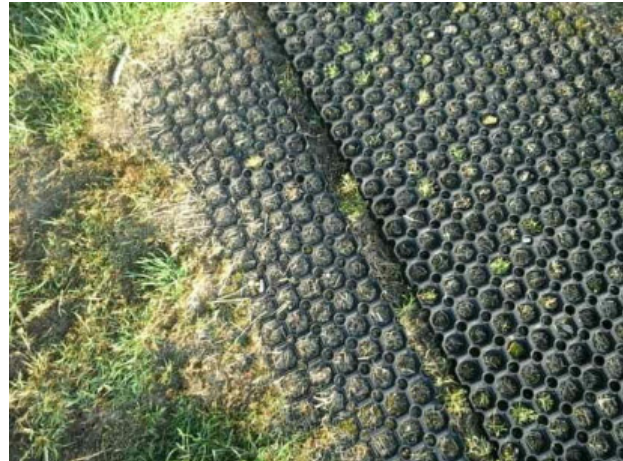
Item: Swings - 1 Bay 2 Seat (Flat)
Manufacturer: Adventure Playgrounds

Finding: There are gaps opening between the grass mat tiles

Action: Reinstate surface

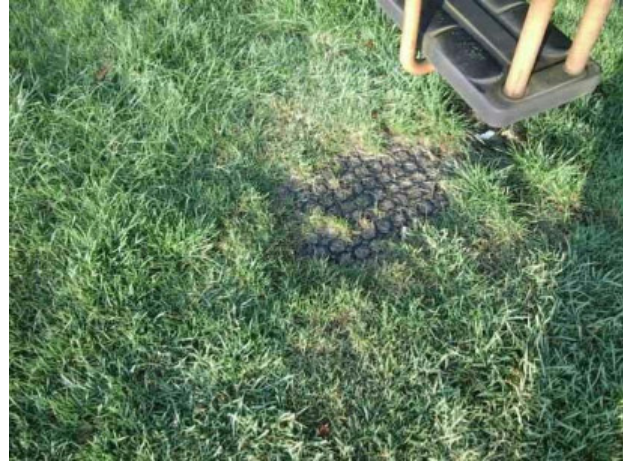
Item: Swings - 1 Bay 2 Seat (Cradle)
Manufacturer: Adventure Playgrounds

Finding: The grass mats are silted up and the soil is compacted; this may have an effect on the impact absorbing properties of the surface

Action: Lift and relay mats or test impact absorbing properties to ensure the correct surface qualities are maintained for the equipment

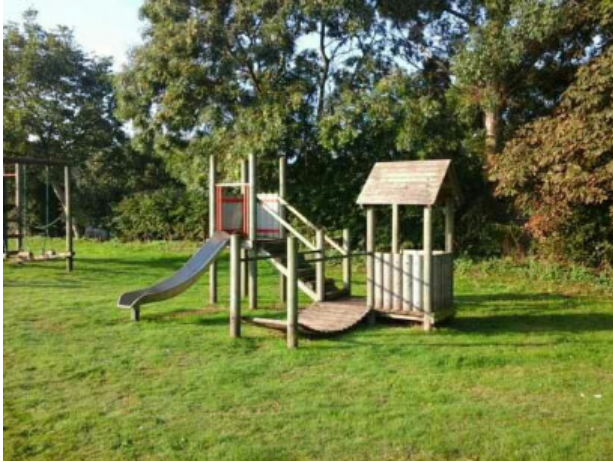
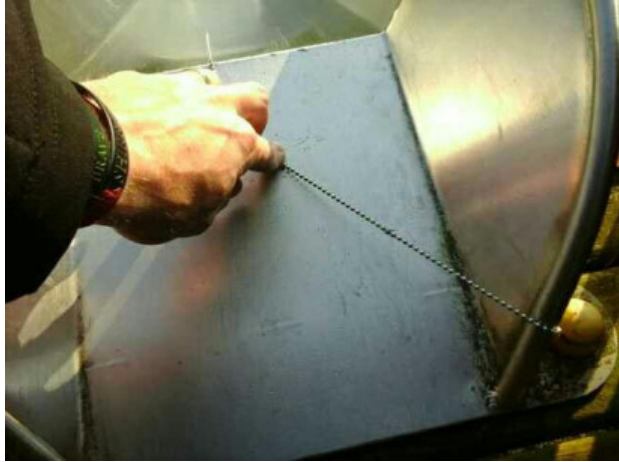
Item: Activity Equipment - Multi Play (Junior) **Risk Level:** V - Very Low Risk
Manufacturer: Adventure Playgrounds **Surface:** Grass Matrix Tiles

Finding: There is a toggle entrapment at the top of the slide **Action:** Monitor Use

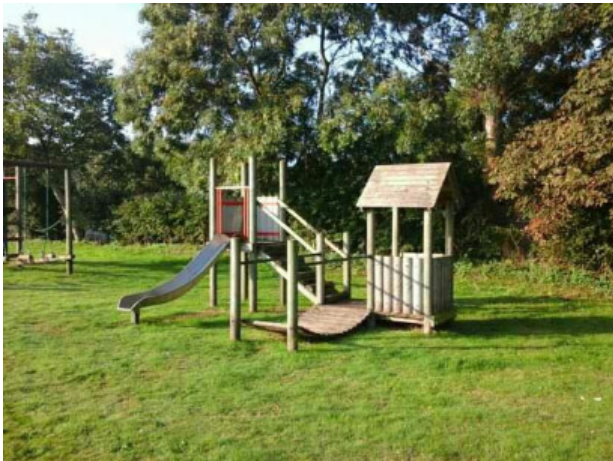
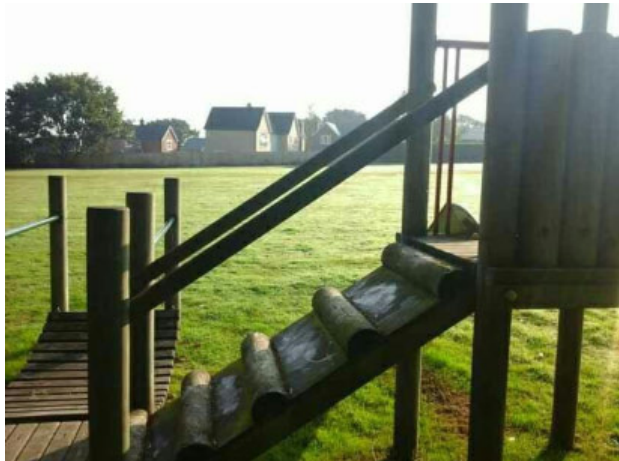
Item: Activity Equipment - Multi Play (Junior) **Risk Level:** L - Low Risk
Manufacturer: Adventure Playgrounds **Surface:** Grass Matrix Tiles

Finding: The unit is easily accessible and should have the appropriate barriers installed as the height of the unit exceeds 600mm **Action:** Monitor use

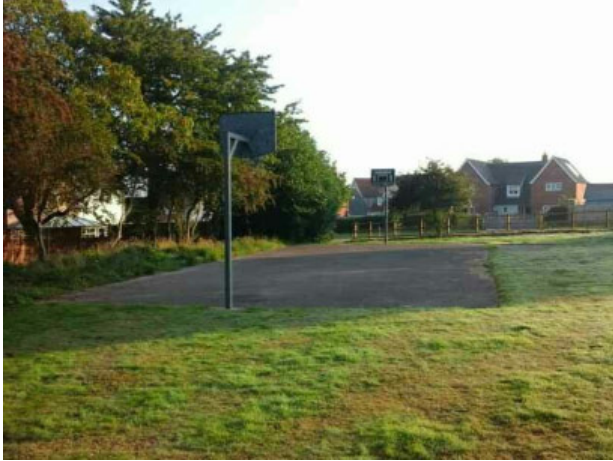
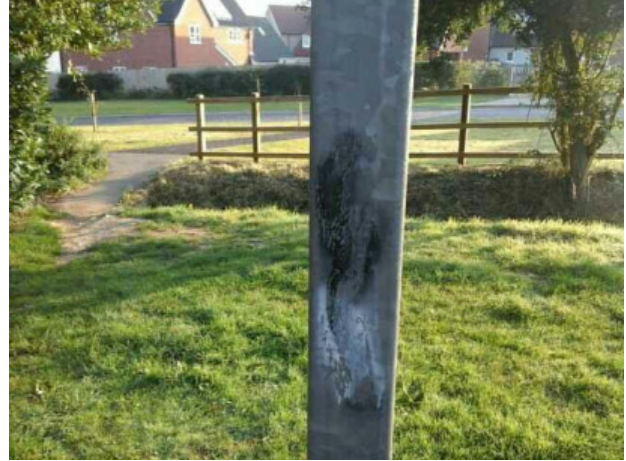
Finding: There is some graffiti present

Action: Remove the graffiti

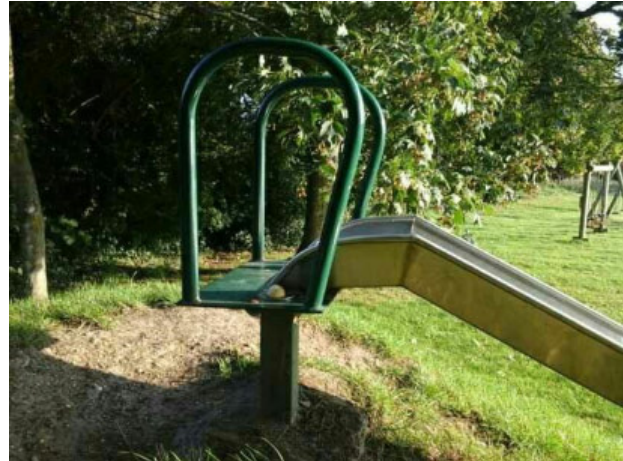
Item: Activity Equipment - Multi Play (Junior) **Risk Level:** V - Very Low Risk
Manufacturer: Owner/Operator **Surface:** Grass

Finding: The slide start section incline is not in the direction of travel; it should slope towards the direction of the sliding surface

Action: Monitor use

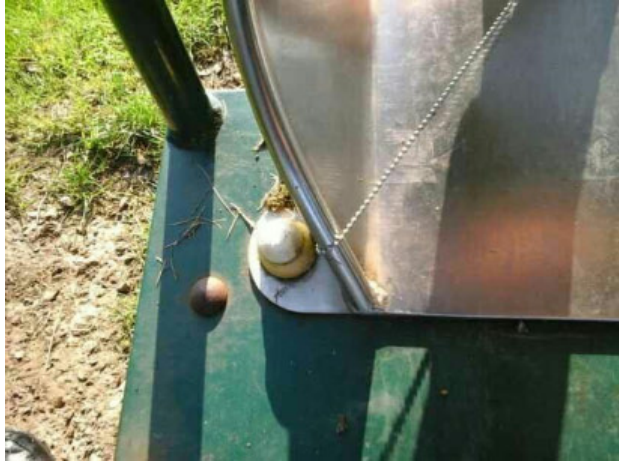
Item: Activity Equipment - Multi Play (Junior) **Risk Level:** V - Very Low Risk
Manufacturer: Owner/Operator **Surface:** Grass

Finding: There is a toggle entrapment at the top of the slide **Action:** Monitor Use
