the **play** inspection company

Annual Inspection

Mid Suffolk District Council

Drinkstone

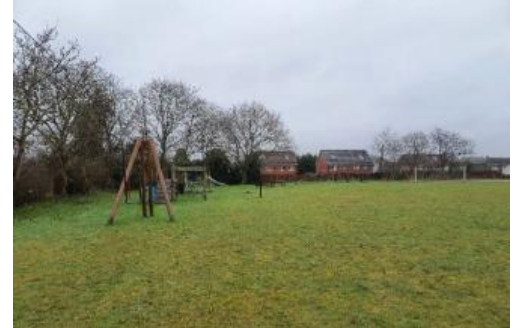
Item: Site General
Manufacturer: Owner/Operator
Surface Type: N/A
Item Quantity: 1
Equipment Compliance: N/A
Surface Area Compliance: N/A

This item is satisfactory - no work required -

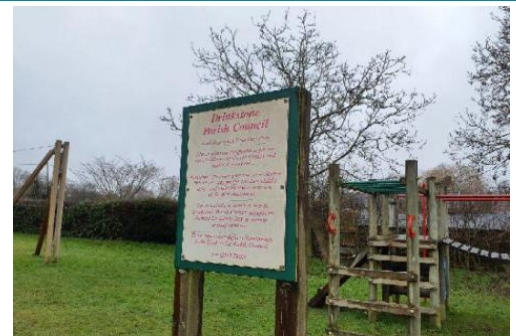
Item: Sign
Manufacturer: Owner/Operator
Surface Type: N/A
Item Quantity: 1
Equipment Compliance: N/A
Surface Area Compliance: N/A

It is recommended that signage, with information including the site address, contact information for maintenance issues and emergency contact details are provided for the facility - Provide in accordance with the recommendations

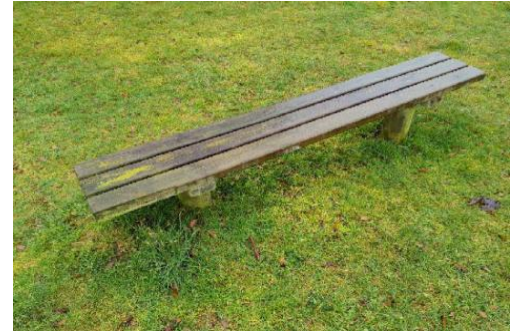
Item: Bench
Manufacturer: Not Identified
Surface Type: Grass
Item Quantity: 2
Equipment Compliance: N/A
Surface Area Compliance: N/A

There is some strimmer / machinery damage apparent on the posts, this can penetrate the preservative applied to the timber and accelerate the rotting process - Monitor for any deterioration (rot) and replace as required

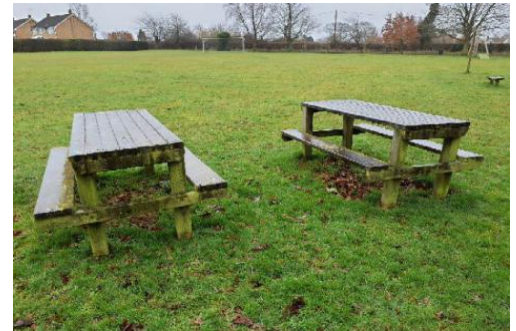
Item: Picnic Table
Manufacturer: Not Identified
Surface Type: Grass
Item Quantity: 2
Equipment Compliance: N/A
Surface Area Compliance: N/A

There are areas or parts of the timber on the structure that have rotted - Replace all affected timbers

There is some strimmer / machinery damage apparent on the posts, this can penetrate the preservative applied to the timber and accelerate the rotting process - Monitor for any deterioration (rot) and replace as required

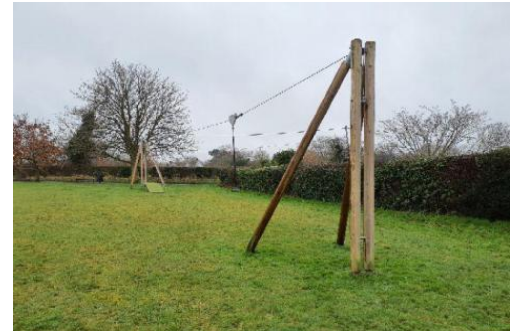
Item: Cable Runway
Manufacturer: Playdale Playgrounds Ltd
Surface Type: Grass Matrix Tiles
Item Quantity: 1
Equipment Compliance: Yes
Surface Area Compliance: Yes

We have completed a visual inspection of the suspension links, cable and fixing points from ground level, however it is not possible to fully inspect these areas without either hiring equipment to gain access or removing the cable and suspension and inspecting at ground level. We recommend that the main cable and fixing security is thoroughly inspected at least in accordance with the manufacturers recommendations to check for wear, damage, security or internal rusting; this will help to ensure the continued safe use of the equipment - Inspect in accordance with the manufacturers recommendations

The seat connection cannot be inspected without dismantling the seat - Dismantle the seat to inspect the seat connection for wear

There is some strimmer / machinery damage apparent on the posts, this can penetrate the preservative applied to the timber and accelerate the rotting process - Monitor for any deterioration (rot) and replace as required

There is some notable evidence of chain and shackle wear - Monitor for any further deterioration and replace when 40% worn

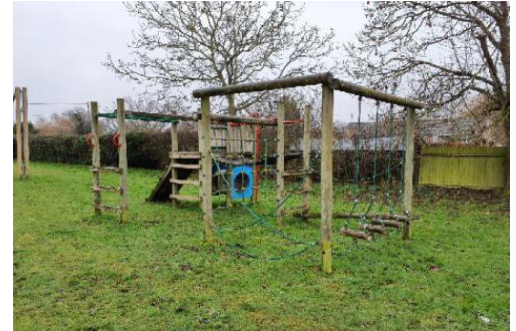
Item: Climbing Frame
Manufacturer: Adventure Playgrounds
Surface Type: Grass Matrix Tiles
Item Quantity: 1
Equipment Compliance: No
Surface Area Compliance: Yes

There is/are bolt cap covers missing or damaged on the item - Replace missing or damaged bolt cap covers

The ropes/nets are worn/damaged in places - Monitor for any further deterioration and repair or replace as required

There are areas or parts of the timber on the structure that have rotted - Replace all affected timbers

There is/are finger entrapment/s in the climbing wall and the item fails to meet the requirements of BS EN 1176 Part 1 4.2.7.6 Entrapment of fingers - Monitor - No remedial work recommended

The item fails to meet the requirements of BS EN 1176 Part 1 4.2.7.2 head and neck entrapment in the barriers and/or steps - Monitor - No remedial work recommended

The connecting links are in excess of 8.6mm and less than 12mm and fail the requirements of BS EN 1176 Part 1; clause 4.2.13, Chains - Monitor use and replace with compliant links at the next maintenance cycle

A number of fixing(s) have worked loose - Secure all loose fixings

There is some strimmer / machinery damage apparent on the posts, this can penetrate the preservative applied to the timber and accelerate the rotting process - Monitor for any deterioration (rot) and replace as required

The timber has a number of splits/shakes or air cracks and this may affect the stability or allow water ingress which will accelerate the rotting process - Monitor to ensure the splits do not cross through fixing points of the structure and/or cause any instability

There is some evidence of rot in the timber - Monitor for any further deterioration and replace as required

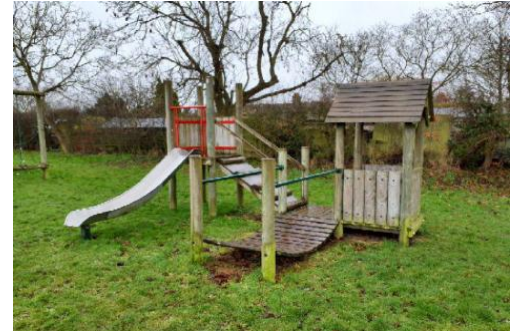
Item: Multi Play (Junior)
Manufacturer: Adventure Playgrounds
Surface Type: Grass Matrix Tiles
Item Quantity: 1
Equipment Compliance: No
Surface Area Compliance: Yes

There is some strimmer / machinery damage apparent on the posts, this can penetrate the preservative applied to the timber and accelerate the rotting process - Monitor for any deterioration (rot) and replace as required

The unit is easily accessible and should have the appropriate barriers installed to meet the requirements of BS EN 1176 Part 1 as the height of the unit exceeds 600mm - Monitor - No remedial work recommended

There is some evidence of rot in the timber - Monitor for any further deterioration and replace as required

There are areas or parts of the timber on the structure that have rotted - Replace all affected timbers

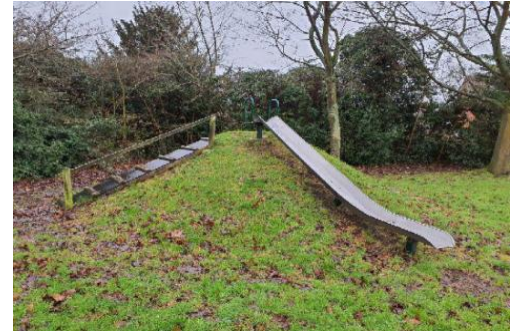
Item: Embankment Slide
Manufacturer: Not Identified
Surface Type: Grass
Item Quantity: 1
Equipment Compliance: No
Surface Area Compliance: Yes

There are a number of dents in the slide surface - Monitor for any further deterioration and repair as required

The surface has eroded and the foundations are exposed - Reinstate surrounding surfaces to cover the foundations

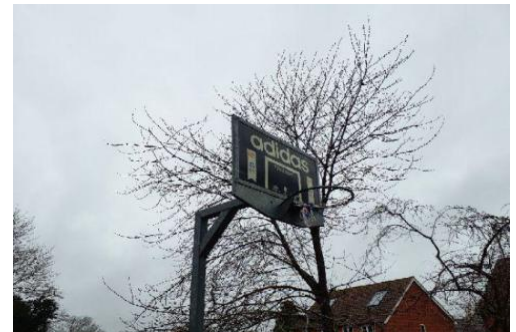
Item: Basketball Post
Manufacturer: Adidas
Surface Type: Bitmac
Item Quantity: 1
Equipment Compliance: Yes
Surface Area Compliance: N/A

The net is damaged - Replace

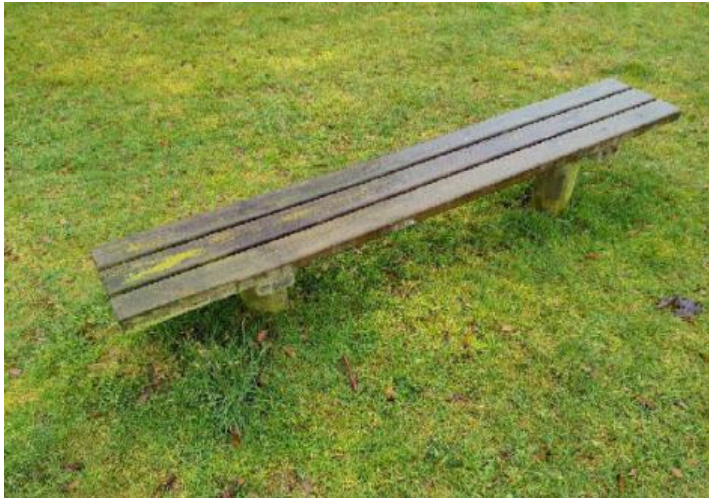
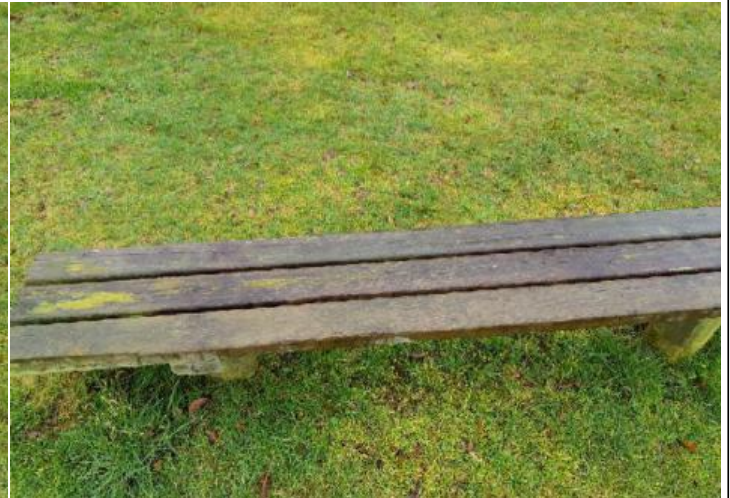
Item: Ancillary Items - Bench
Manufacturer: Not Identified

Finding: There is algae or moss on the surface of the equipment

Action: Clean and treat appropriately

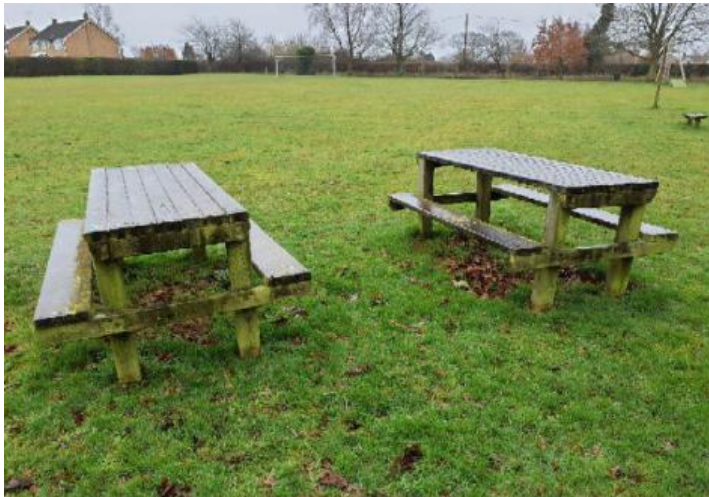
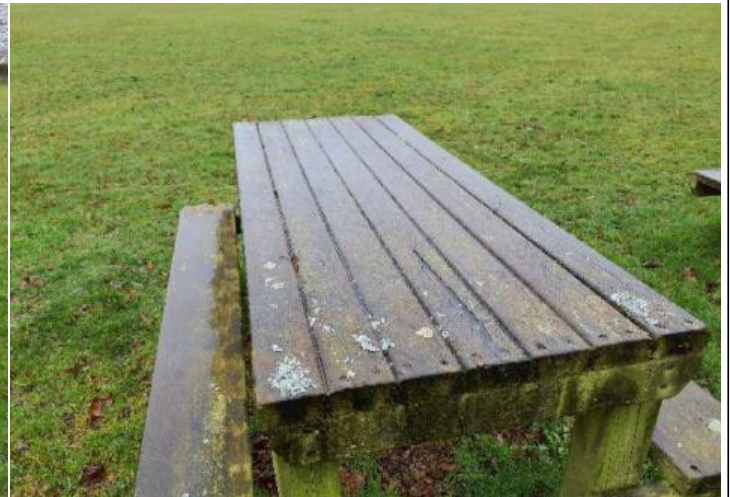
Item: Ancillary Items - Picnic Table
Manufacturer: Not Identified

Finding: There is algae or moss on the surface of the equipment

Action: Clean and treat appropriately

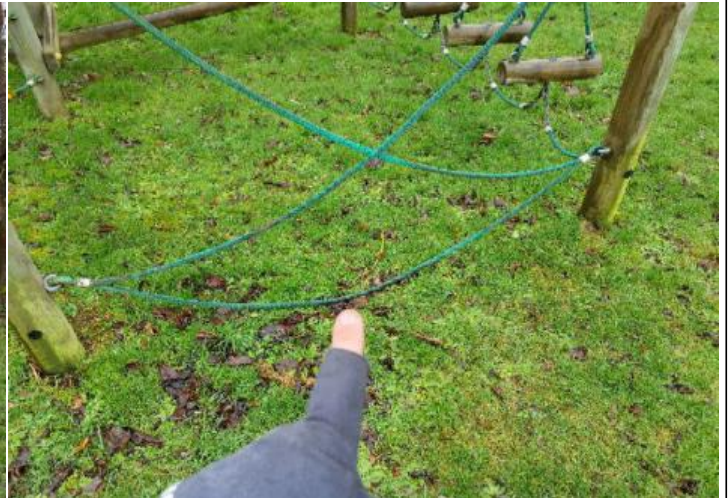
Item: Activity Equipment - Climbing Frame
Manufacturer: Adventure Playgrounds

Finding: The rope is making contact with the surface

Action: Adjust rope

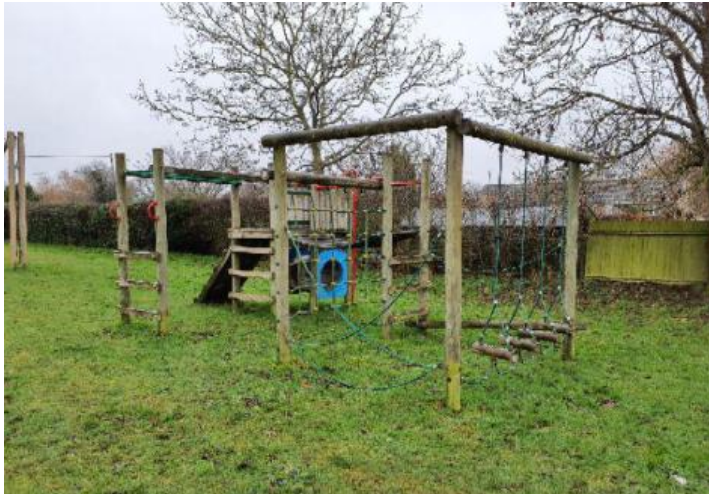
Item: Activity Equipment - Climbing Frame
Manufacturer: Adventure Playgrounds

Finding: The ropes/nets are worn/damaged in places

Action: Monitor for any further deterioration and repair or replace as required

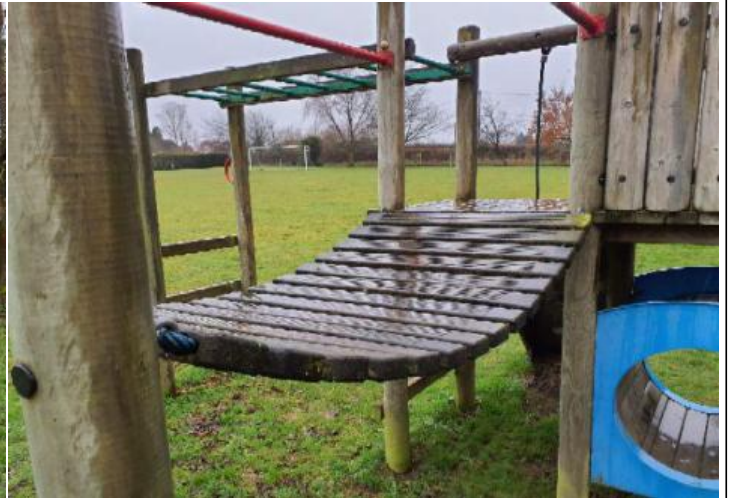
Item: Activity Equipment - Climbing Frame
Manufacturer: Adventure Playgrounds

Finding: There is algae or moss on the surface of the equipment

Action: Clean and treat appropriately

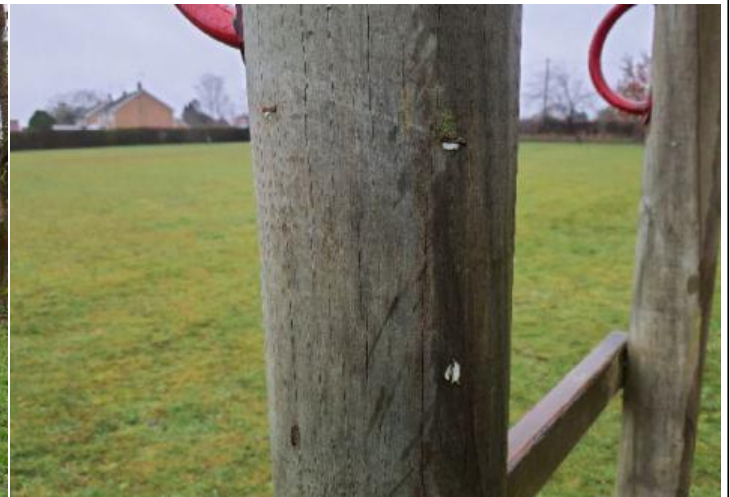
Item: Activity Equipment - Climbing Frame
Manufacturer: Adventure Playgrounds

Finding: There are redundant staples attached to the equipment

Action: Remove redundant staples

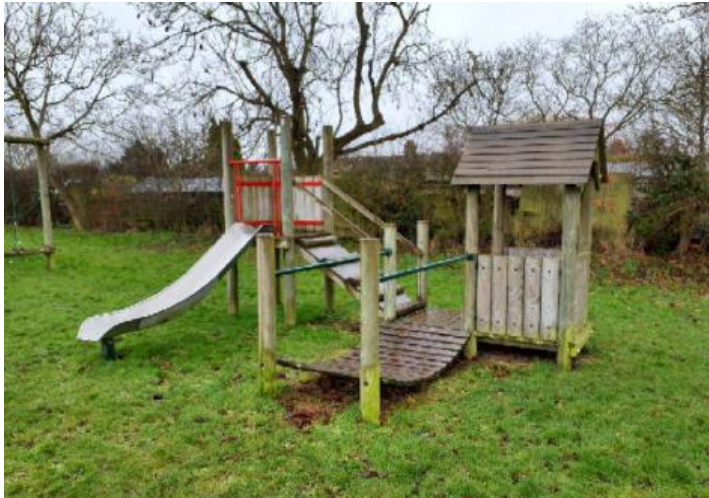
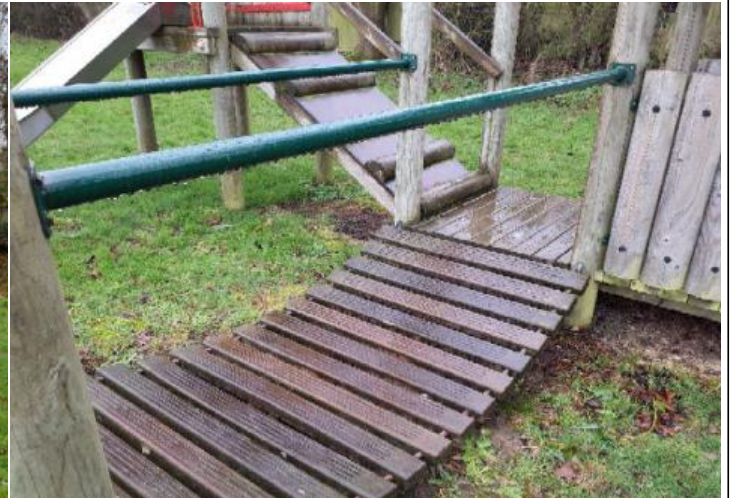
Item: Activity Equipment - Multi Play (Junior)
Manufacturer: Adventure Playgrounds

Finding: There is algae or moss on the surface of the equipment

Action: Clean and treat appropriately

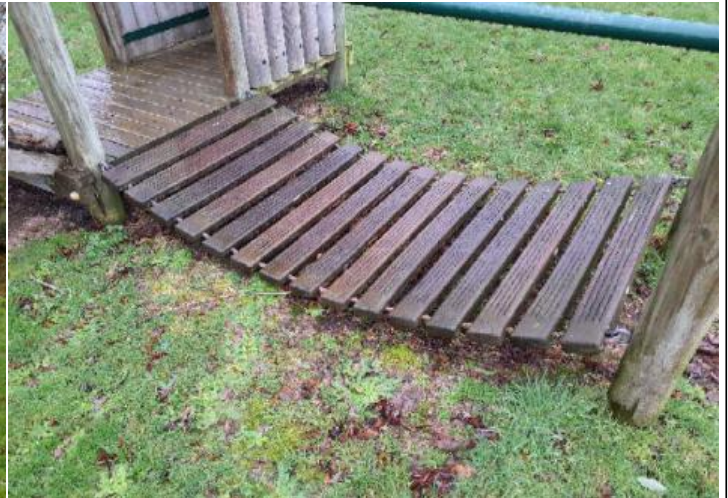
Item: Activity Equipment - Multi Play (Junior)
Manufacturer: Adventure Playgrounds

Finding: The bridge is making contact with the surface

Action: Adjust bridge

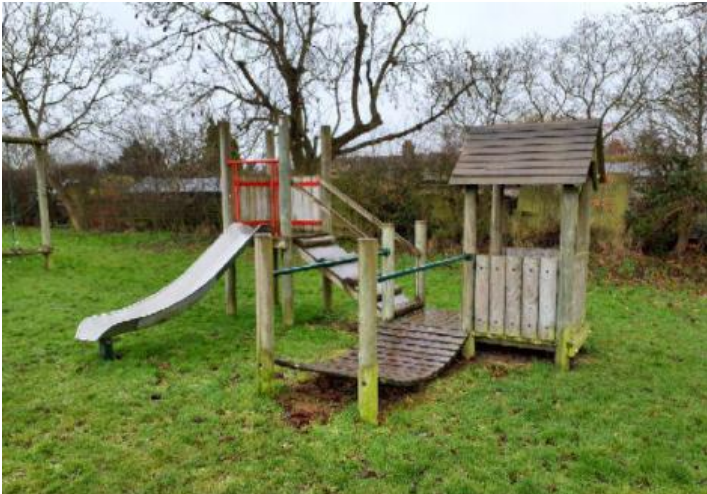
Item: Activity Equipment - Multi Play (Junior)
Manufacturer: Adventure Playgrounds

Finding: There is some evidence of rot in the timber

Action: Monitor for any further deterioration and replace as required

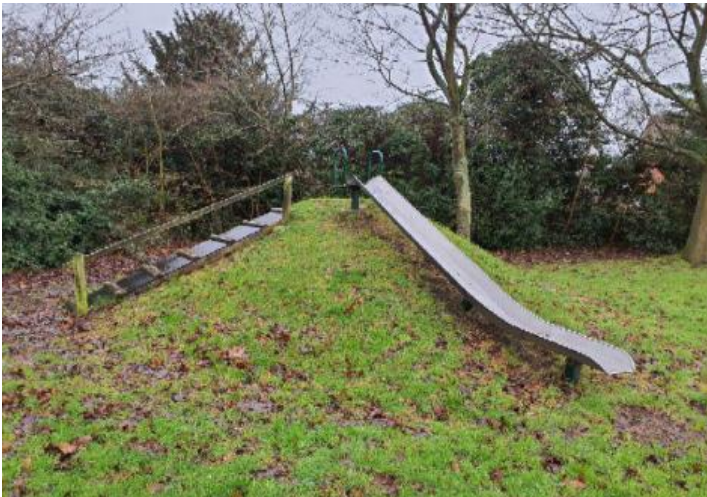
Item: Other - Embankment Slide
Manufacturer: Not Identified

Finding: The slide start section incline is not in the direction of travel; it should slope towards the direction of the sliding surface to meet the requirements of BS EN 1176 Part 3

Action: Monitor - No remedial work recommended

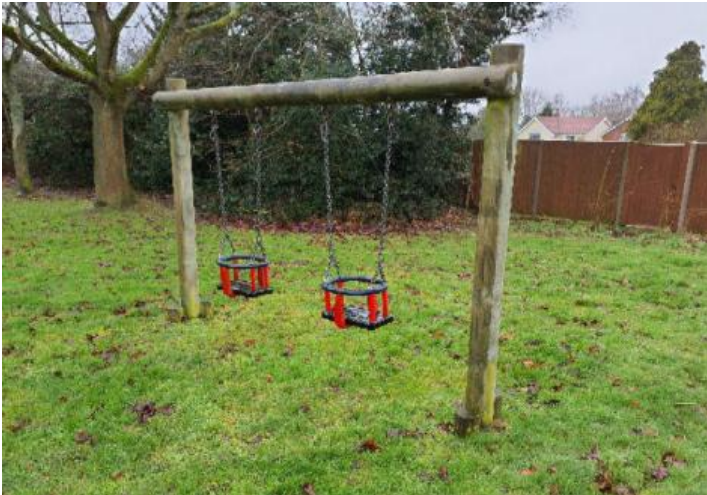
Item:	Swings - 1 Bay 2 Seat (Cradle)	Risk Level:	L - Low Risk
Manufacturer:	Adventure Playgrounds	Surface:	Grass Matrix Tiles

Finding: There is some notable evidence of chain wear	Action: Monitor for any further deterioration and replace when 40% worn
--	--

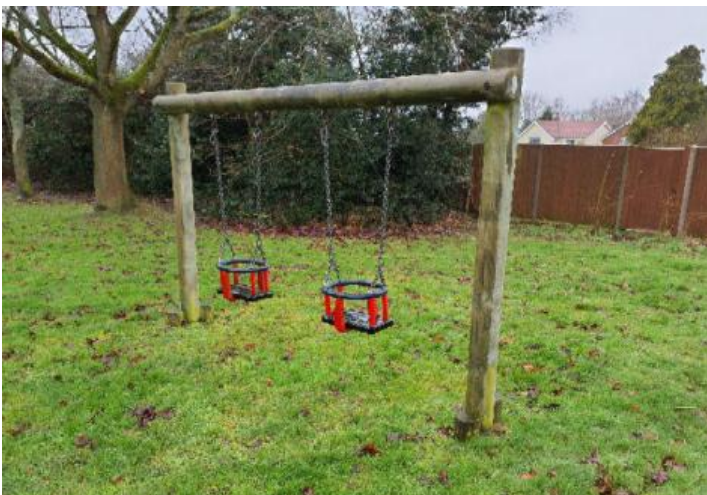
Item:	Swings - 1 Bay 2 Seat (Cradle)	Risk Level:	L - Low Risk
Manufacturer:	Adventure Playgrounds	Surface:	Grass Matrix Tiles

Finding: There is some wear to the shackles	Action: Monitor for any further deterioration and replace when 40% worn
--	--

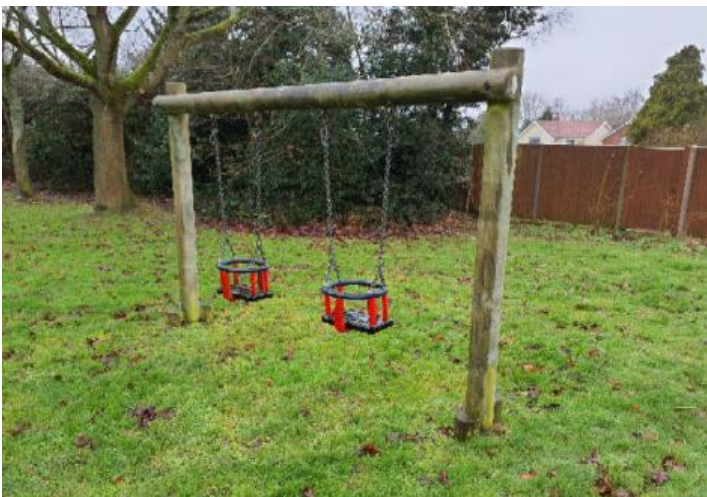
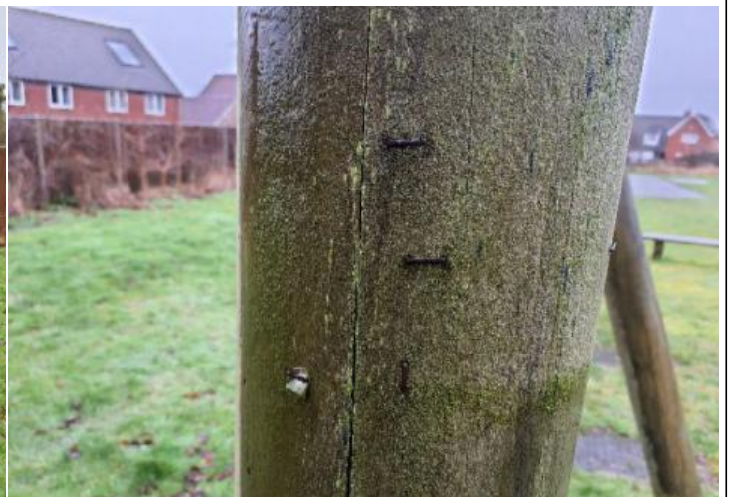
Item: Swings - 1 Bay 2 Seat (Cradle)
Manufacturer: Adventure Playgrounds

Finding: There are redundant staples attached to the equipment

Action: Remove redundant staples

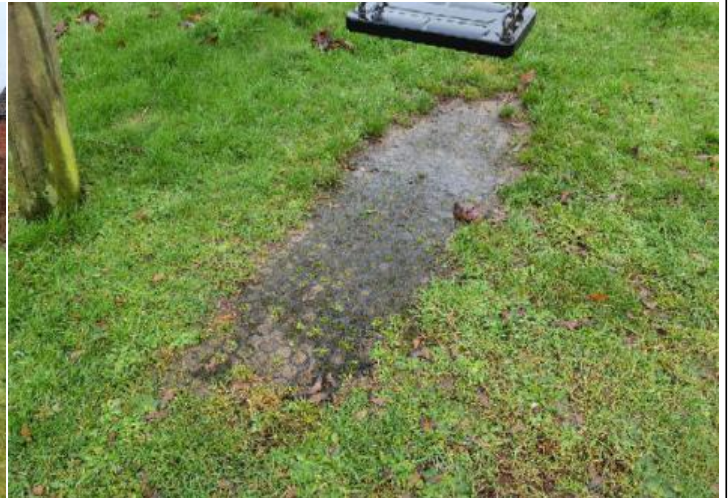
Item: Swings - 1 Bay 2 Seat (Flat)
Manufacturer: Adventure Playgrounds

Finding: The grass mats are silted up and the soil is compacted; this may have an effect on the impact absorbing properties of the surface. Consideration should be given to HIC testing the surface to verify impact attenuating properties (<https://playinspections.co.uk/inspection-services/safety-surface-testing/>)

Action: Contact our office for a quotation for this service

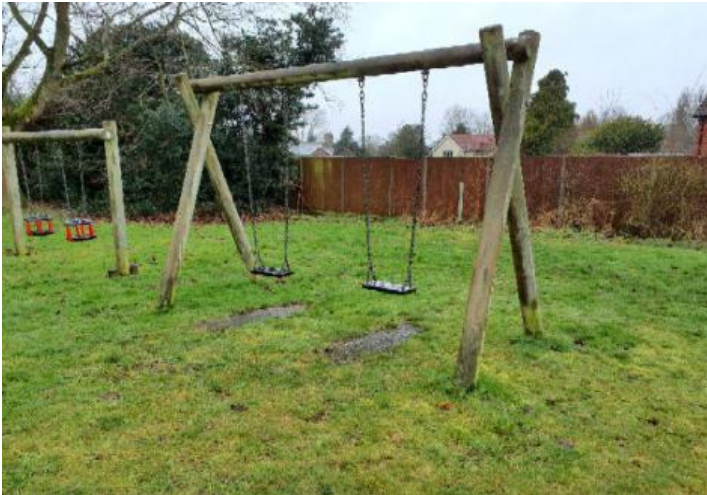
Item: Swings - 1 Bay 2 Seat (Flat)
Manufacturer: Adventure Playgrounds

Finding: There is some wear to the shackles

Action: Monitor for any further deterioration and replace when 40% worn

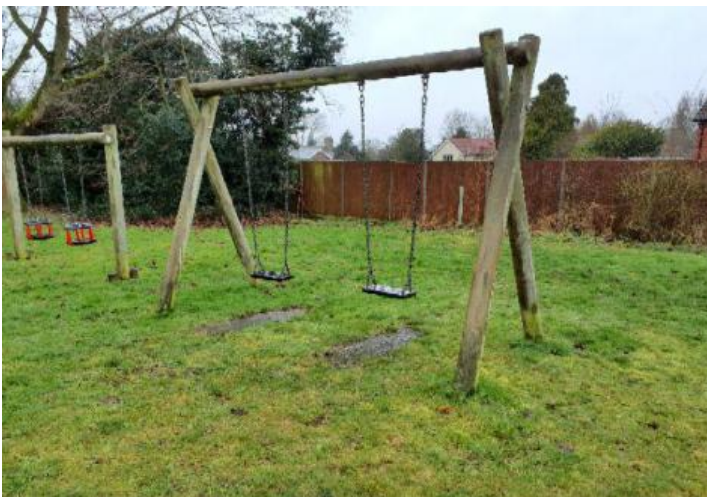
Item: Swings - 1 Bay 2 Seat (Flat)
Manufacturer: Adventure Playgrounds

Finding: The bushes are worn or missing

Action: Replace worn or missing bushes

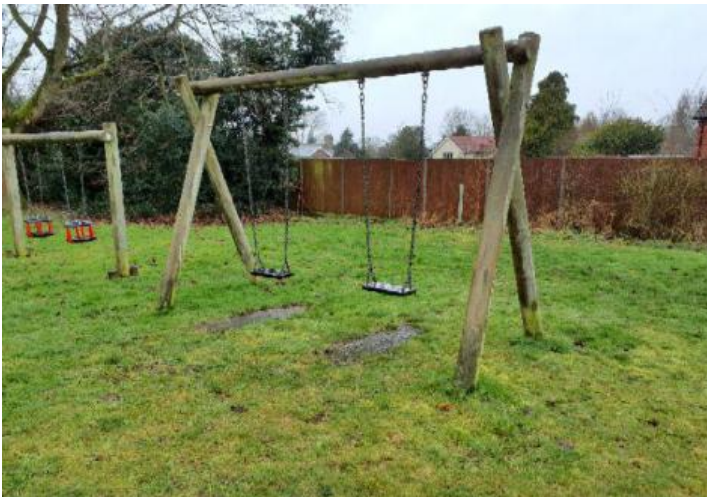
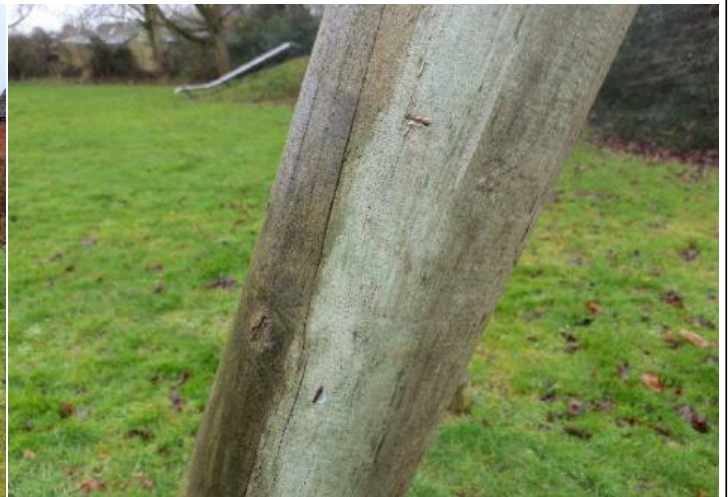
Item: Swings - 1 Bay 2 Seat (Flat)
Manufacturer: Adventure Playgrounds

Finding: There are redundant staples attached to the equipment
Action: Remove redundant staples

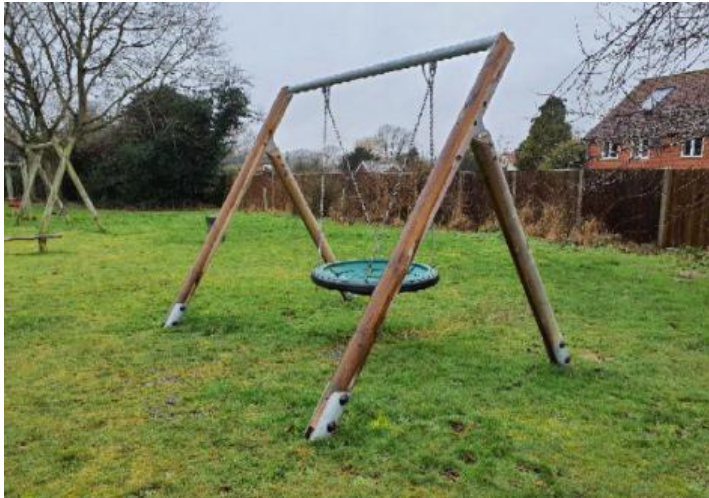
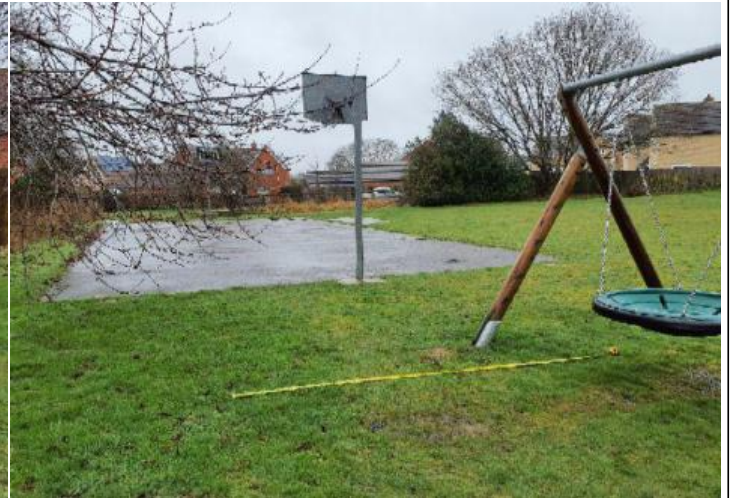
Item: Swings - Basket Swing - Type 1
Manufacturer: Playdale Playgrounds Ltd

Finding: The overhanging branches forms a hard object within the falling space of the equipment in contravention of the requirements of BS EN 1176 Part 1

Action: Cut back and maintain

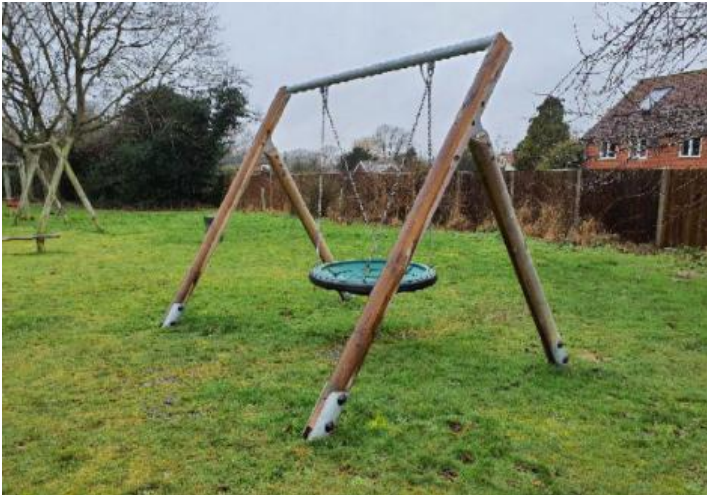
Item: Swings - Basket Swing - Type 1
Manufacturer: Playdale Playgrounds Ltd

Finding: The fixings have corroded excessively

Action: Replace all corroded fixings

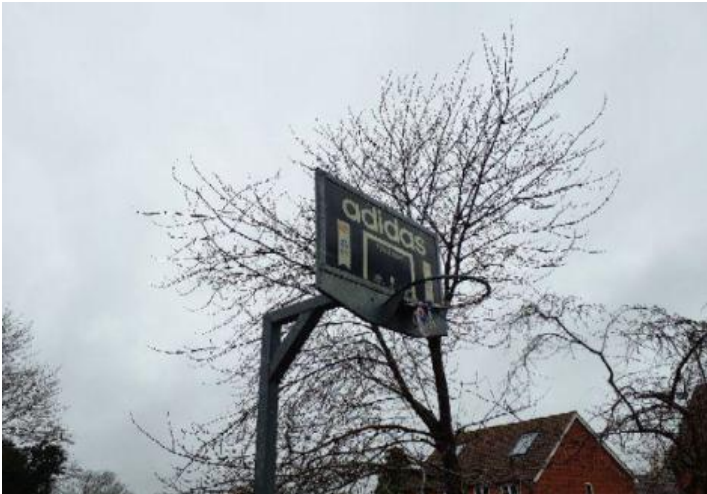
Item: Multi Use Games Area - Basketball Post
Manufacturer: Adidas

Finding: The net is damaged

Action: Replace

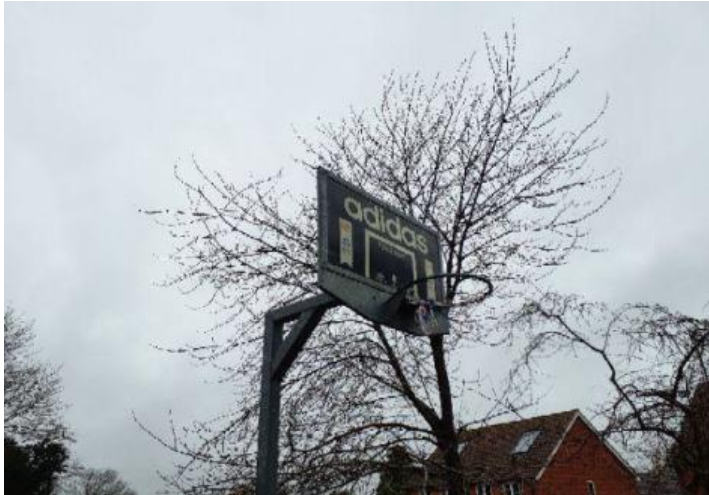
Item: Multi Use Games Area - Basketball Post
Manufacturer: Adidas

Finding: The backboard is damaged

Action: Replace backboard

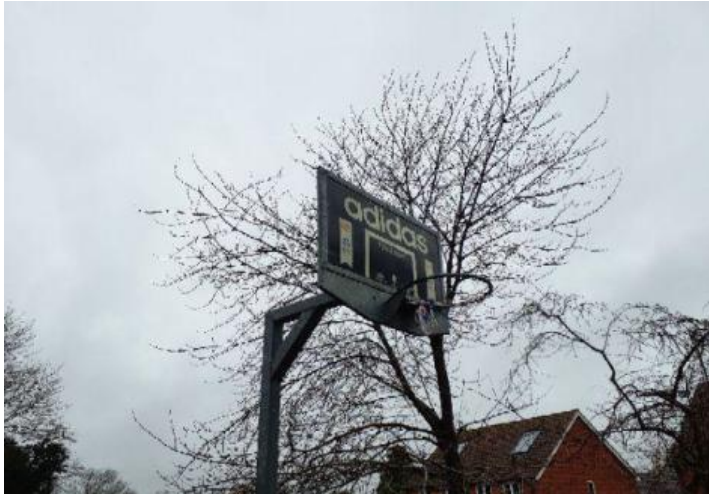
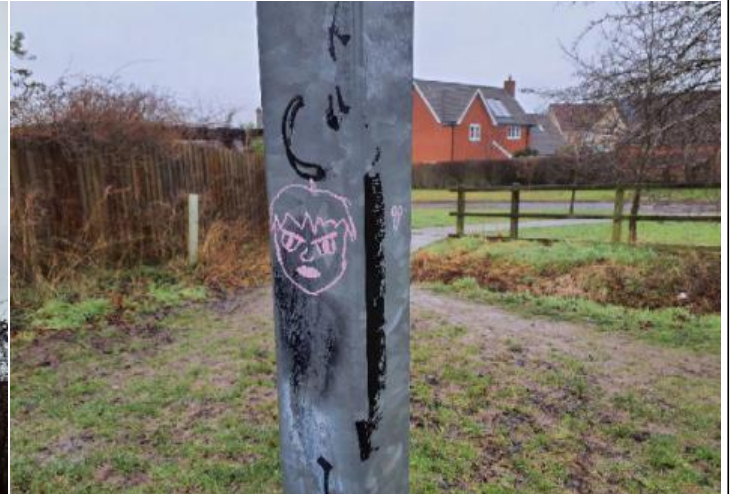
Item: Multi Use Games Area - Basketball Post
Manufacturer: Adidas

Finding: There is offensive graffiti present

Action: Remove as soon as practicable
